Inspection Report

3 Crestview Ct.
Arden NC 28704

Peter Young Home Inspections

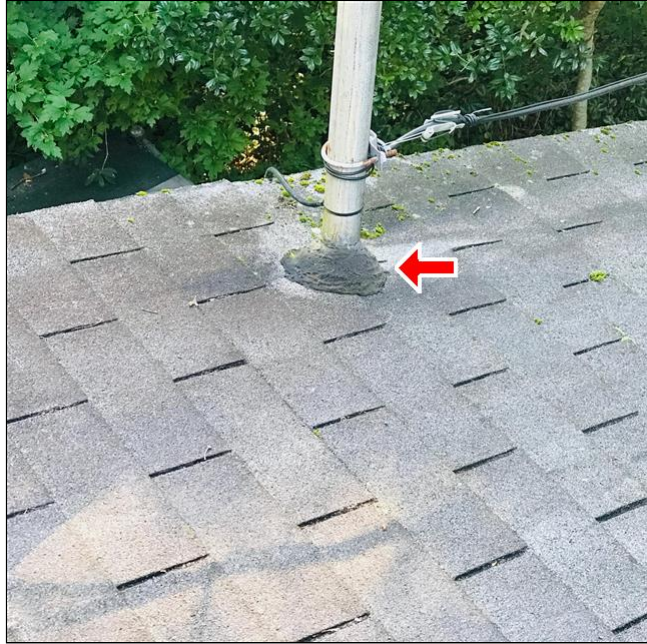
1.1 Item 2 Tared flashing

The electric mast flashing is sealed with roofing tar which will ultimately leak.

I recommend repairs by a roofing contractor.

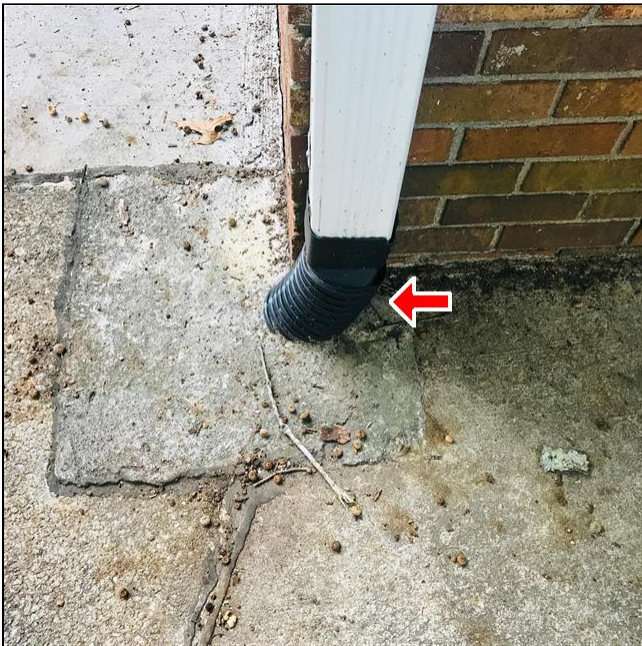
1.2 Item 1

1.2 (1) The drain lines for the downspouts are buried and should be cleaned on an annual basis to be sure that the water is being carried away from the foundation.

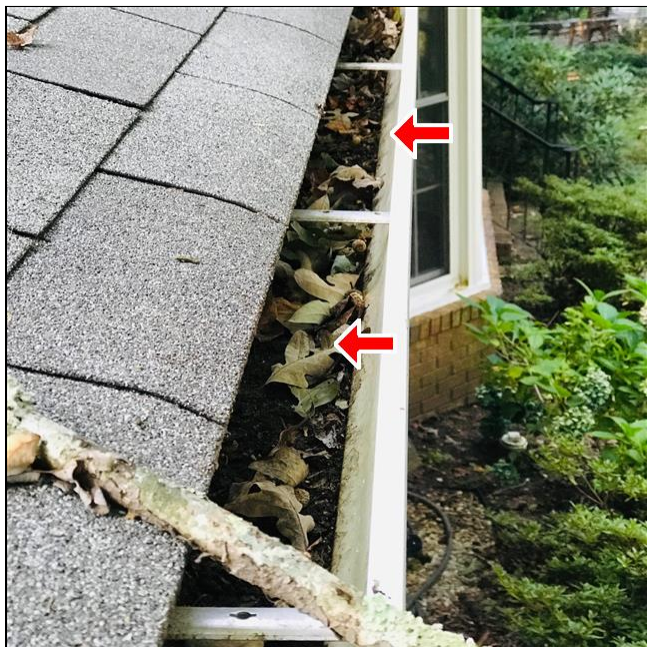
1.2 Item 2

1.2 (2) I always encourage my clients to keep gutters and downspouts free of debris as part of an ongoing maintenance program and to make sure the downspouts discharge the water as far away from the foundation as possible. Water that discharges next to the house from the downspouts or overflowing gutters can go through the foundation wall and enter the crawlspace or basement.

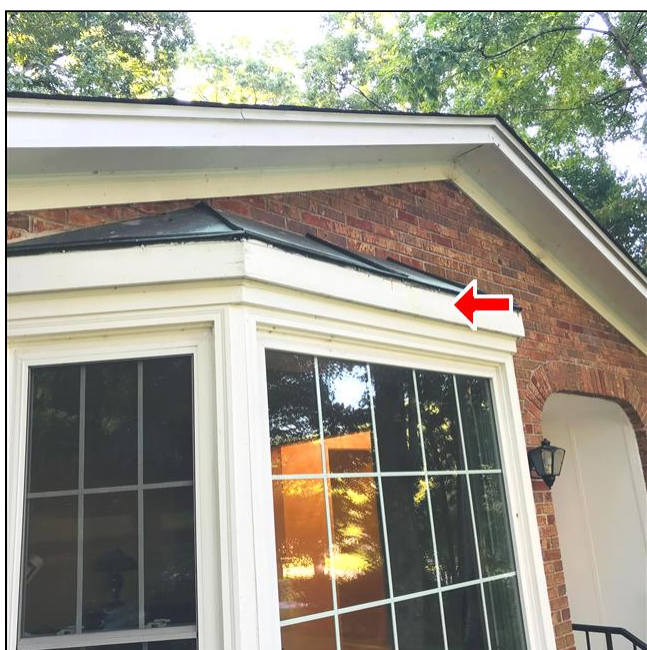
1.2 Item 3 No gutters

1.2 (3) This house has partial gutters. The front bay window did not have gutters. It would be beneficial to have gutters installed throughout the exterior of the house to make sure that water draining from the roof is directed away from the foundation and structure.

I recommend repairs by a gutter installer.

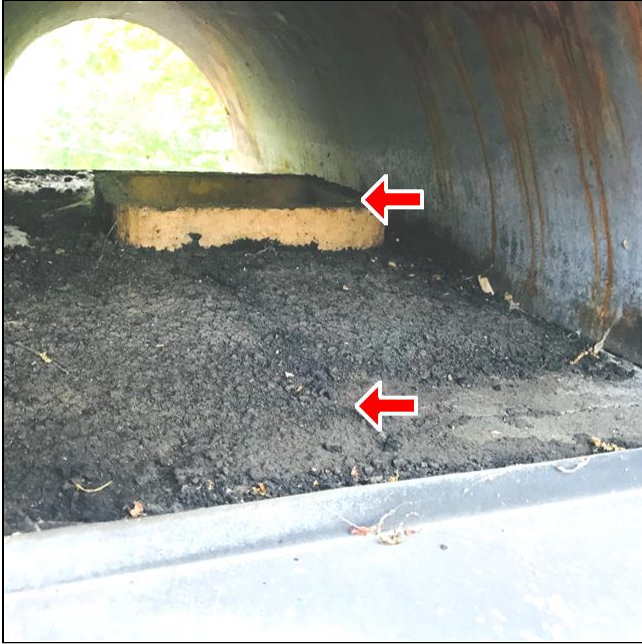
1.3 Item 1 Creasote, no spark arrestor

The chimney(s) had no spark arrestor. All chimneys should have an approved spark arrestor installed to prevent pest and water entry, and to help protect the roof-covering materials from a potential chimney source ignition.

1.3 Accurate inspection of the chimney flue/liner lies beyond the scope of the home inspection. I recommend a chimney sweep inspect the flue/liner and clean as needed for safety before use.

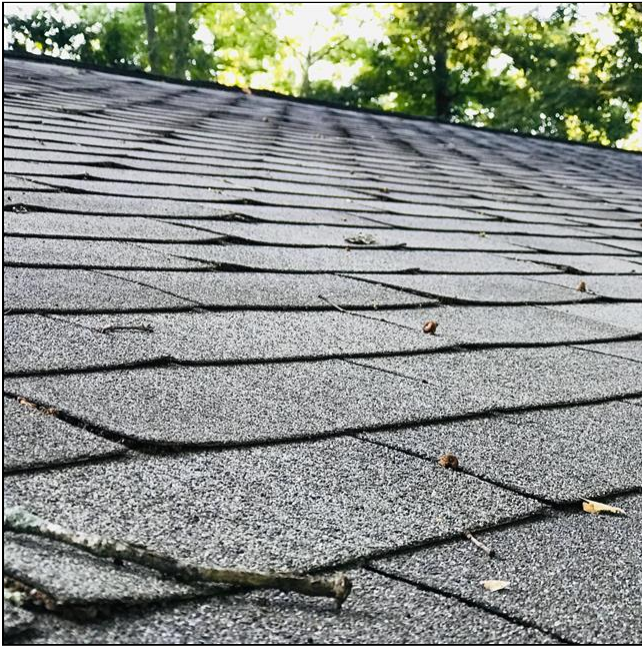
1.4 Item 1 Lifted

1.4 The roof had many shingles that are starting to lift and some granular loss which is a sign of age.

I recommend evaluation by a roofing contractor to determine how many years are left before the roof should be replaced.

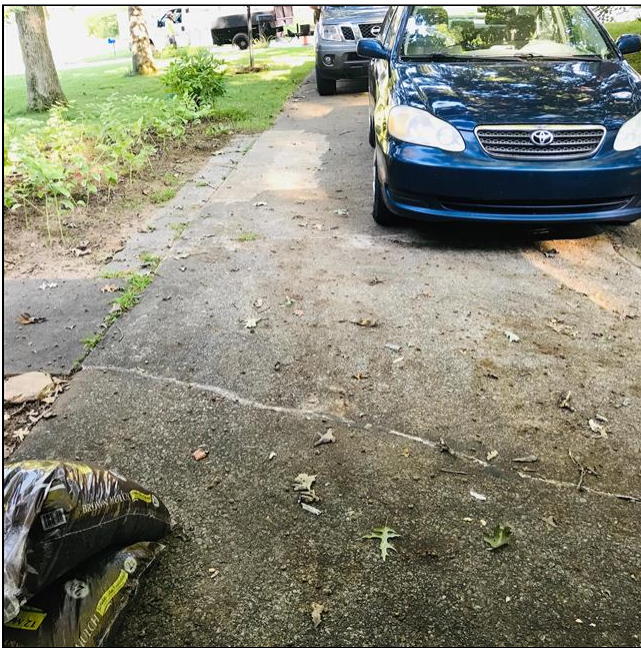
2.0 Item 3

2.0 (4) The grading at the front of the house does not favor the drainage away from the house. This situation can result in water entering the crawlspace or basement. Monitor the drainage and make corrections to the landscaping and drainage as necessary, or consult with a landscape contractor.

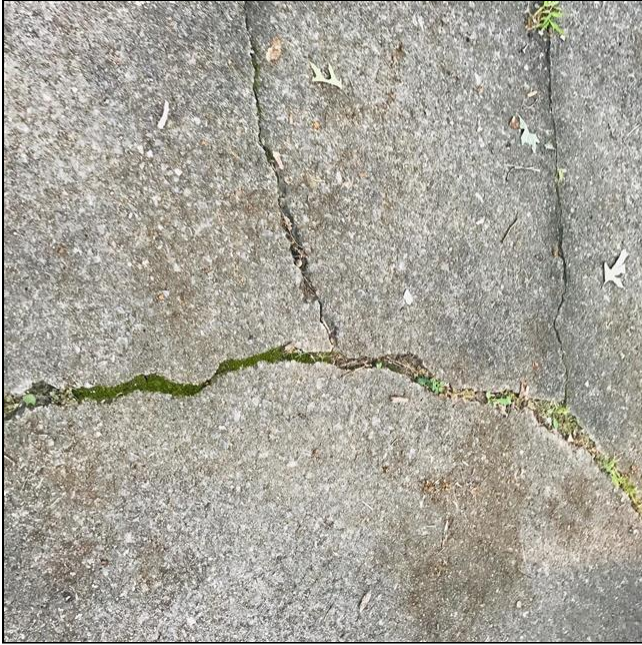
2.1 Item 1

2.1 Common cracks and settlement were visible in the driveway. The cracks should be monitored for further movement and filled with an appropriate sealant to avoid continued damage to the driveway surface from moisture as part of an annual maintenance program.

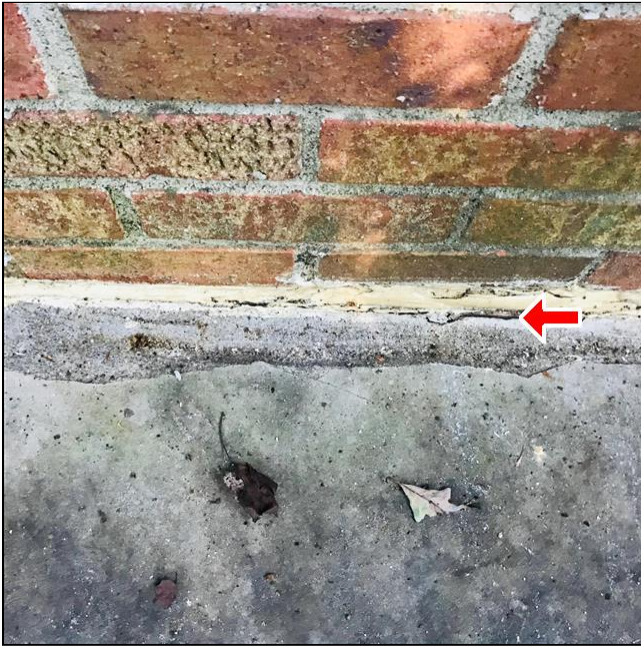
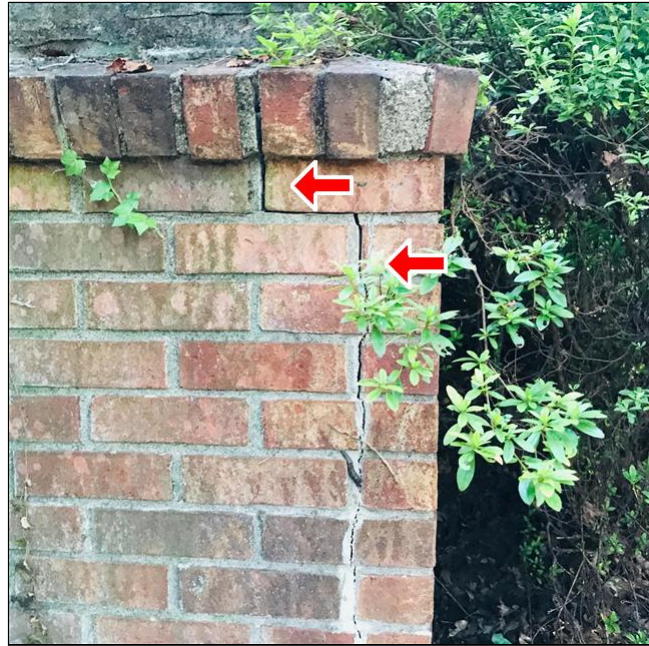
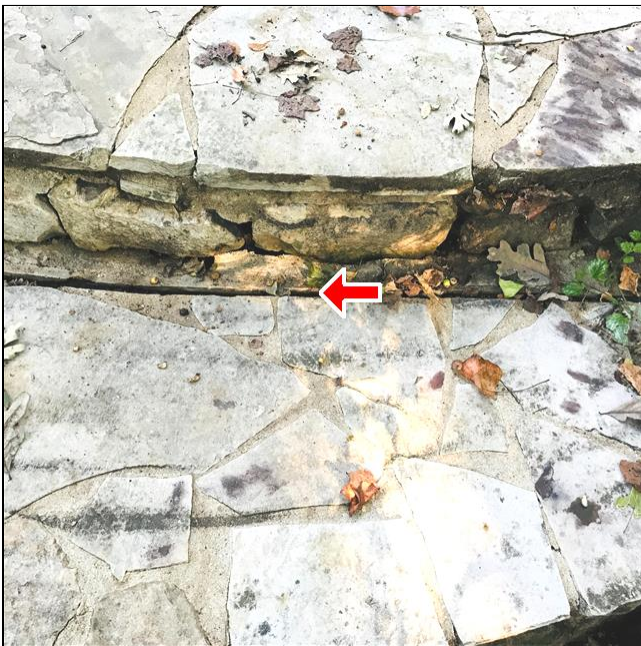
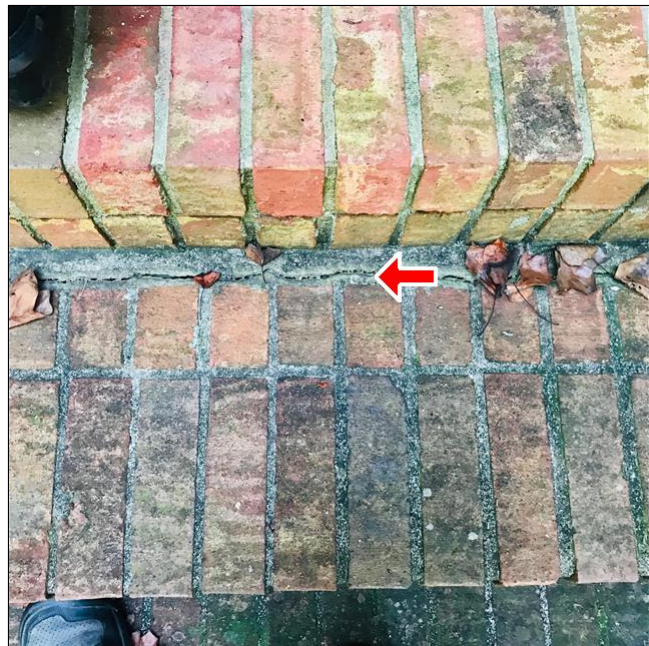
2.3 (1) The rear patio and steps, and the front steps are moving away from the house due to age and settlement.

I recommend evaluation and repairs as needed by a qualified contractor.

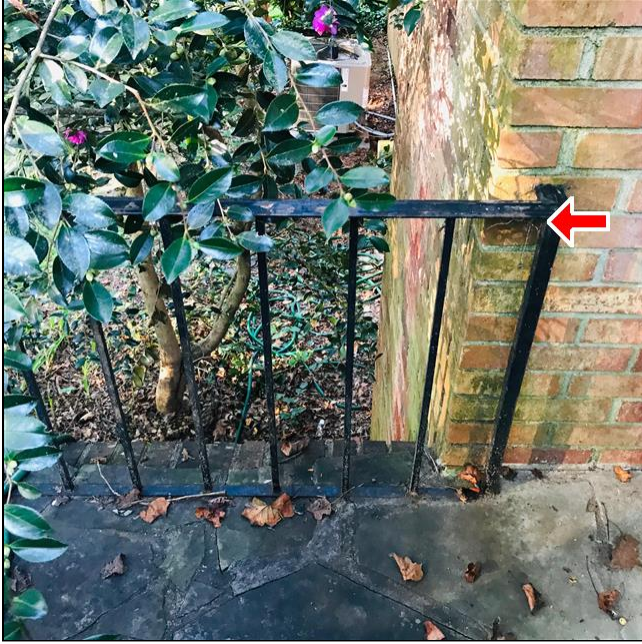
2.3 Item 5

2.3 (2) The rear patio guardrails were too low. Safe building practices dictate that guardrails height should be no lower than 36 inches above the walking surface. This condition is a safety concern.

This would have been allowed when the house was built.

I recommend repairs by a qualified contractor.

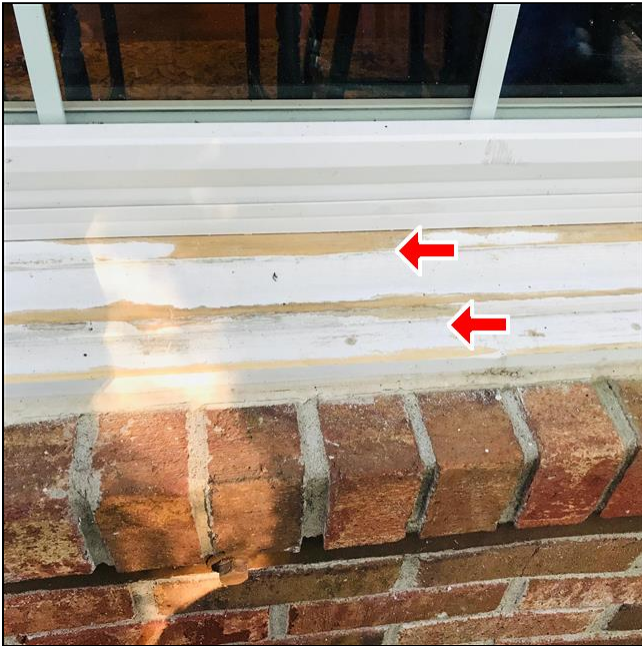
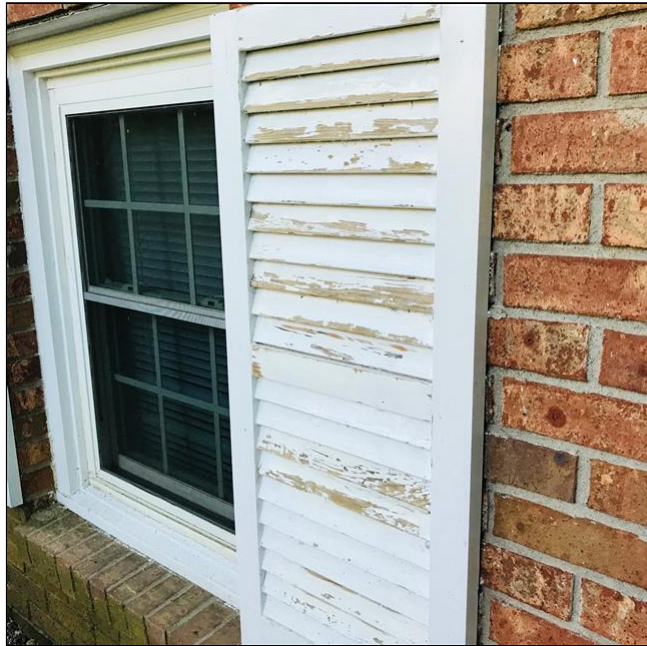
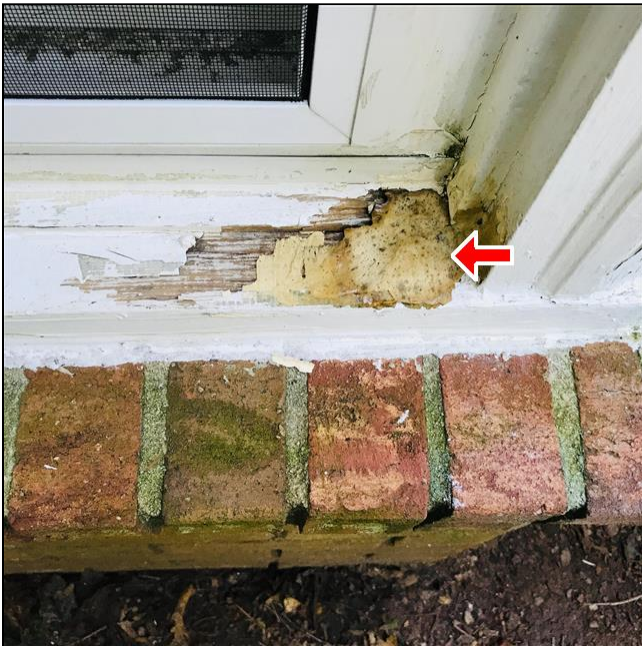
2.4 (1) Areas of the exterior trim had bare wood exposed to weather. To avoid the need for replacement, repair and paint this trim soon.

I recommend repairs by a painting contractor.

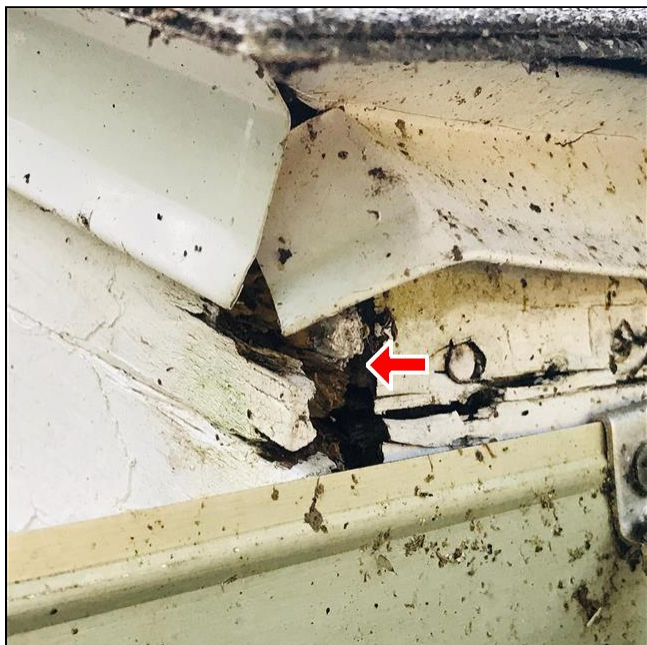
2.4 Item 4

2.4 (2) Areas of the soffit and fascia were water damaged and should be repaired/replaced to prevent water infiltration and further damage.

I recommend evaluation and repairs by a qualified contractor.

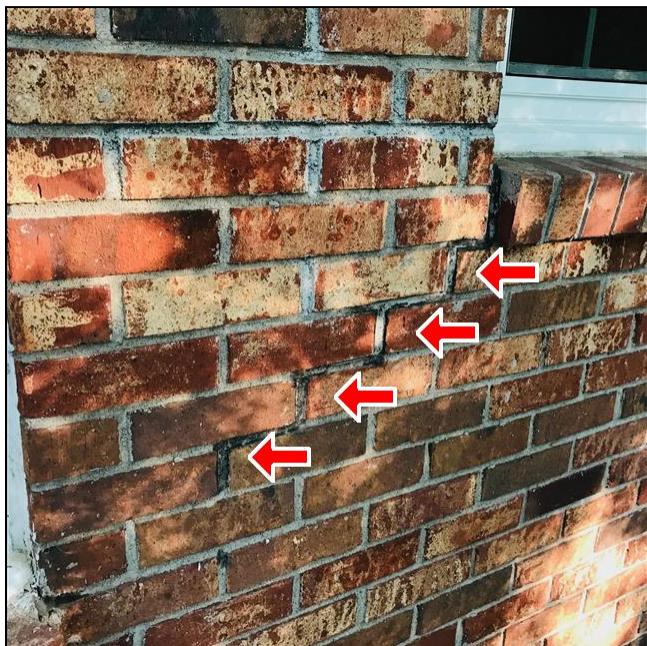
2.7 Item 1

2.7 There are visible repairs to the brick at the rear wall and rear bay window. The repairs appear to be intact at the time of inspection but should be monitored for further movement and repaired when needed.

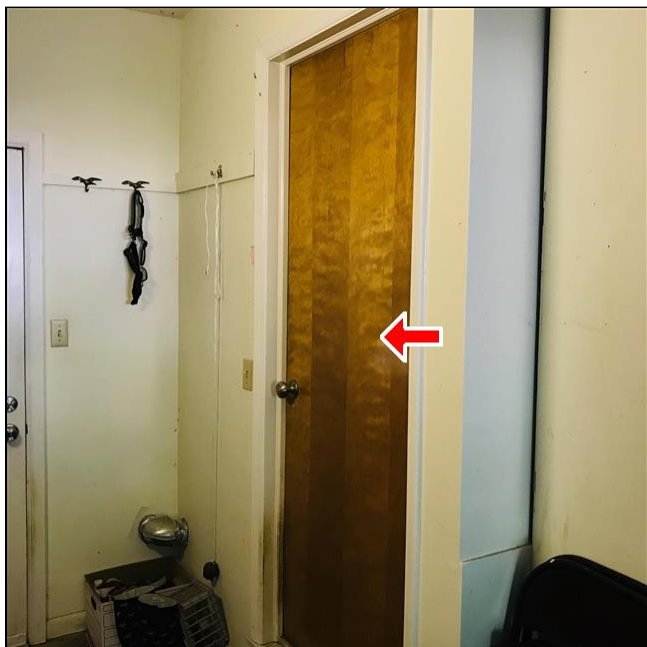
3.1 Item 1

This was not required when the house was built, and is a safety recommendation, not a defect.

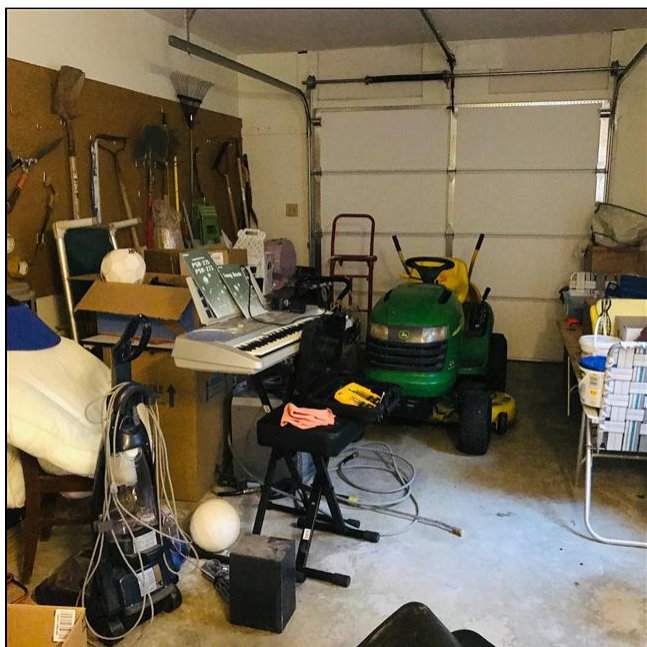
3.4 Item 1

3.4 I could not inspect all of the garage components due to stored items in the garage.

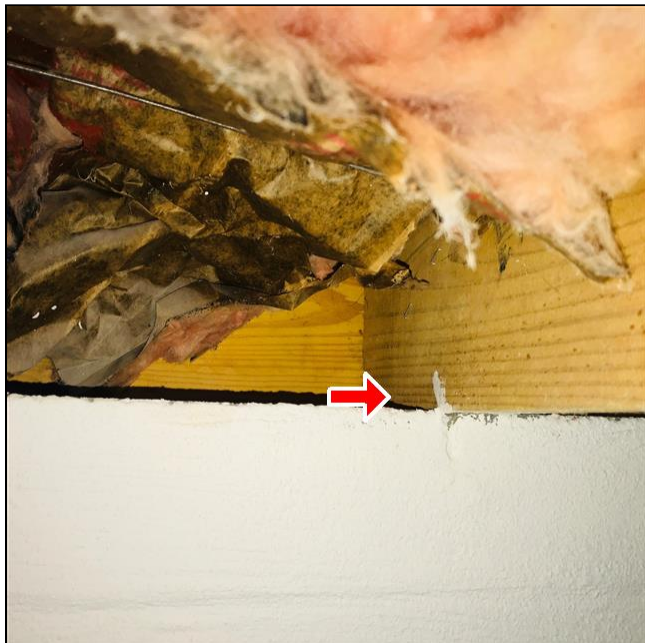
4.0 Item 1

4.0 (1) No anchor bolts were installed to fasten the home structure to the foundation. Installation of anchor bolts may not have been required when this home was built. Older homes are inspected within the context of the time period in which they were built, taking into account the generally-accepted building practices of that time period. Homes are not required to be constantly upgraded to comply with newly-enacted building codes but are only required to comply with building codes or generally-accepted standards that existed at the time of original construction.

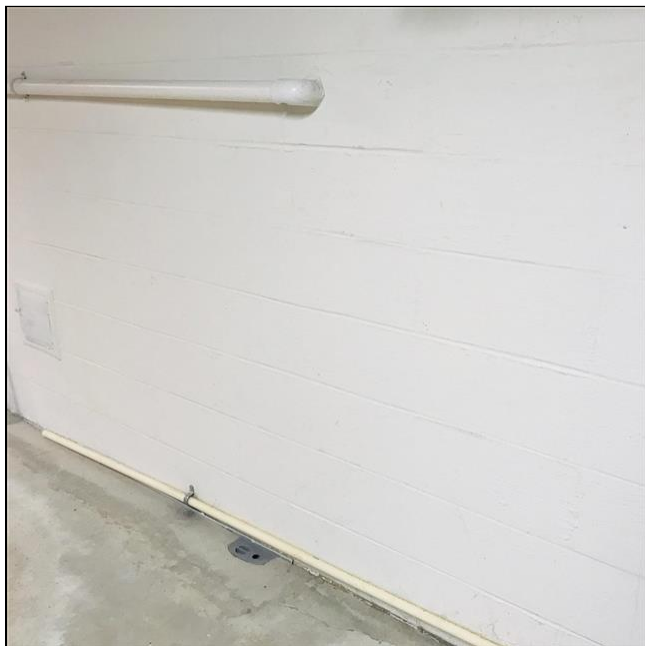
4.0 Item 2

4.0 (2) The basement walls are painted which makes it difficult to see water infiltration.

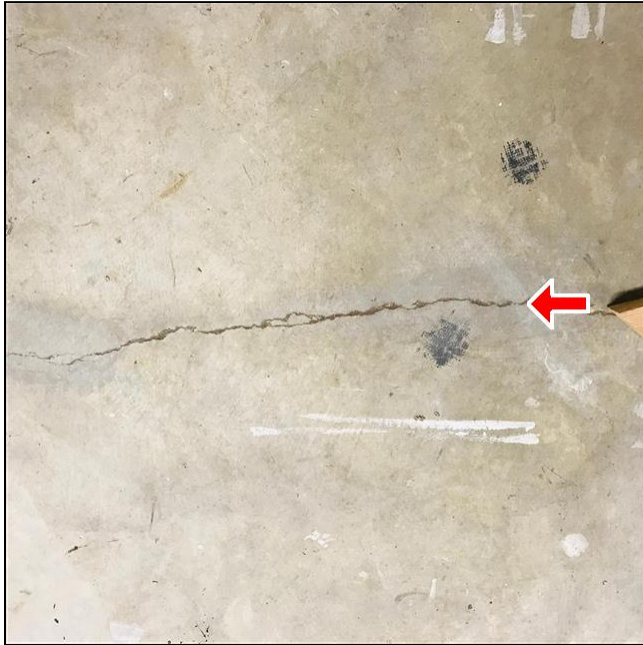
4.2 Item 1

4.2 Common cracks were visible in the concrete slab. The cracks should be monitored for further movement and filled with an appropriate sealant to avoid continued damage to the concrete slab from moisture.

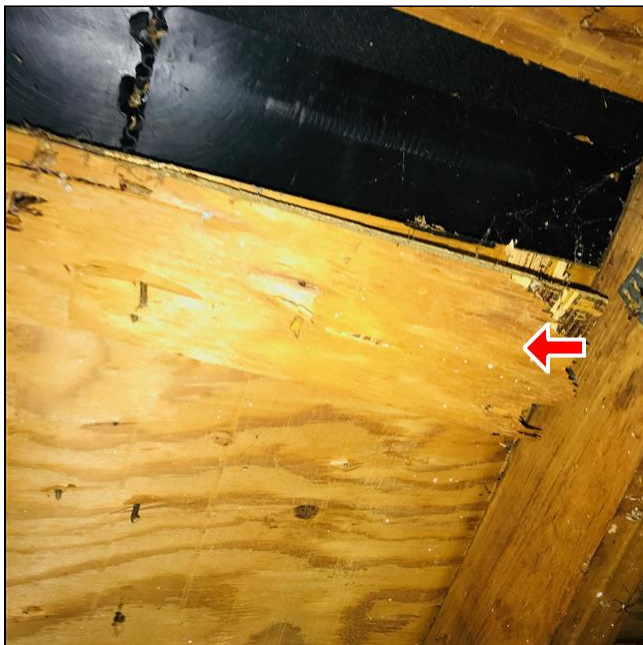
4.6 Item 1

4.6 (2) There is roof sheathing at the peak of the roof that is less than 16" wide. This will cause excessive flexing of the sheathing in this area. The sheathing should be replaced the next time the roof is resingled by a roofing contractor.

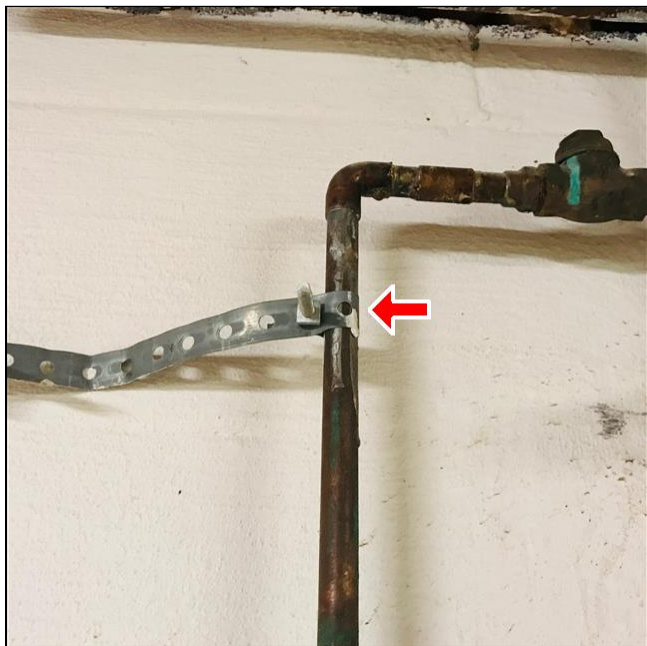
5.2 Item 1

5.2 (1) The piece of steel strapping near the main water shut off should be removed as steel will corrode copper piping.

I recommend repairs by a competent handyperson.

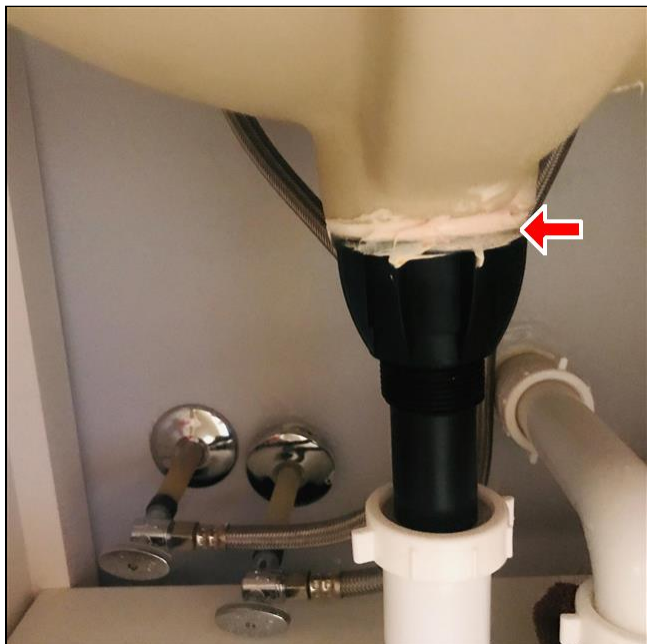
5.8 Item 1

5.8 The bathroom sink drains are sealed with caulk which is unusual. Either the sinks have leaked or the installation was poor. Monitor the sinks for leaking and repair if needed.

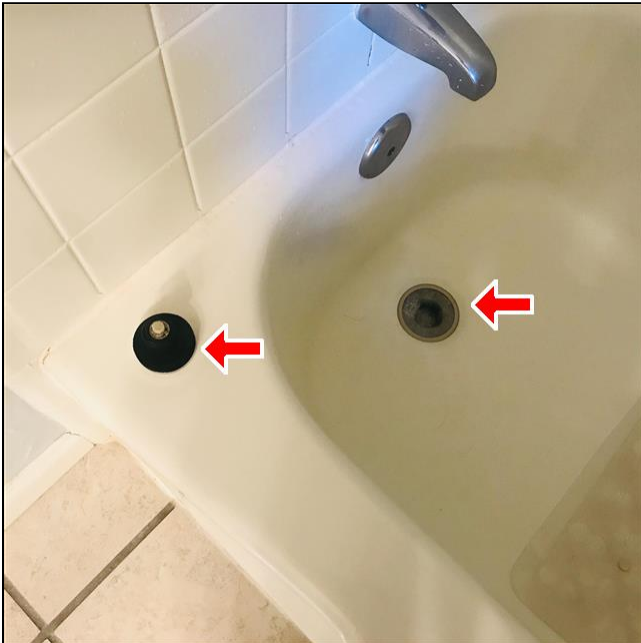
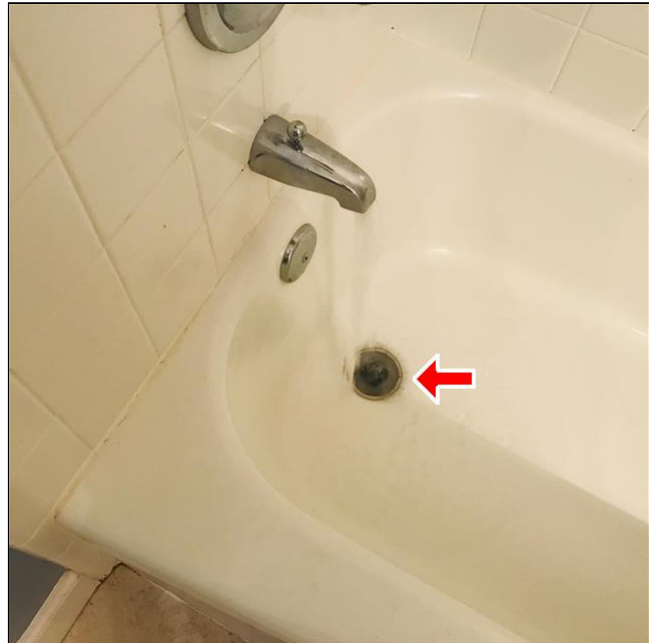
5.9 The tub in the hallway bathroom and master bathroom had an inoperable or missing stopper which means the tub cannot hold water.

I recommend repairs by a plumbing contractor.

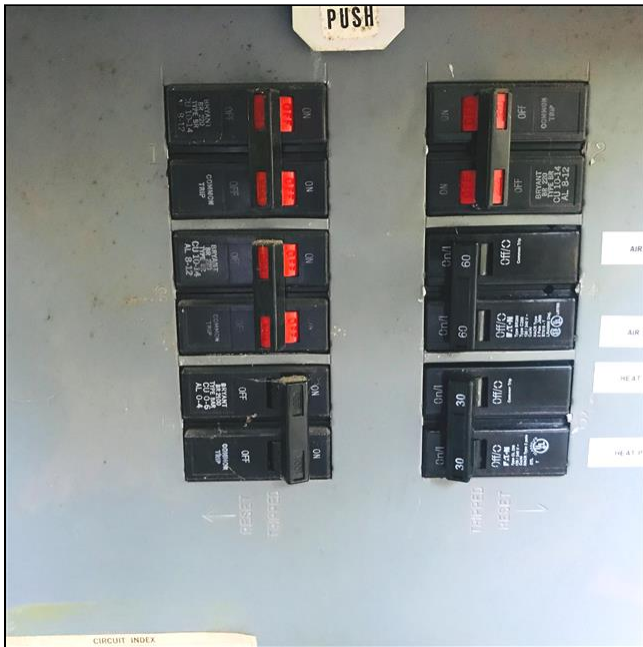
6.1 Item 1

6.1 (1) Circuit breakers in the service panel were of a brand different from the service panel brand. Because circuit breakers made by different manufacturers vary in design, panel manufacturers typically require that breakers manufactured by their company, or breakers listed on the load center info sheet on the inside panel cover, be used in their panels. Breakers from one manufacturer used in the panel of another manufacturer may result in poor connections which can create a potential shock hazard. I recommend inspection/correction by an electrical contractor.

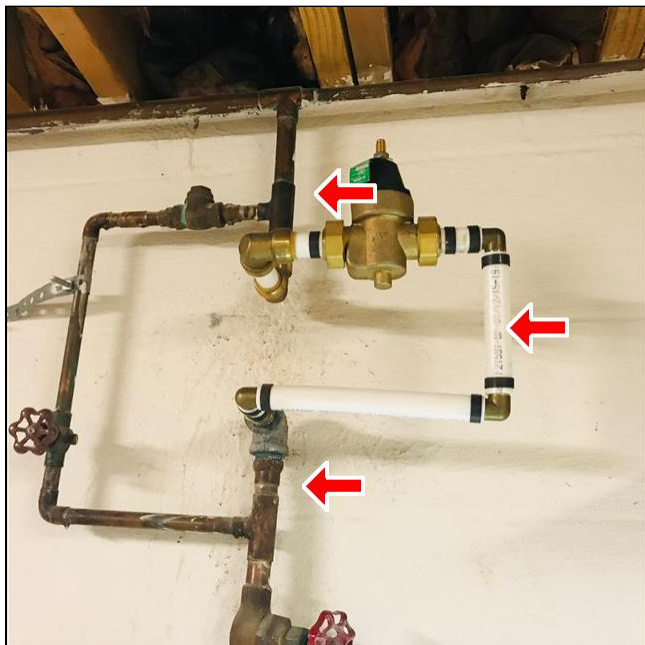
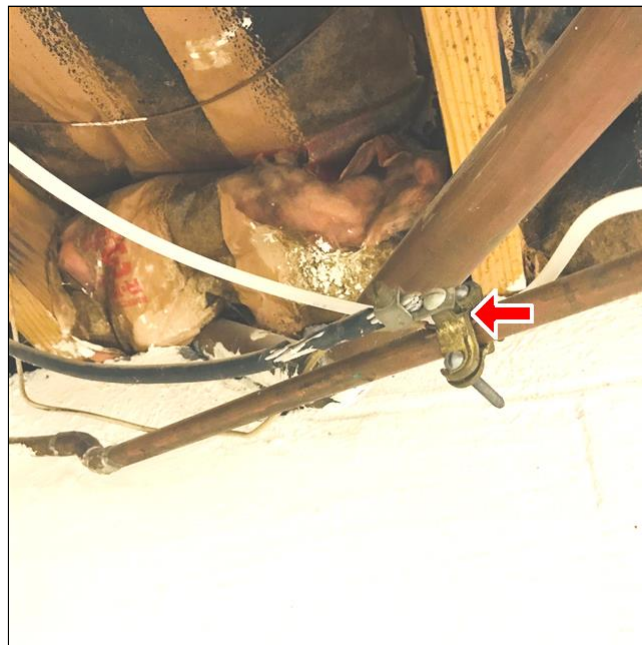
6.1 (2) There are both metal and plastic water supply pipes in the basement. When both plastic and metal pipes are installed it is important that an electrical grounding connection be provided between any separate metal pipes. This connection is called a "bonding jumper". I could not determine if all of the metal pipes are properly bonded.

I recommend evaluation and repairs as needed by an electrical contractor.

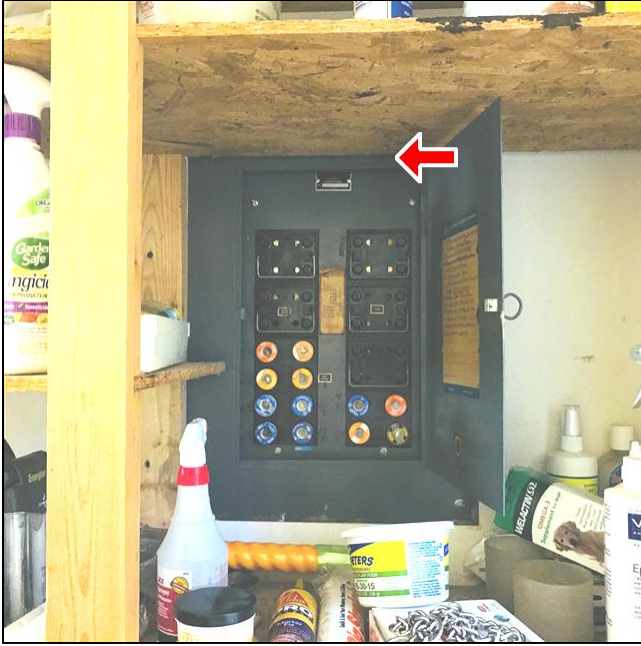
6.2 Item 1

6.2 The sub panel did not have proper clearances to provide quick access for an emergency disconnect. The clear working space required in front of a panel is 30" wide by 36" deep with a minimum headroom clearance of 6 feet-6 inches. I could not remove the panel cover due to shelving that blocked access. Once the shelving is removed I recommend evaluation of the panel by an electrical contractor.

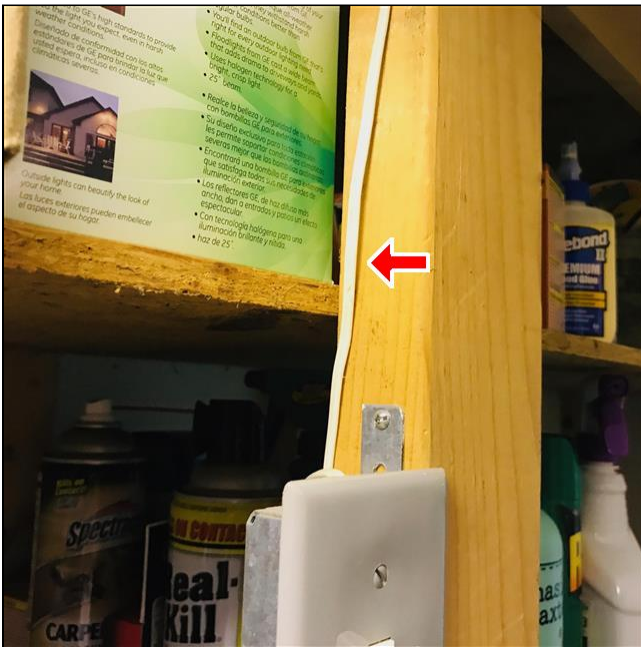
6.3 Item 1

6.3 Extension cords used as permanent wiring were visible at the garage. This condition is a potential fire hazard.

I recommend repairs by an electrical contractor.

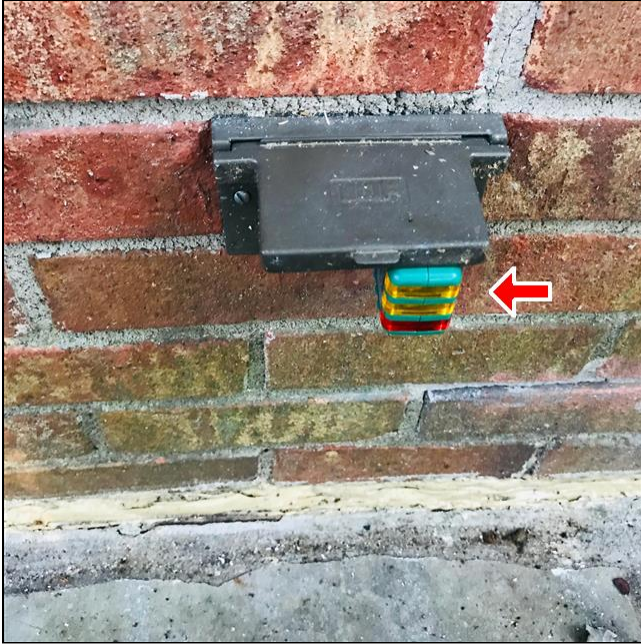
6.4 Item 1 No power

6.4 There was no power to the rear exterior receptacle.

I recommend repairs by an electrical contractor.

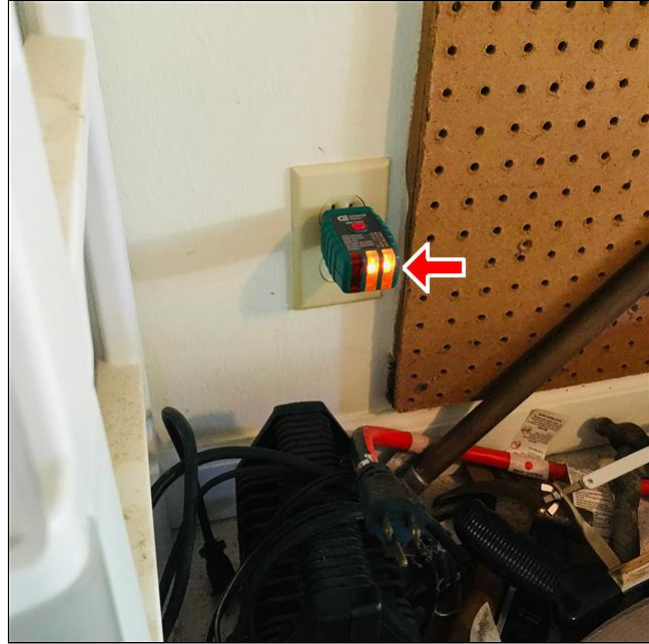
6.4 Item 2 No GFCI, garage

No GFCI protection was provided at the garage. Although GFCI protection may not have been required at the time the home was built I recommend that GFCI protection be provided to avoid potential electric shock.

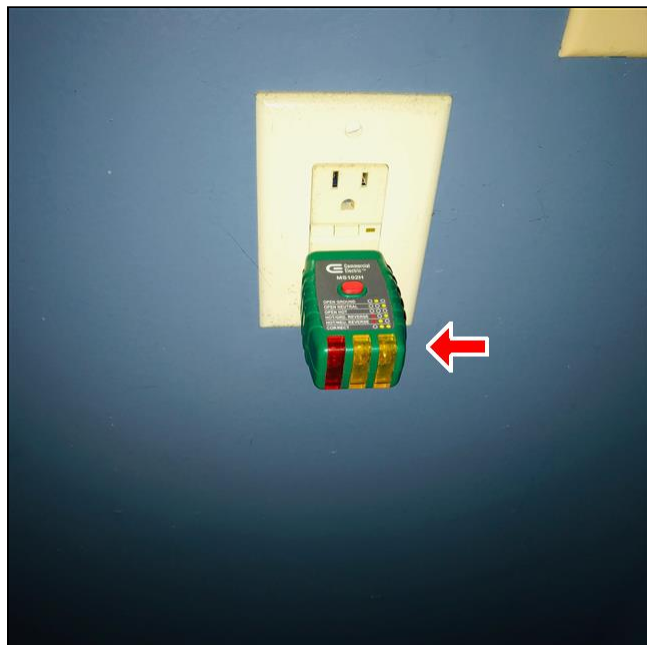
6.6 Item 1 No power

6.6 (1) There is no power to 1 GFCI receptacle in the basement.

I recommend evaluation and repairs by an electrical contractor.

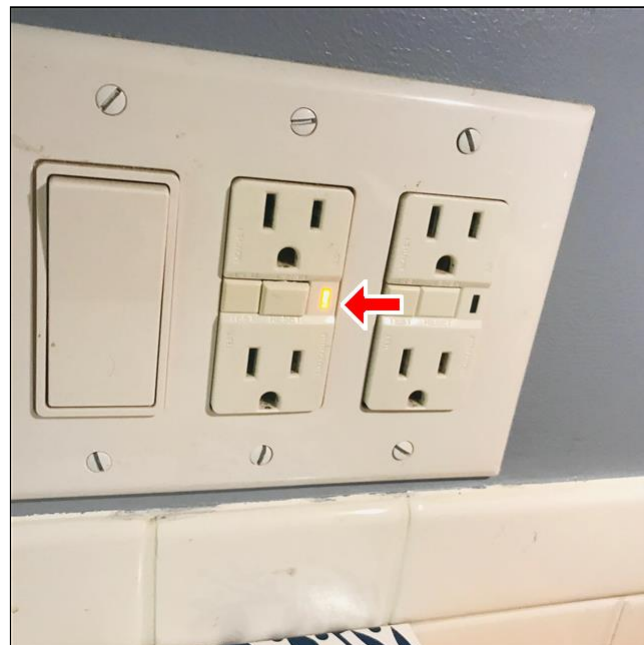
6.6 Item 2 Did not reset

One GFCI receptacle in the kitchen tripped but will not reset and needs to be replaced.

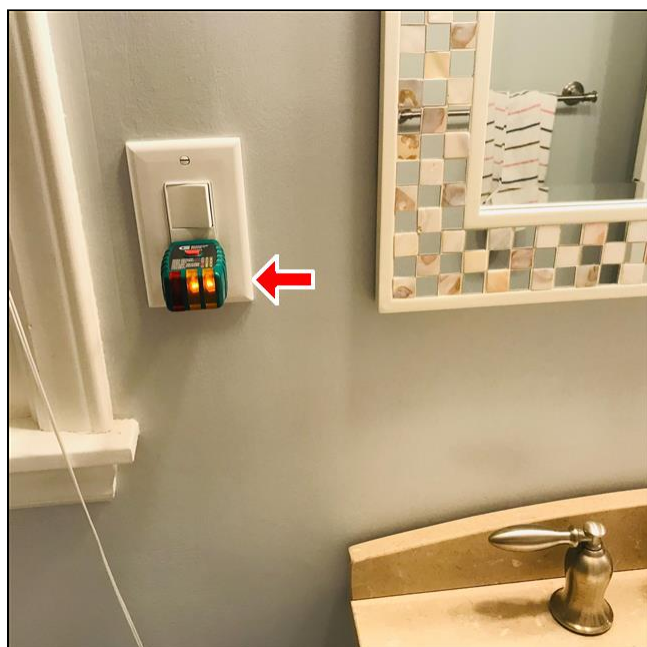
6.6 Item 3 No GFCI

The left side receptacle in the master bathroom is not GFCI protected which is a shock hazard.

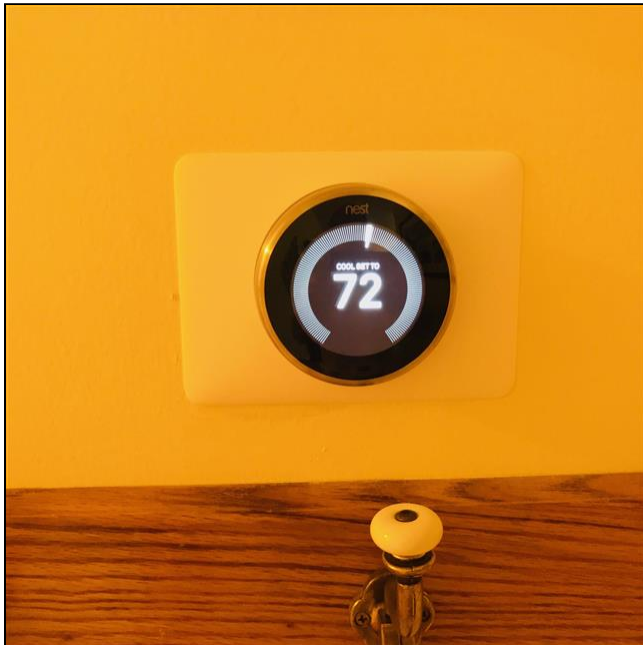
7.2 Item 1

7.2 The furnaces had Nest thermostats which make it difficult for me to access all the functions of the HVAC systems without the smart phone that is linked to the thermostat. Have an HVAC contractor show you how the thermostats function and be sure that all the functions operate as intended.

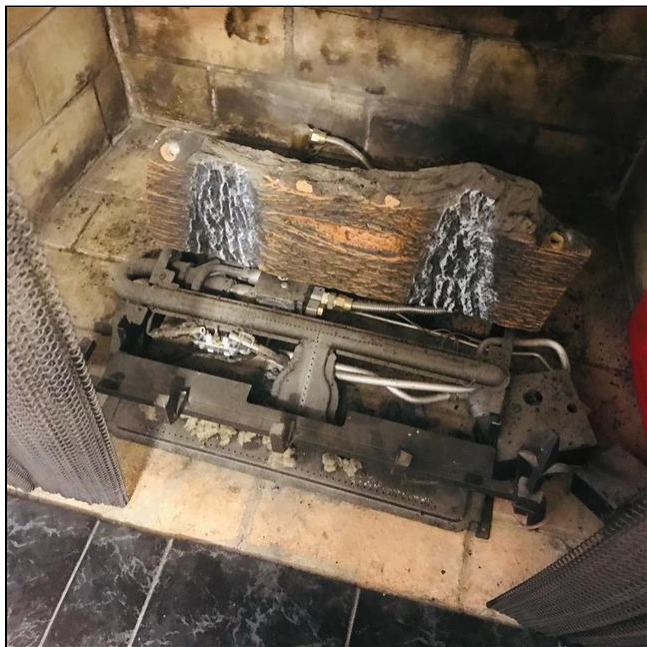
7.7 Item 1

7.7 The gas log unit in the living room was turned off at the gas shut off or controls. Turning on gas appliances lies beyond the scope of the home inspection. Ask the seller to demonstrate the functionality of this fireplace or have it inspected by a specialist.

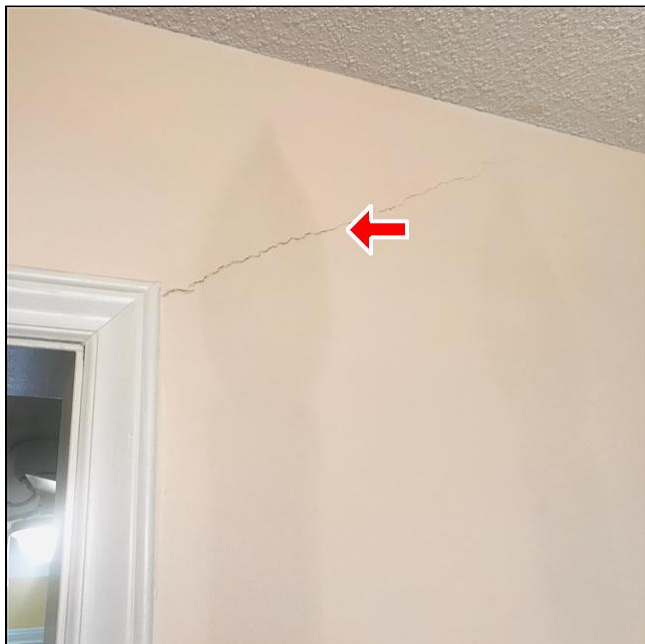
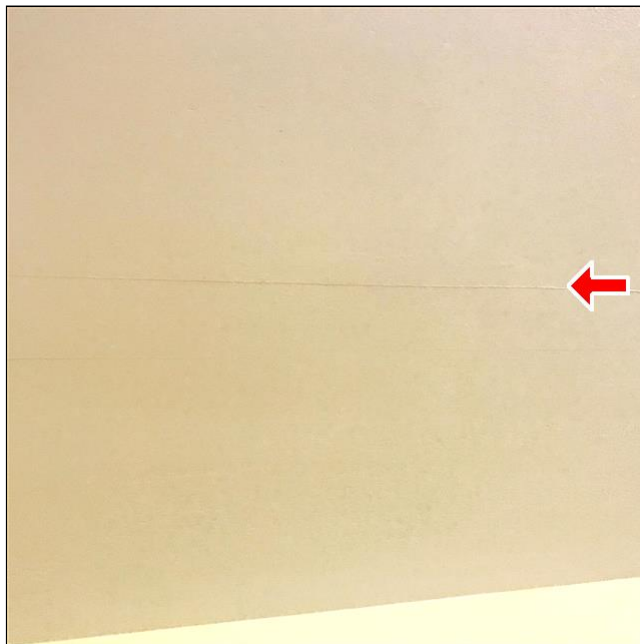
9.1 The crack(s) that can be seen in the walls and/or ceilings are due to settling of the house and movement of the framing over the years. The cracks do not indicate structural problems unless they become quite wide or the wallboard begins to loosen from the framing.

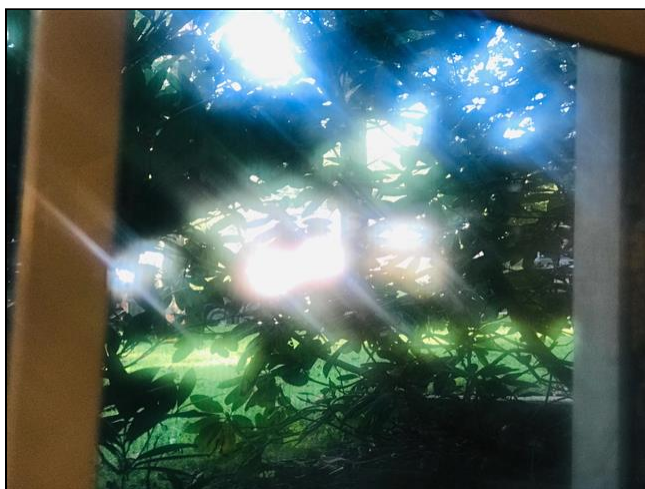
9.2 Item 1

9.2 (1) A window or windows in the basement have lost their thermal seal. When insulated glass loses its seal, condensation can occur between the panes and the glass generally clouds on the inner faces where it cannot be cleaned. There is a slight loss of insulating quality, but the main problem is visual. The glass may eventually become so clouded that it completely loses its transparency.

I recommend repairs by a window repair specialist, but try washing the window first to be sure it is not a dirty window.

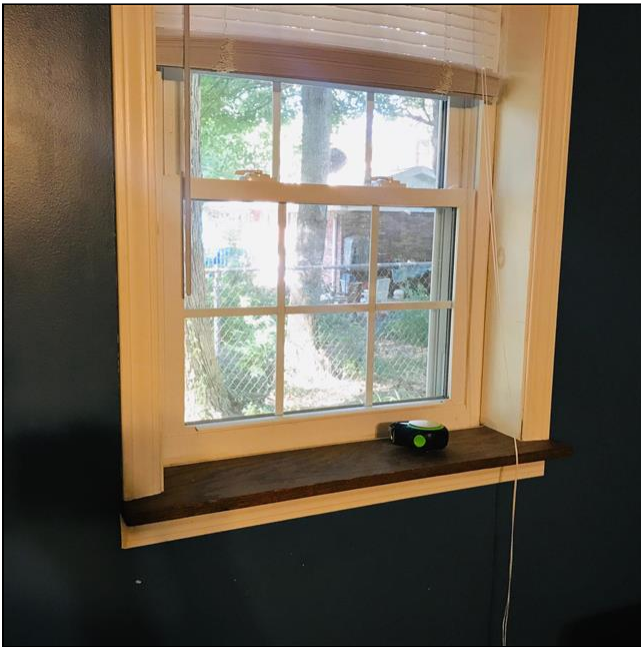
9.2 Item 2

9.2 (2) All bedrooms need a window that meet the requirements for emergency egress in case of a fire, unless they have a door to the exterior. The minimum net clear opening shall be not less than 5 square feet for a window at ground level and not less than 5.7 square feet for a upper story window. The minimum width shall be 20 inches and the minimum height shall be 24 inches. The sill height cannot be more than 44" off the floor.

The front basement room does not have this requirement. This would not have been required when the house was built and is for your information.

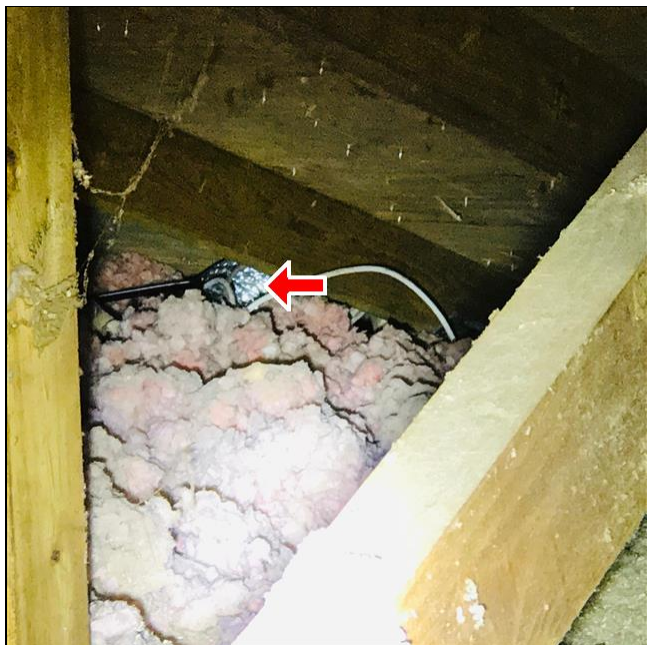
10.3 Item 1

10.3 The vent fans in the bathrooms are ducted into the soffits without any duct cap or damper. This means that moist air drawn from the bathrooms is blown into the eave, where over time it could contribute to moisture related problems in the wood framing of the soffit. The ducts should be extended through the cladding and an appropriate cap/damper be installed to terminate the duct.

I recommend repairs by an HVAC contractor.
