Inspection Report

Property Address:
580 Maple Street
Brevard NC 28712

**Dan O'Brien 2421 2421
O'Brien Home Inspections
791 Capps Road
Pisgah Forest, NC 28768**

Date: 11/13/2020	Time: 10:00 AM	Report ID:
Property: 580 Maple Street Brevard NC 28712	Customer: Sam & Piper Potter	Real Estate Professional: Catherine Craven Looking Glass Realty

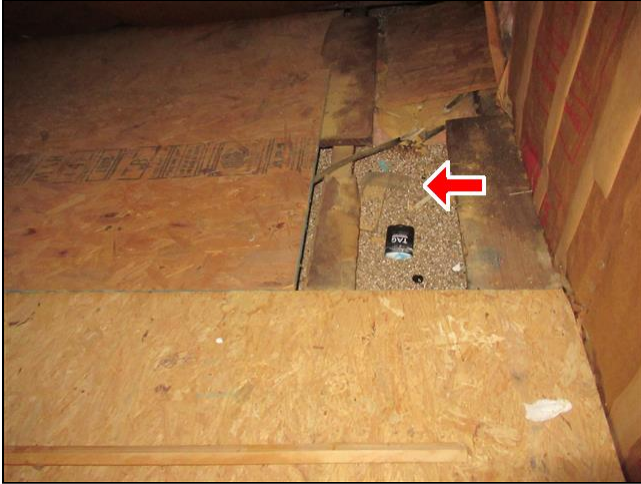
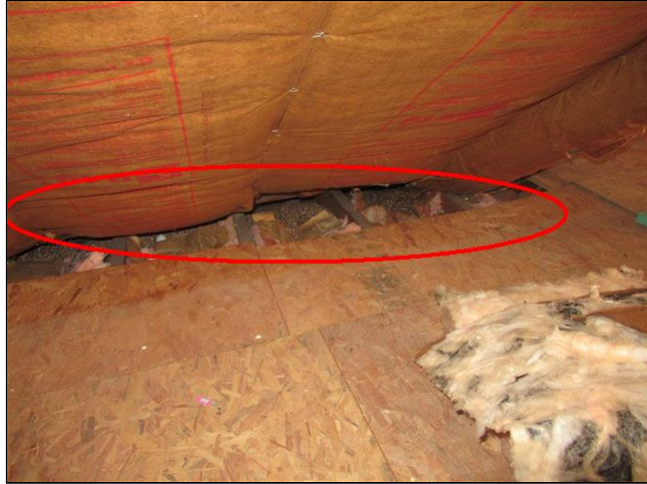
1.7 (1) Evidence suggests that there is vermiculite insulation installed in the attic. This material may contain asbestos fibers. It is recommended to have a certified indoor air quality specialist test the material and safely remove the material as necessary to reduce the risk of health concerns regarding carcinogens.

1.7 Item 1(Picture) vermiculite

1.7 Item 2(Picture) vermiculite

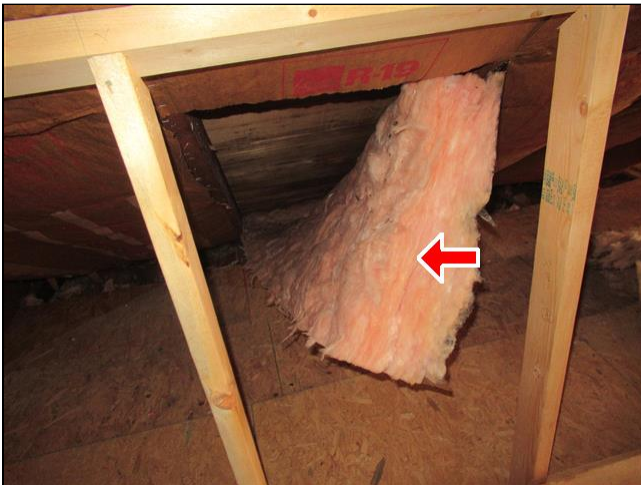
1.7 (2) It is recommended to have a qualified contractor secure all loose fiberglass insulation to promote the intended function.

1.7 Item 3(Picture) secure the insulation

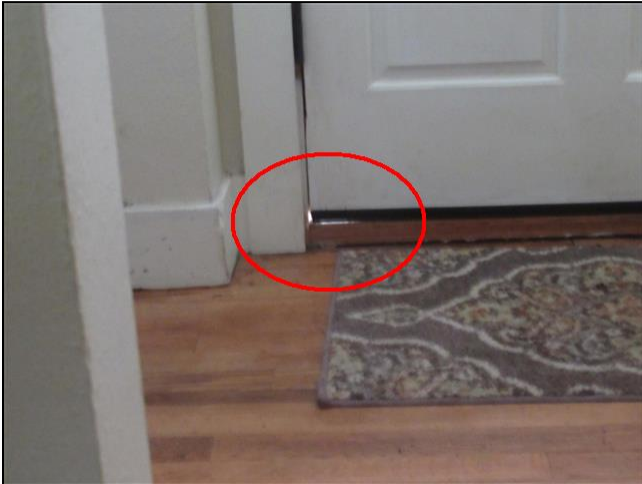
🏠 2.1 Daylight is visible at the main entry door. It is recommended to have a qualified person install weather stripping to reduce the risk of weather and pest entry into the structure.

2.1 Item 1(Picture) front door

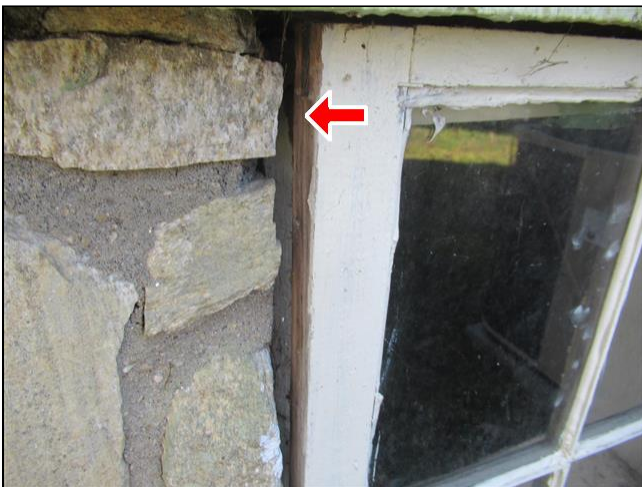
🏠 2.2 The right basement window, as viewed from the exterior, is loose and there are air gaps. The basement window under the deck has broken glass. It is recommended to have a qualified carpenter repair or replace the windows to reduce the risk of weather and pest entry.

2.2 Item 1(Picture) right basement window

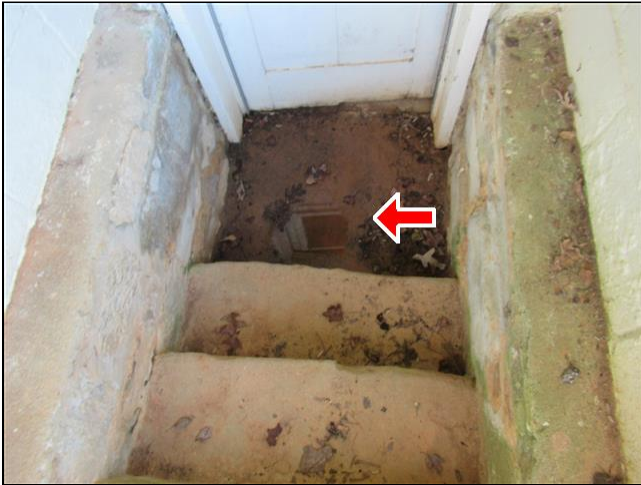
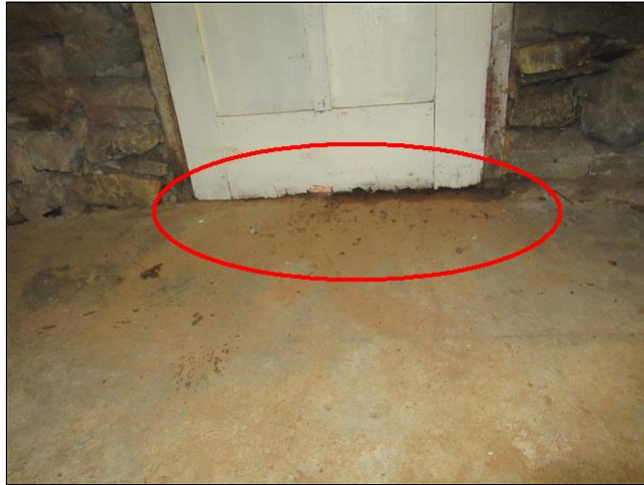
2.4 There is standing water visible at the bottom of the basement exterior stairs. The basement door is damaged, most likely due to water intrusion. It is recommended to have a qualified contractor make all necessary repairs to the site drainage prior to replacing the damaged door.

2.4 Item 1(Picture) standing water

2.4 Item 2(Picture) basement door

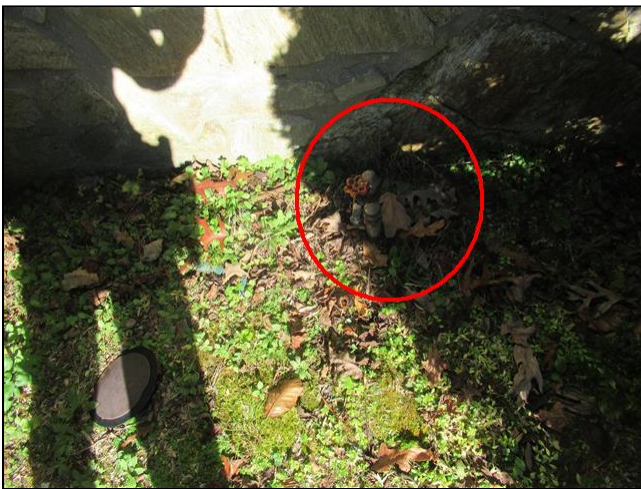
2.6 There is a galvanized water line at the South side of the house. It is recommended to insulate this water line as necessary to reduce the risk of damage during freezing temperatures.

2.6 Item 1(Picture) galvanized plumbing

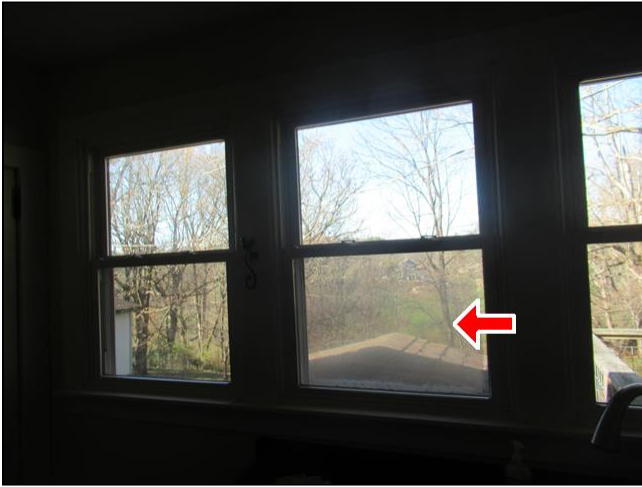
3.4 The bottom sash at the center window is cloudy in between the panes of glass. This is indicative of a failed thermal seal. It is recommended to have a qualified window contractor repair or replace the window to reduce the risk of further damage.

3.4 Item 1(Picture) kitchen window

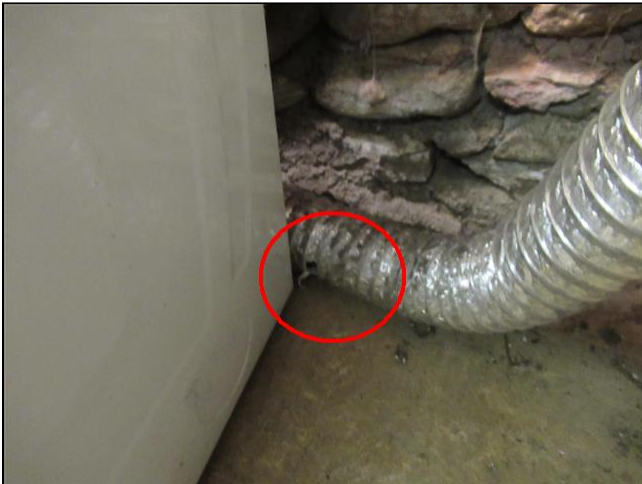
3.15 There is a hole in the dryer duct. It is recommended to have a qualified contractor repair or replace the duct to promote proper ventilation.

3.15 Item 1(Picture) hole in the duct

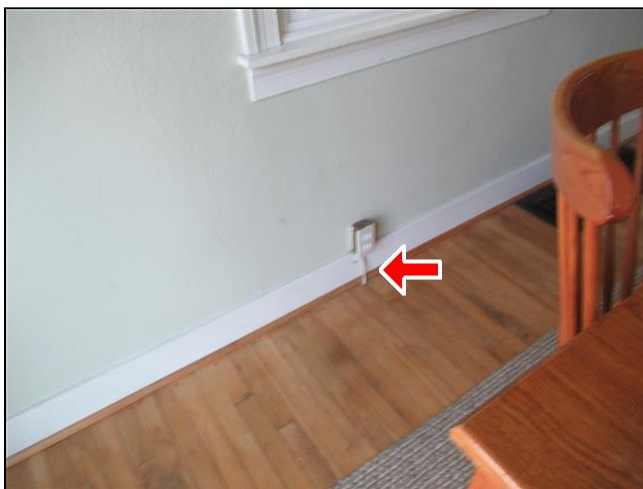
↑ 4.6.A There is unprotected wiring at the outlet below the window. It is recommended to have a qualified electrician or carpenter provide physical protection for the wiring to reduce the risk of personal injury and property damage.

4.6.A Item 1(Picture) protect the wiring

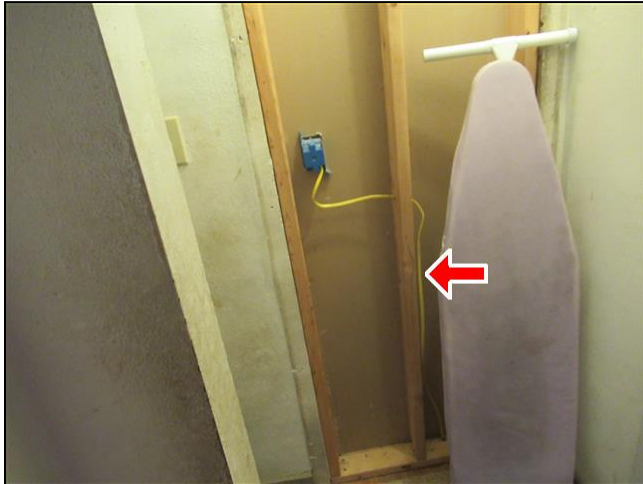
4.6.B (1) It is recommended to have a qualified carpenter provide physical protection for the wiring at the top of the interior basement stairs.

4.6.B Item 1(Picture) protect the wiring

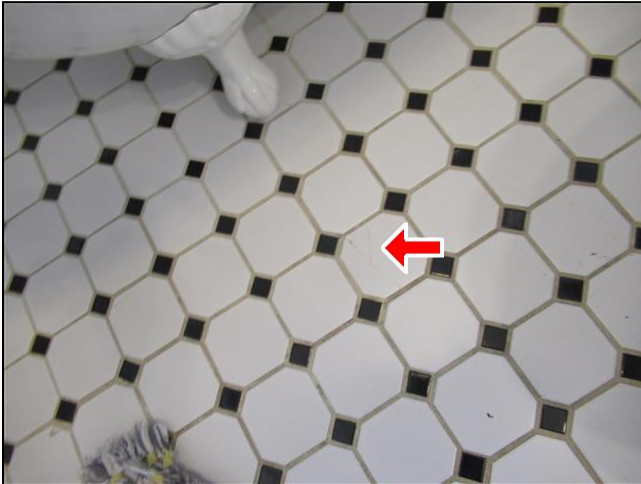
**5.7** There are cracked tiles in the bathroom floor. It is recommended to have a qualified flooring contractor repair or replace the damaged tiles.

5.7 Item 1(Picture) cracked tile

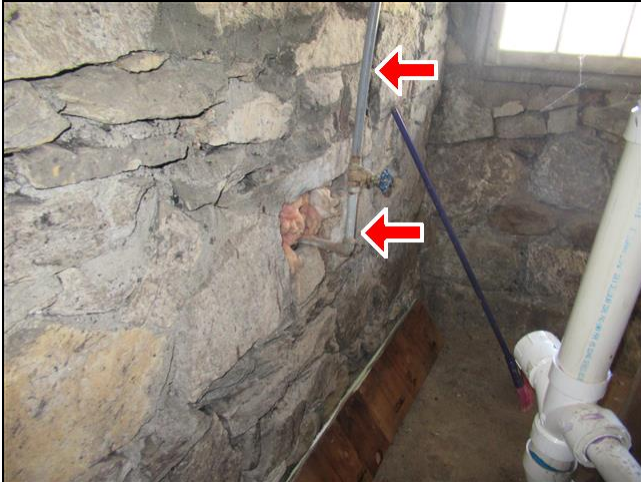
7.1 The main water line that enters the house is made of galvanized metal. This material has a history of corroding. If reduced water pressure or water consumption increases without just cause, it is recommended to have a licensed plumber replace the main water line. Reduced water pressure is evident.

There is a small section of polybutylene water line at the main shut off location. Replacement is recommended due to a known history of material defects.

7.1 Item 1(Picture) galvanized and polybutylene

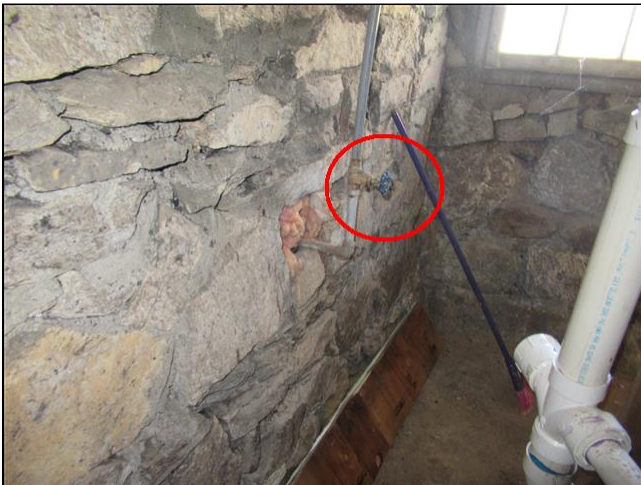
7.3 The main water shut off valve is a green handle located near the basement interior stair system.

7.3 Item 1(Picture) main water shut off valve

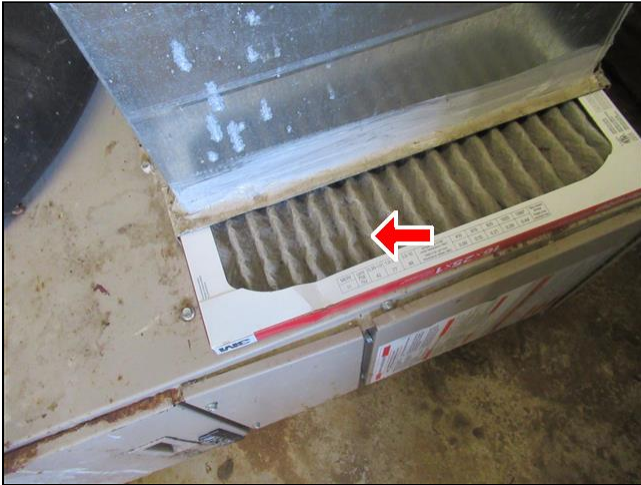
9.3 The Filter is dirty and needs replacing in the basement.

9.3 Item 1(Picture) dirty air filter

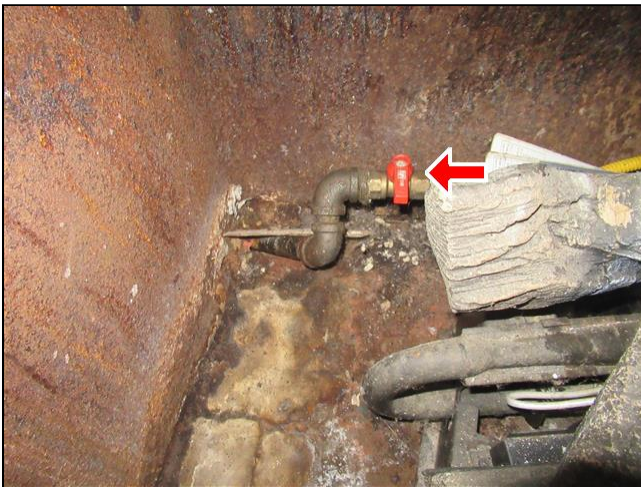
9.7 The gas fired log insert could not be lit at the time of the inspection. The gas supply is shut off at the gas logs. It is recommended to ensure that the gas logs are functioning as intended prior to closing on the purchase of the property.

9.7 Item 1(Picture) gas shut off valve

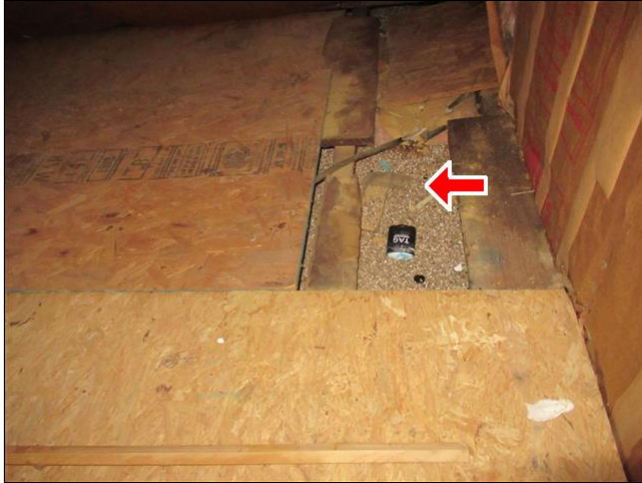
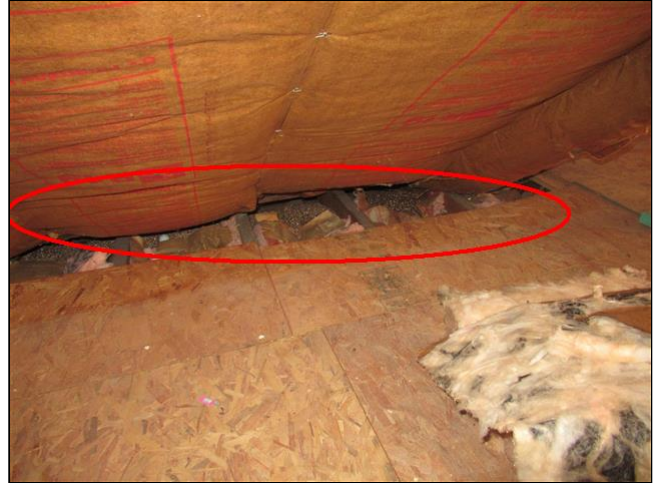
(1) Evidence suggests that there is vermiculite insulation installed in the attic. This material may contain asbestos fibers. It is recommended to have a certified indoor air quality specialist test the material and safely remove the material as necessary to reduce the risk of health concerns regarding carcinogens.

1.7 Item 1(Picture) vermiculite

1.7 Item 2(Picture) vermiculite

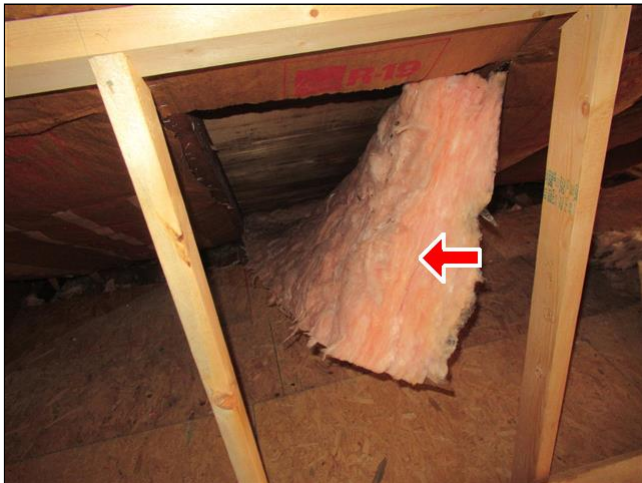
(2) It is recommended to have a qualified contractor secure all loose fiberglass insulation to promote the intended function.

1.7 Item 3(Picture) secure the insulation

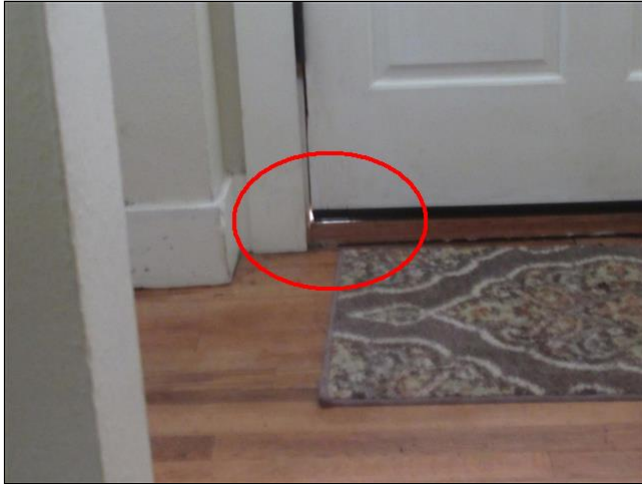
Daylight is visible at the main entry door. It is recommended to have a qualified person install weather stripping to reduce the risk of weather and pest entry into the structure.

2.1 Item 1(Picture) front door

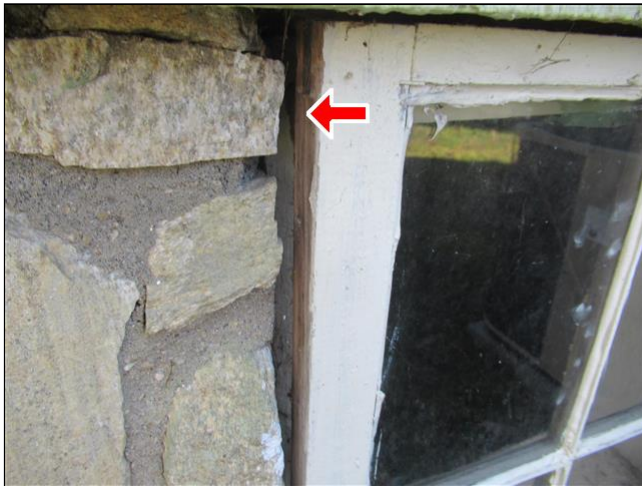
The right basement window, as viewed from the exterior, is loose and there are air gaps. The basement window under the deck has broken glass. It is recommended to have a qualified carpenter repair or replace the windows to reduce the risk of weather and pest entry.

2.2 Item 1(Picture) right basement window

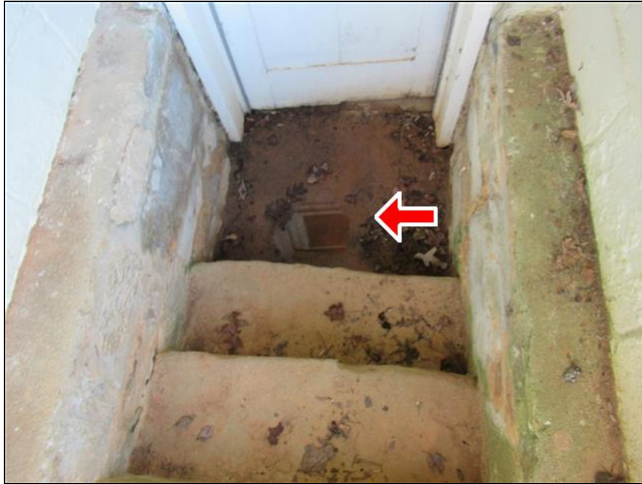
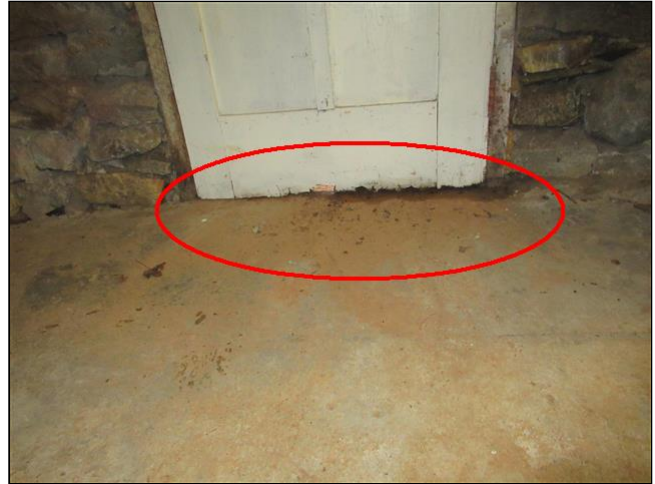
There is standing water visible at the bottom of the basement exterior stairs. The basement door is damaged, most likely due to water intrusion. It is recommended to have a qualified contractor make all necessary repairs to the site drainage prior to replacing the damaged door.

2.4 Item 1(Picture) standing water

2.4 Item 2(Picture) basement door

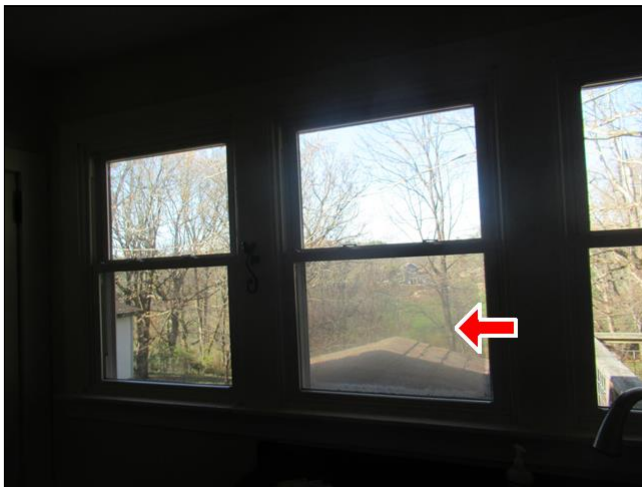
The bottom sash at the center window is cloudy in between the panes of glass. This is indicative of a failed thermal seal. It is recommended to have a qualified window contractor repair or replace the window to reduce the risk of further damage.

3.4 Item 1(Picture) kitchen window

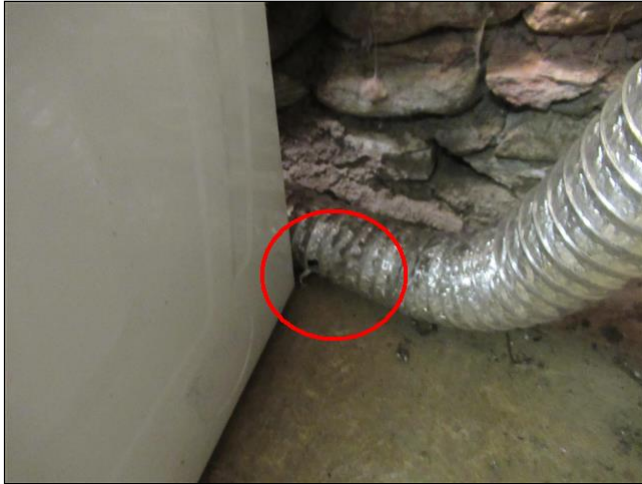
There is a hole in the dryer duct. It is recommended to have a qualified contractor repair or replace the duct to promote proper ventilation.

3.15 Item 1(Picture) hole in tje duct

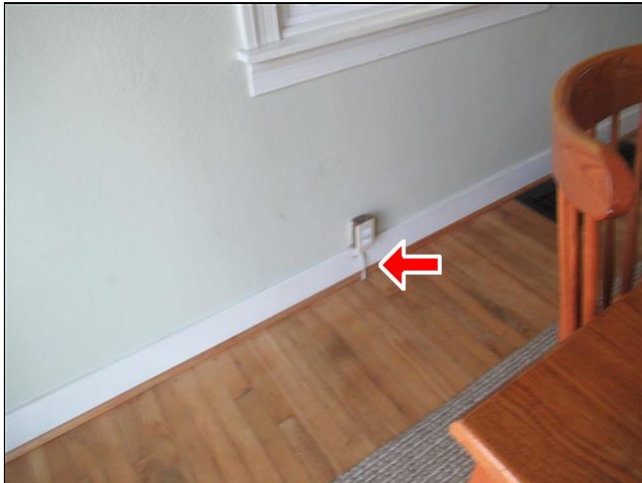
There is unprotected wiring at the outlet below the window. It is recommended to have a qualified electrician or carpenter provide physical protection for the wiring to reduce the risk of personal injury and property damage.

4.6.A Item 1(Picture) protect the wiring

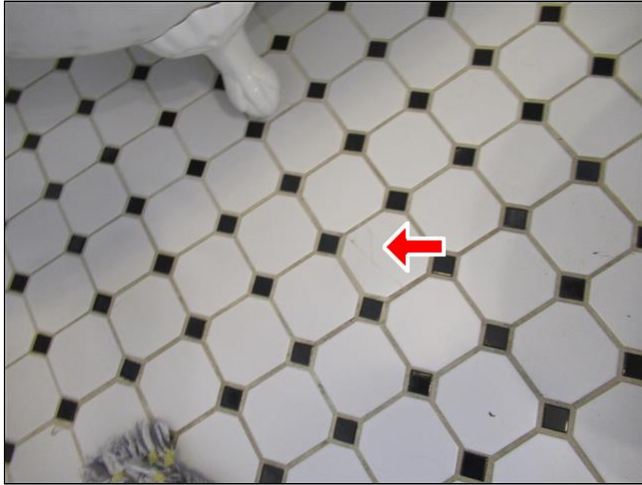
There are cracked tiles in the bathroom floor. It is recommended to have a qualified flooring contractor repair or replace the damaged tiles.

5.7 Item 1(Picture) cracked tile

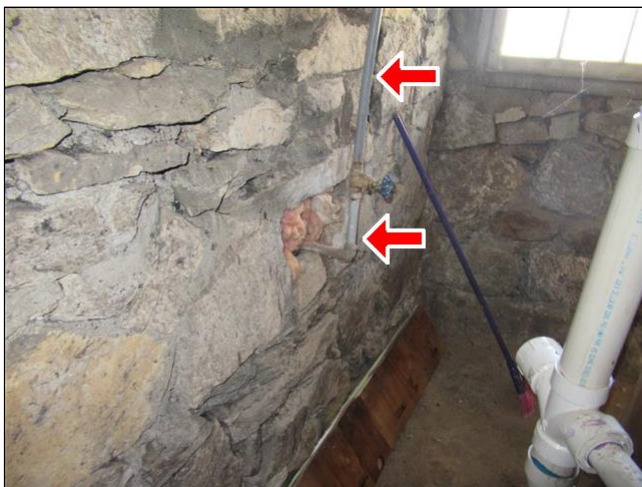
The main water line that enters the house is made of galvanized metal. This material has a history of corroding. If reduced water pressure or water consumption increases without just cause, it is recommended to have a licensed plumber replace the main water line. Reduced water pressure is evident.

There is a small section of polybutylene water line at the main shut off location. Replacement is recommended due to a known history of material defects.

7.1 Item 1(Picture) galvanized and polybutylene

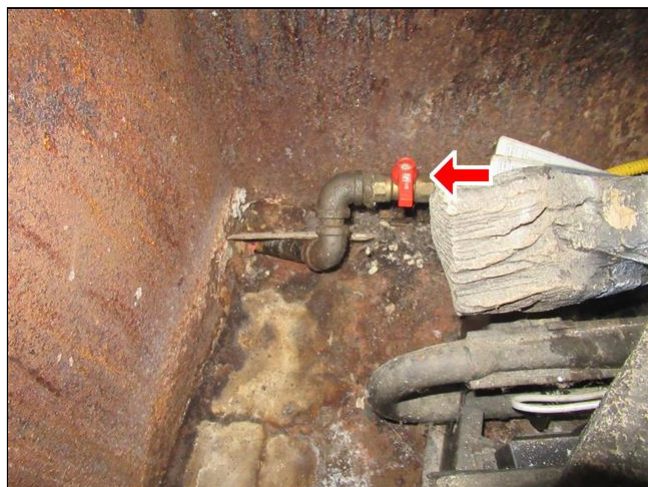
The gas fired log insert could not be lit at the time of the inspection. The gas supply is shut off at the gas logs. It is recommended to ensure that the gas logs are functioning as intended prior to closing on the purchase of the property.

9.7 Item 1(Picture) gas shut off valve
