RE: 935 Utsonati Lane
Crack in Slab Floor

Engineering of Brevard, PLLC – PO Box 202 – Brevard, NC 28712

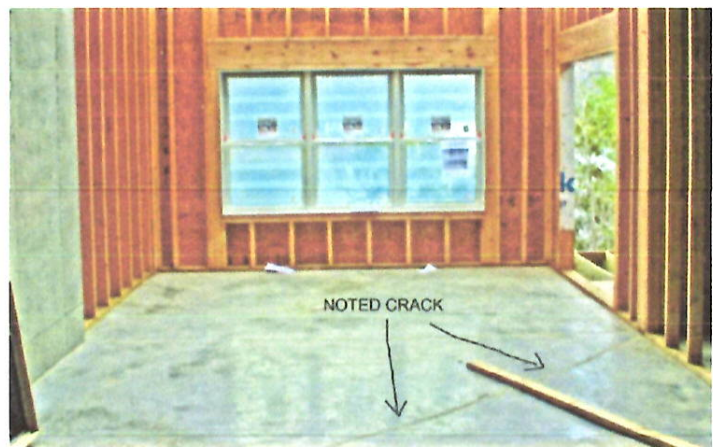
The home, like many in Connestee, was built on a slope. A typical residential framed construction with a poured wall foundation was done. For this type of construction, a footer (~24"-36" wide) is dug and poured in undisturbed soils at the perimeter. Then a concrete wall is formed and poured. All is reinforced with structural steel (rebar). The poured walls showed no signs of cracking or movement.

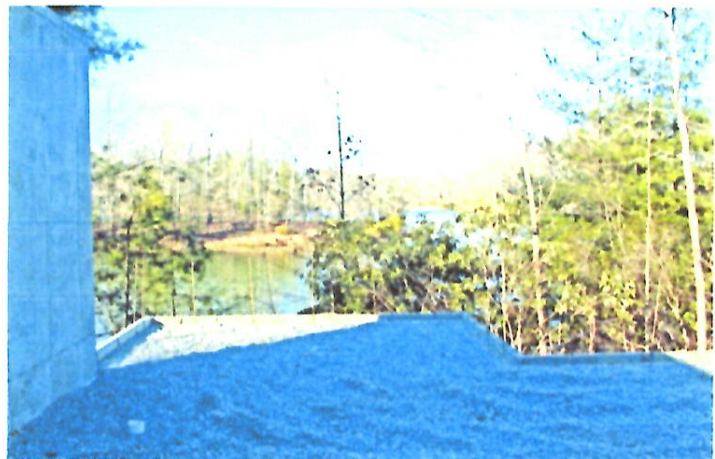
The area of the slab with the crack was then filled to subgrade elevation. In ~2007, this fill was usually accomplished by moving site soils dug or cut from another area of the foundation. These soils were typically compacted, but no inspections were usually done to confirm the quality of the compaction. The final 4" of fill typically consisted of clean #57 (washed) stone. This is visible in pictures taken during construction.

It is our belief that this fill has settled under the slab and caused the displaced crack in the floor. We do expect some minor additional settlement may occur in the future. This is not a structural concern but rather a cosmetic issue.

There is not a structural concern. The structure of the house sits directly on the poured exterior walls and the loads are transferred to the footers and stable earth. No structural repairs are needed associated with these cracks in the slab.
