Summary

Buyer's Edge LLC

Customer
Samuel McManus

Address
238 Kawani Ln
Brevard NC 28712

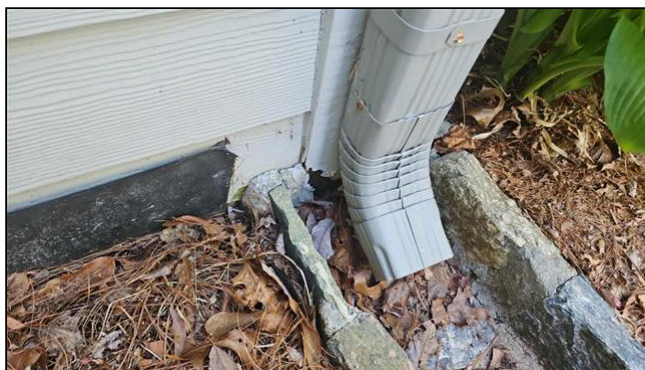
1.1 Item 1(Picture)

- It is noted that the corner trim and a small piece of siding was slightly damaged and peeling paint at the front of the house to the left of the covered porch.

Repaired

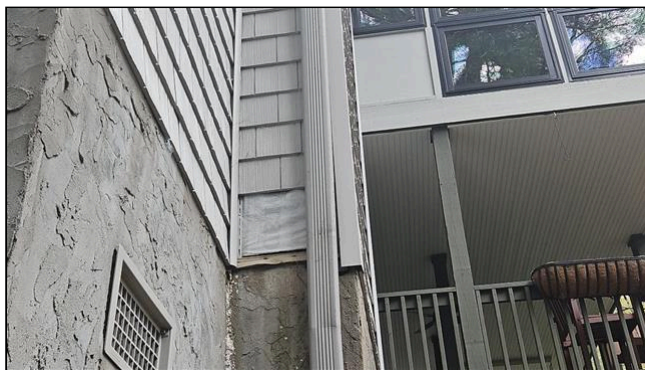
1.1 Item 2(Picture)

- The vinyl at the rear of the home around the chimney was missing in a localized area.

Repaired

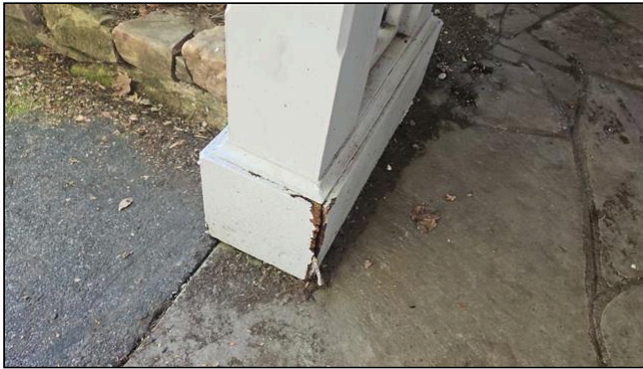
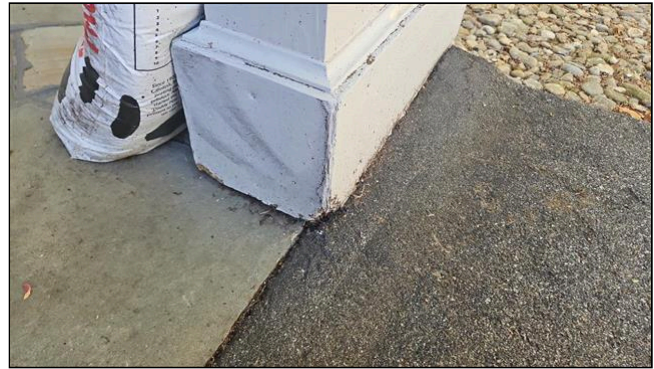
- The trims of the latticed columns in front of the main story garage door had rot at the bottoms. The trims of these columns should be repaired or replaced.

Repaired

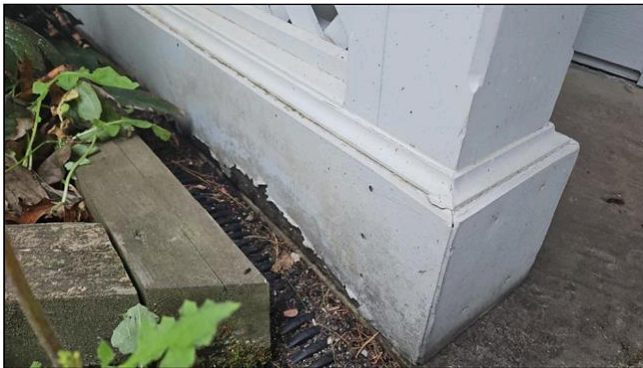
1.1 Item 5(Picture)
(5)

- There is some slight deterioration and peeling paint with moisture at the bottom of the latticed wall between the garage doors off the left side of the house.

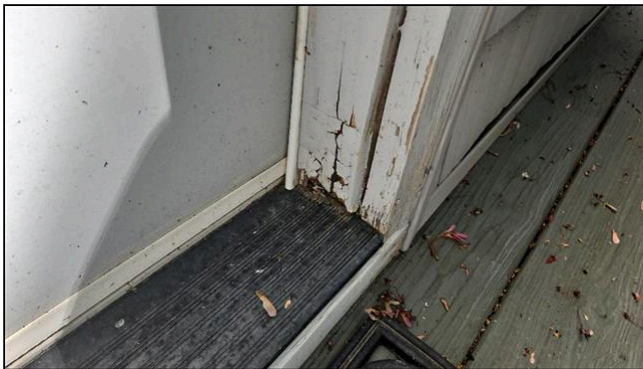
1.1 Item 6(Picture)
(6)

- The trim/ jamb of the door at the laundry room off the right side of the home had local rot toward the threshold. This should be repaired to prevent further damage.

Repaired

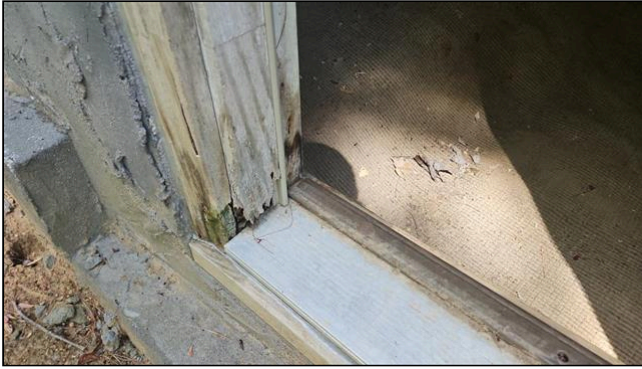
1.1 Item 7(Picture)

- The trim/ jamb of the crawlspace entry door at the right side of the home had local rot toward the threshold. This should be repaired to prevent further damage.

Repaired

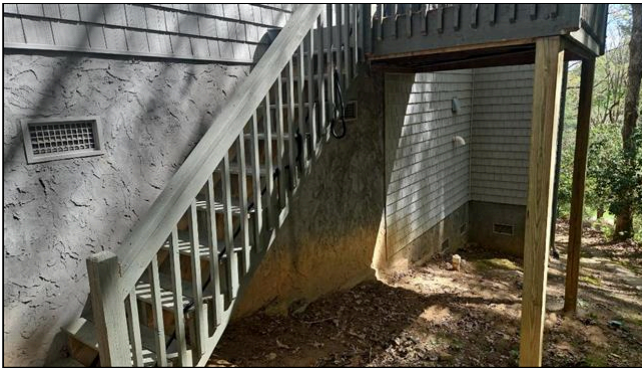
1.5 Item 1(Picture)

-
- (1)
- The stringers for the staircase at the rear of the home were over-spanned. Typically stair stringers are supported at least every seven feet. There was no significant movement on these stairs when walked on.

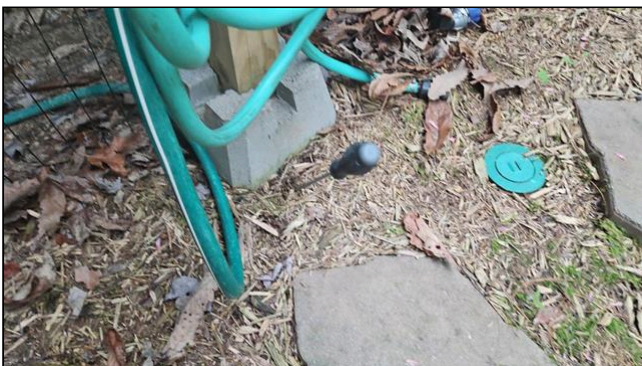
1.5 Item 2(Picture)

- (2)
- The wood column(s) on the staircase of the deck at the rear of the home had improper footings. These columns are resting on a surface masonry units. A qualified contractor should be consulted in regard to adding the appropriate footings that extend below the frost line.

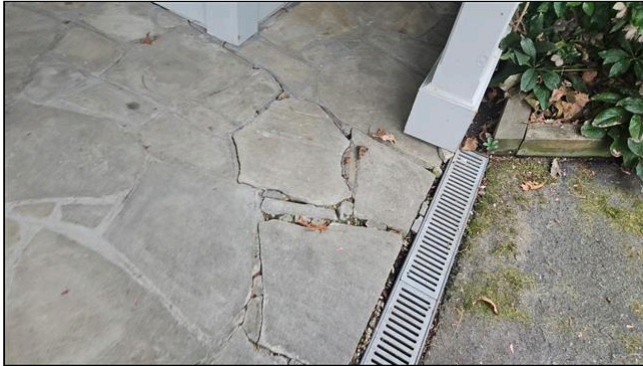
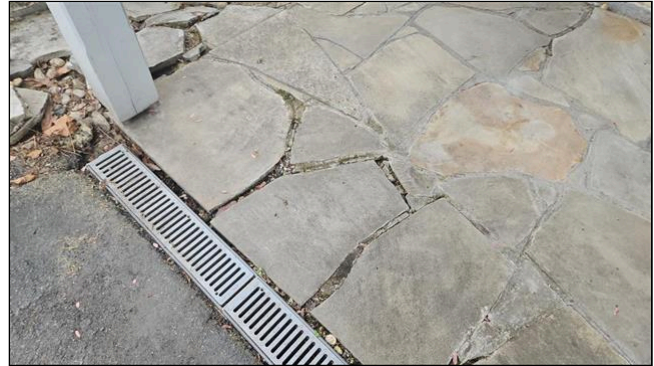
-
- The rock entry at the basement garage door off the left side of the house had grout that was deteriorated and several rocks that were loose.

Repaired

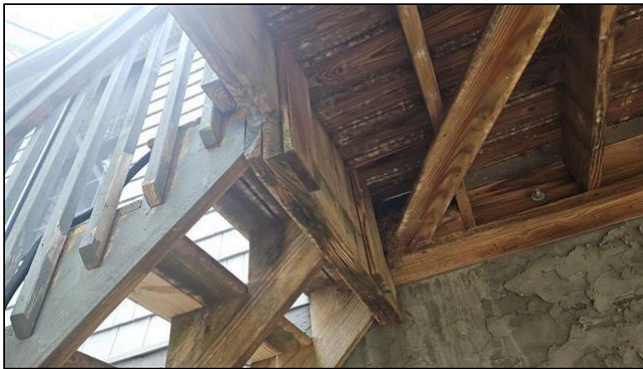
1.5 Item 3(Picture)

- The attachment of the stair stringers to the deck off the right side of the house at the laundry room entry was atypical. Much of the bearing of the stair stringers was in the form of deck boards that were nailed to the band. This attachment should be reviewed by qualified contractor and repair it is necessary.

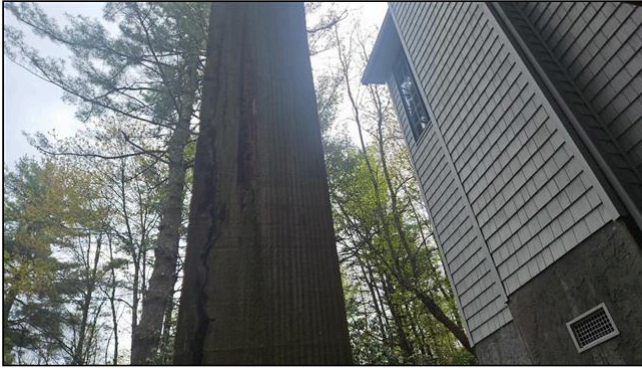
1.5 Item 4(Picture)

- There was rot noted on the wood column of the deck at the rear the house closest to the air compressors. I recommend having a qualified contractor or structural engineer review this column. Repairs should be made as necessary.

The column was reviewed and is structurally sound

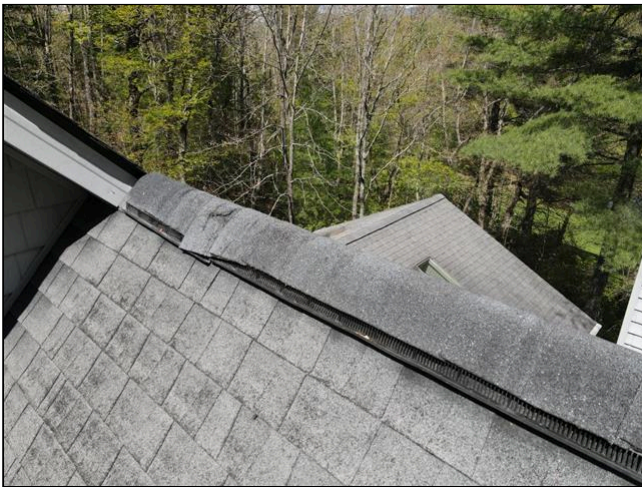
2.1 Item 1(Picture)

- There is a loose ridge shingle toward the right side of the home.

Roof was replaced

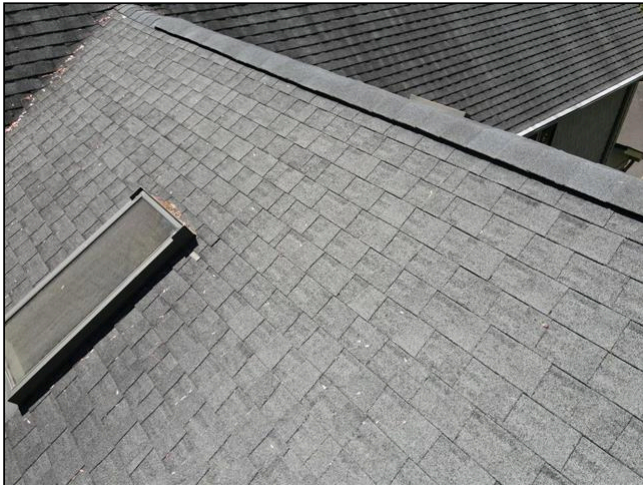
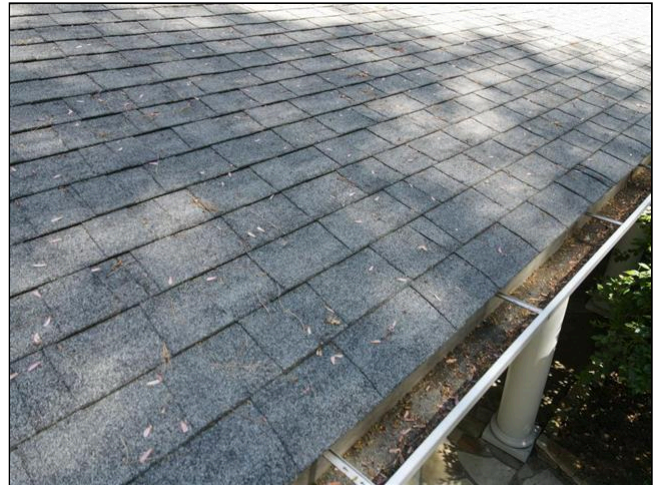
- The roofing was older and in fair condition. We did not see evidence of active leaks nor need for

immediate major repair. there was significant granular loose on shingles at areas that shed larger amounts of water. I recommend consulting a qualified roofer in regard to the remaining service life of this roof.

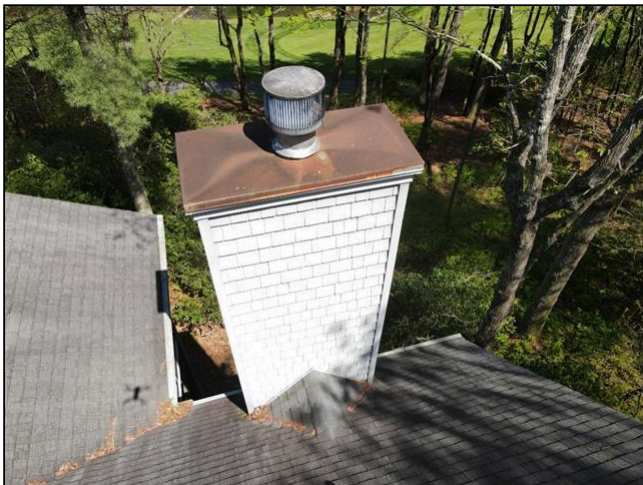
2.4 Item 1(Picture)

- It is noted that the metal chimney cap was rusted. This is typical of older chimney caps and I recommend having this cap reviewed by a chimney specialist and repaired as necessary.

This is a cosmetic issue

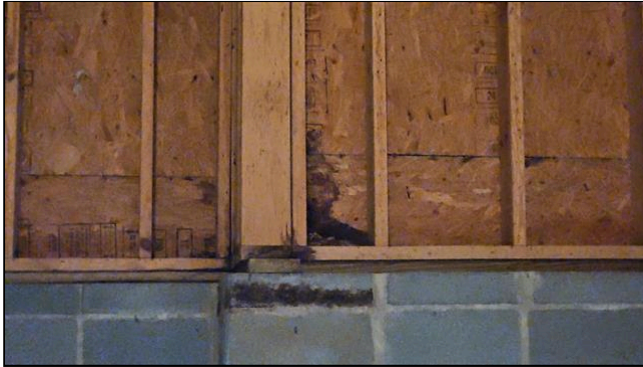
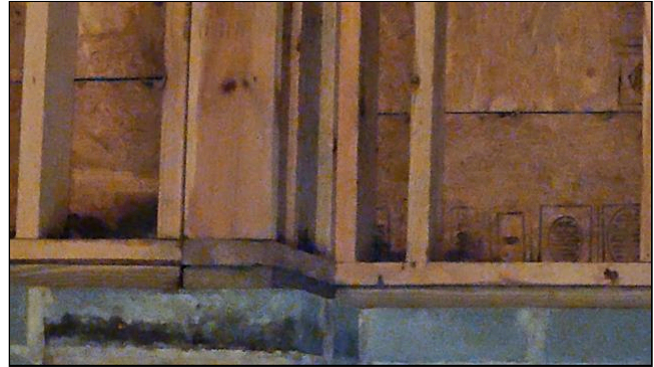
-
- (1)
 - The sheathing and bottom plate at the chimney toward the rear right corner of the home had discoloration and rot. Vinyl siding was missing part in this area as noted in the exterior section of this report. I recommend correcting all water entry (likely from gutter terminating at the chimney) and repairing all damaged sheathing.

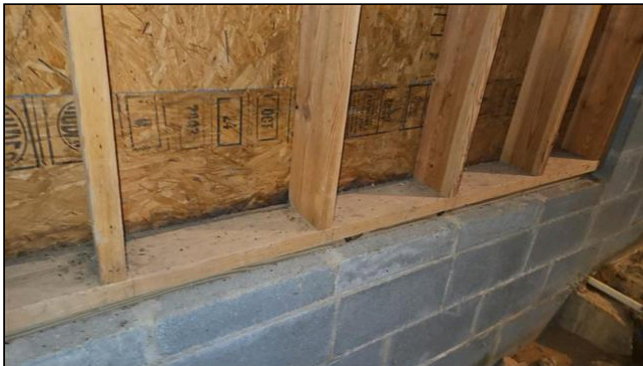
3.2 Item 3(Picture)

- (2)
 - The sheathing in the crawl space was discolored toward the foundation wall in a localized area off the right side of the home toward the rear.

All rotted sheathing was replaced

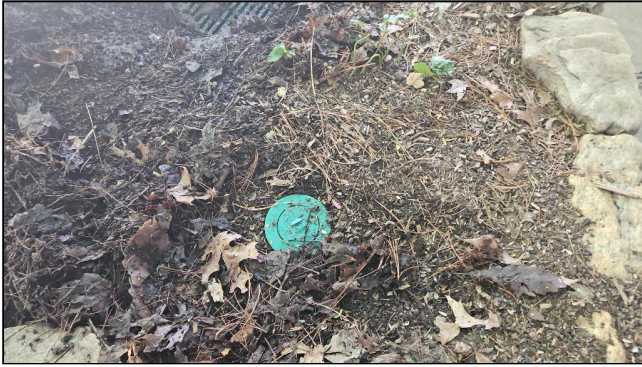
3.1 Item 1(Picture)

-
- (1)
 - It s noted that there were bait stations for the treatment of wood destroying insects around the parameter of the home. This system is typically a part of a servicing contract.

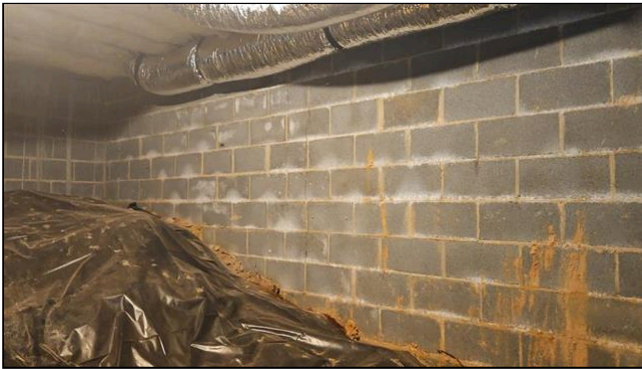
3.1 Item 2(Picture)

- Efflorescence was seen at the exterior foundation wall off the crawlspace. White efflorescence (powder substance) on block wall indicates moisture is in contact with the masonry. This does not necessarily indicate that intrusion will occur. Efflorescence can occur as a natural process of moisture leaching out of newly placed concrete blocks that has no effect of the structure. This is known as New Building Bloom.

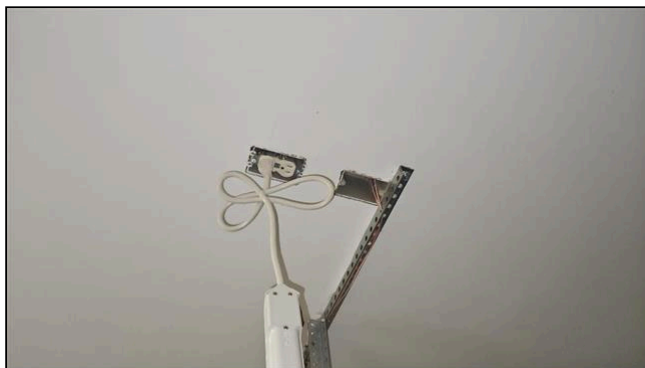
4.3 Item 1(Picture)

- One outlet in the first floor garage ceiling servicing the garage door opener was missing a cover.

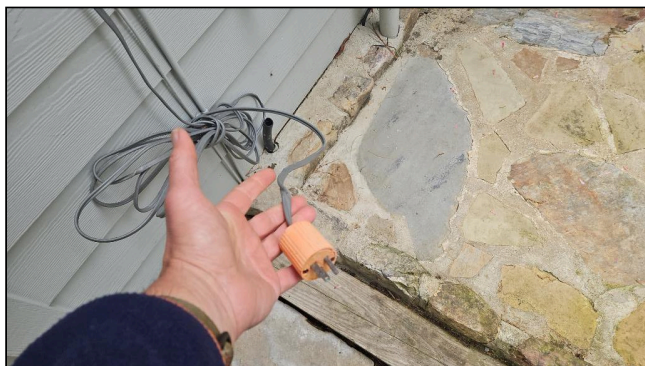
4.5 Item 1(Picture)

-
- (1)
 - There's a plug with a male connection off the front left corner of the house. This is likely for a generator. This connection exposed can be a safety issue and I recommend removing this wire.

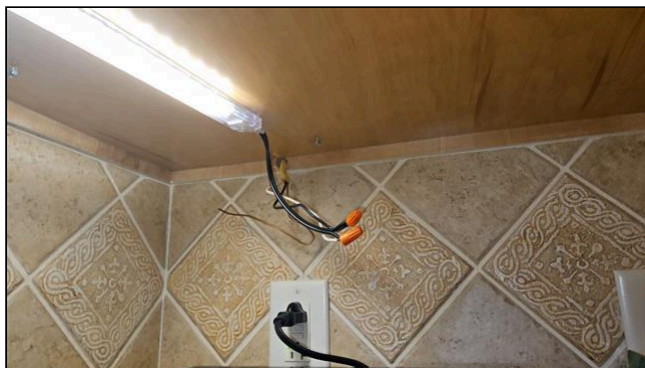
4.5 Item 2(Picture)

- (2)
 - There is an abandoned wire in the corner bread cabinet at the kitchen to the right of the dishwasher. This wire should be removed or placed in an enclosed junction box.

Wire was removed

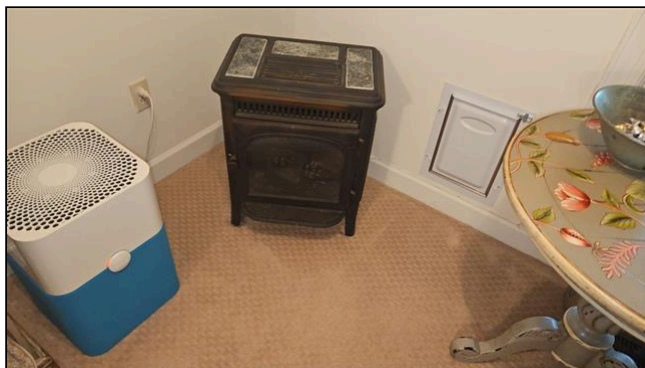
5.5 Item 1(Picture)

-
- (1)
- Typically wood stoves require a clearances from combustibile materials on all sides and the floor. This can requirement can vary with the manufacture of the stove. I recommend verifying that this wood stove is suitable on carpet and in the proximity it is placed to the walls.

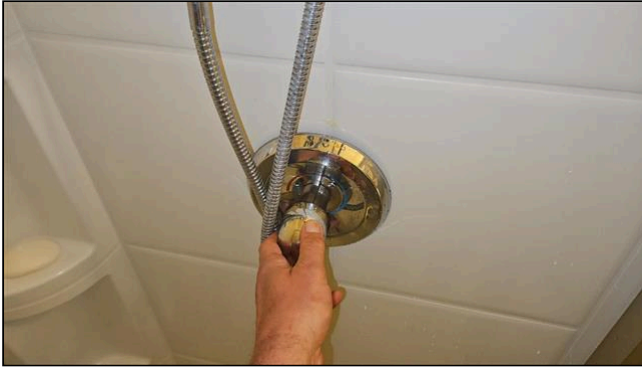
7.1 Item 1(Picture)

- The control knob for the basement common bath shower was loose.

Repaired

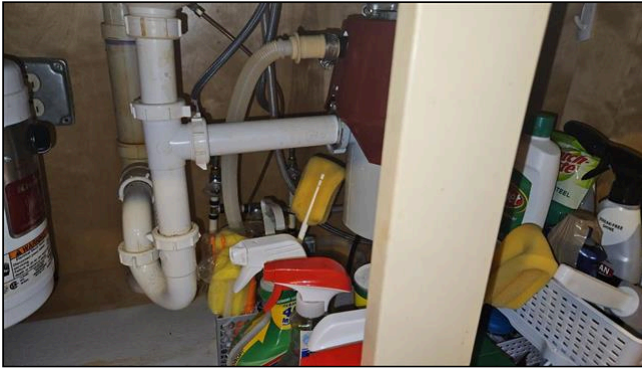
7.3 Item 1(Picture)

-
- (1)
- The dishwasher drain line should be mounted and form a "Loop" that extends above the bottom of the sink base under sink to prevent a possible backflow of contaminants at the kitchen sink. This is a small fix.

Repaired

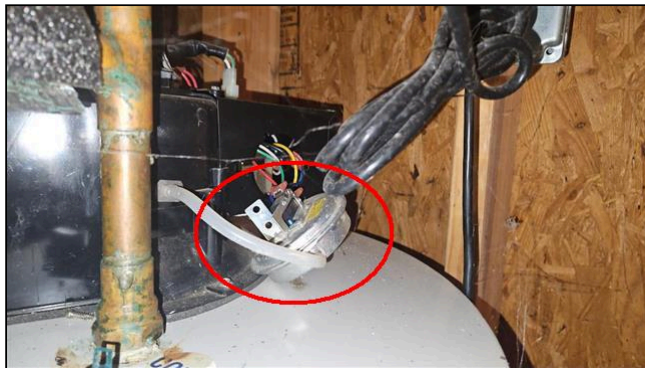
7.5 Item 1(Picture)

-
- A pressure switch at the top of the water was loose.

Repaired

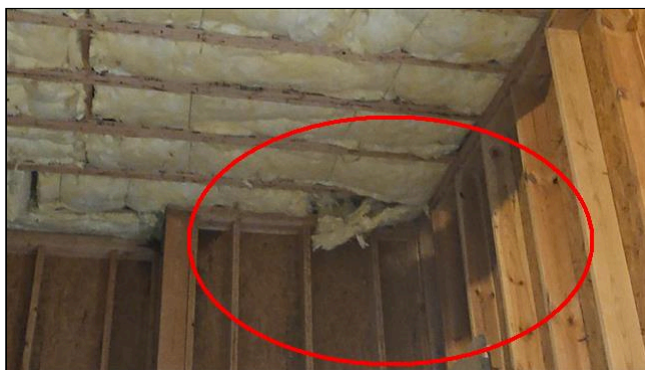
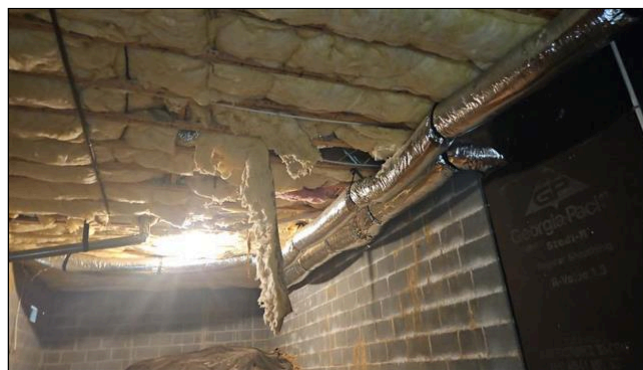
- The insulation in the floor system revealed evidence of pest (likely mice or squirrels). I recommend consulting a pest specialist and correcting this. Damaged insulation should be repaired.

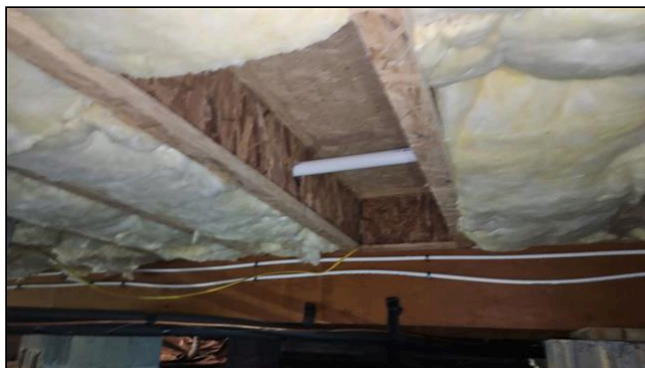
8.2 Item 3(Picture)

- The insulation was fallen and missing in small localized areas in the crawlspace. This should be corrected.

Repaired

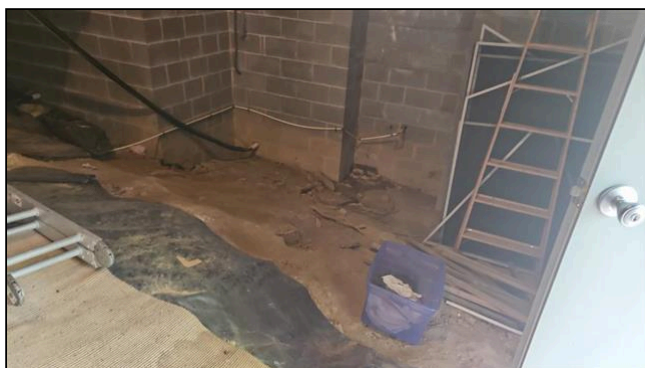
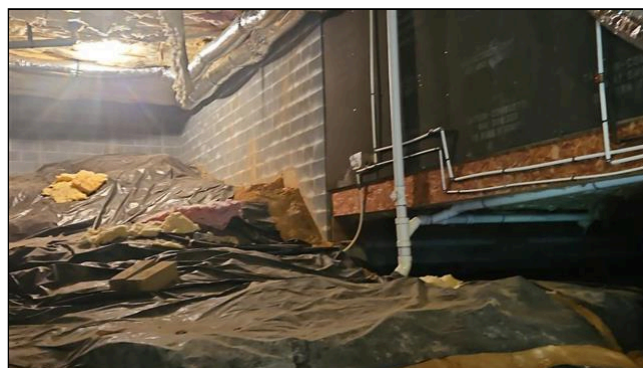
-
- The vapor barrier (plastic) on the crawlspace ground was missing in areas and needs to be spread out and secured. A vapor barrier provides added protection to the floor system from moisture or dampness that can enter from ground.

-
- (1) **Vapor barrier was spread out properly**

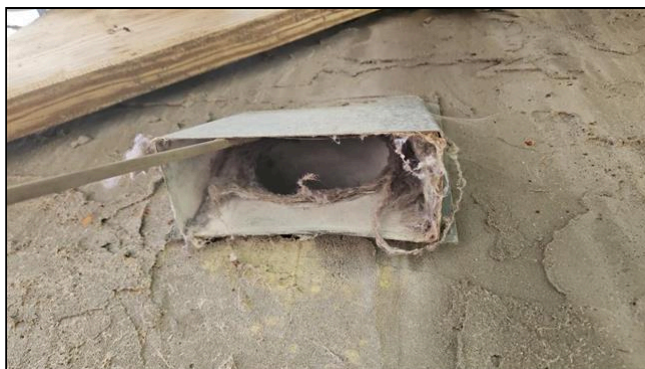
8.6 Item 1(Picture)

- The dryer vent piping was had lint in it and should be cleaned.

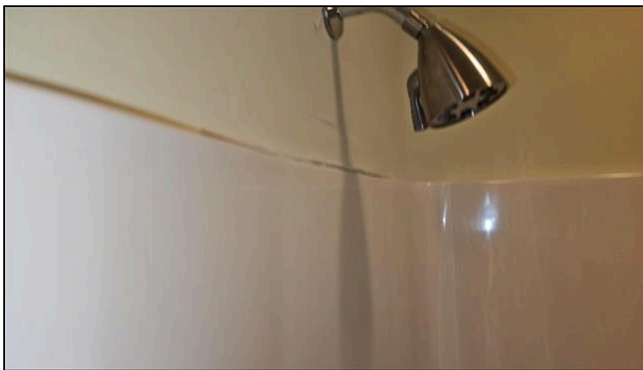
9.1 Item 1(Picture)

- The sheetrock and the upstairs private bathroom off the left side of the house was slightly damaged at the intersection with the shower surround.

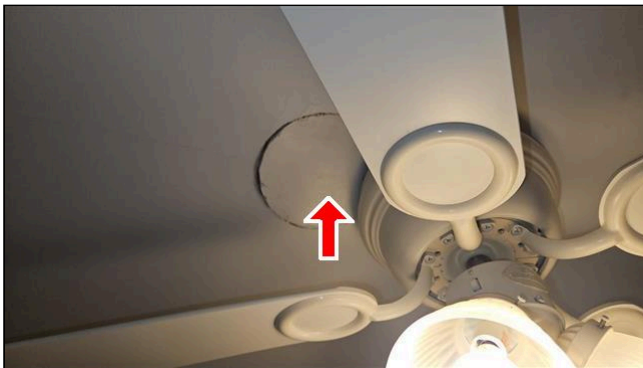
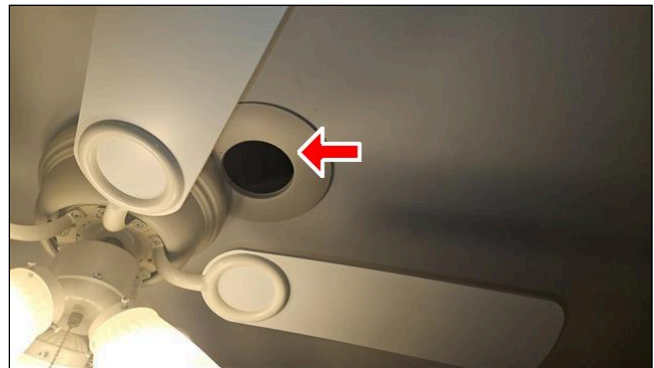
- There were holes in the ceiling of the downstairs basement den. I recommend patching these holes.

Holes have been covered

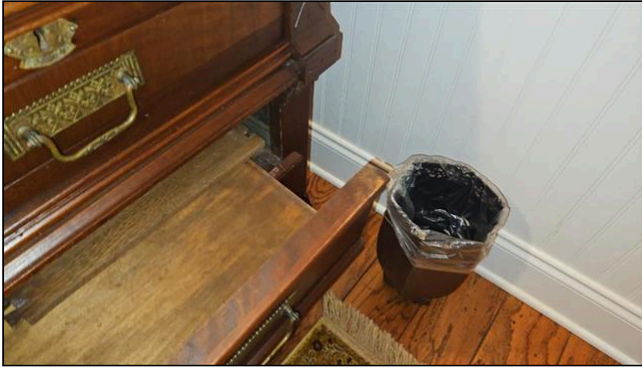
9.4 Item 1(Picture)

- The vanity drawer at the half bath off the main entry was damaged.

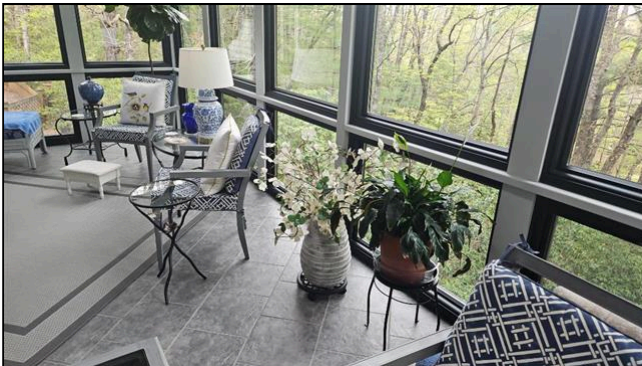
9.6 Item 1(Picture)

-
- (1)
 - Because of the proximity of the window above the grade in the sun room, I recommend adding a guard rail. This arrangement may not have been a locally required building practice when this home was built.

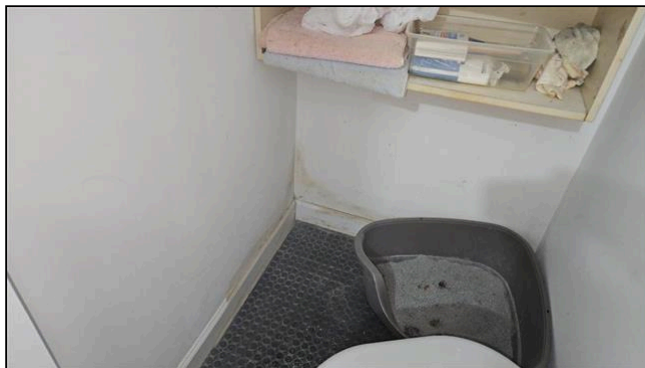
9.1 Item 4(Picture)

- There is staining in the basement garage closet. I was unable to determine what this is from.
