The William H. Grogan House
Brevard, North Carolina

The house is now listed on the National Register of Historic Places as the William H. Grogan house (named for the original owner).

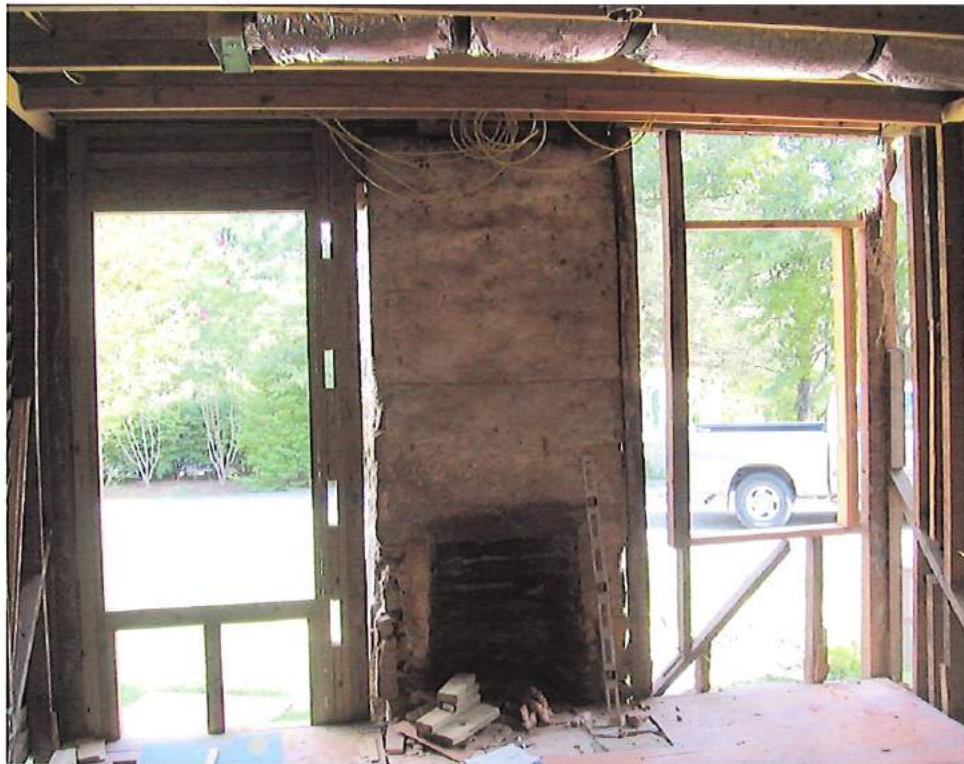
All beadboard was removed from the walls and ceiling for structural repair, new wiring and insulation. The ceiling was badly sagging due to the use of undersized joists in the floor above, so it was removed and new lumber was sistered to the original bowed joists to achieve a flat (albeit slightly lower) ceiling. Then the salvaged beadboard from the ceiling was used to replace

Den walls and ceiling stripped to studs. New framing to the left of the fireplace had just been completed before this photo was taken. The rough-in is resized to accept a larger, correct size window that matches the original one facing the front porch. The modified framing from the smaller, modern window on the right awaits replacement. New HVAC duct on the ceiling is seen in place. Wiring is visible at ceiling level, waiting to be routed to the fireplace sconces and the electrical outlets.

damaged lengths on the walls during the reinstallation. A new sheet rock ceiling was installed.

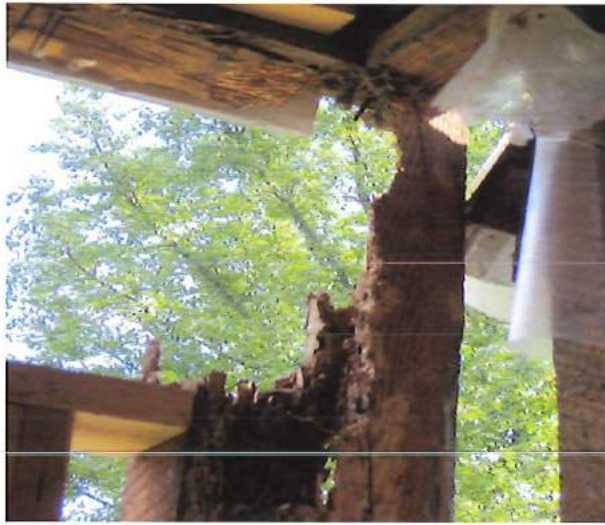
Closeup top right view of the previous photo showing rot on the right corner post. Rot on the North wall studs at floor level (not shown) was equally as bad. All were of course replaced. One wonders how this part of the house was still standing!

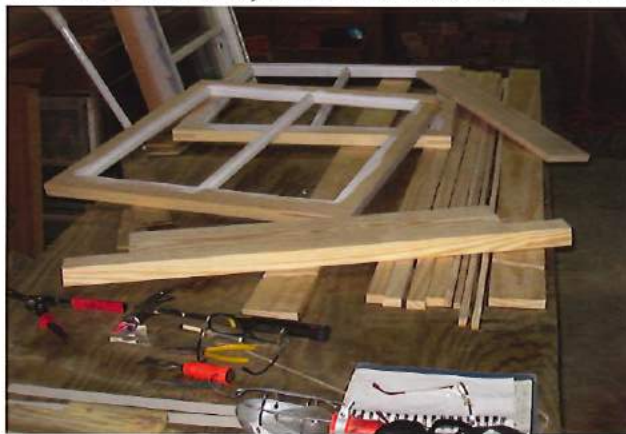
It was not possible to locate commercially available replacement windows for either side of the fireplace that matched the remaining original window facing the front porch. An Asheville woodworking shop was contracted to replicate the window sashes, and new frames were constructed on site.

Window sashes and frame components precut on site are shown ready for assembly and installation to the left and right side of the Den fireplace.

When installed these two new windows were virtually indistinguishable from the original, although they are single hung vs. original double hung.

To maintain authenticity the window frames were designed to accept original style sash weights with ropes and pulleys.

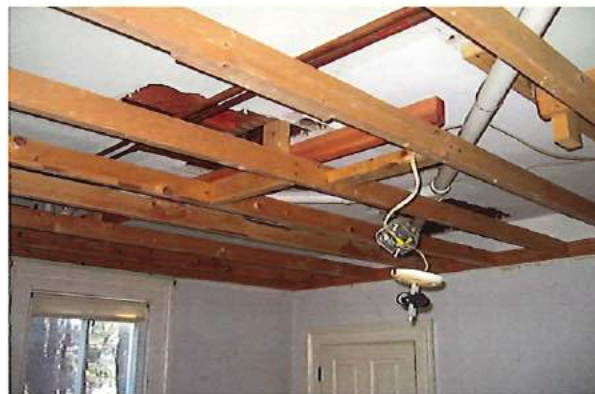
Removal of the dropped ceiling revealed it's 2X4 framework and plumbing.

This overhead ceiling framework was removed and new plumbing for the upstairs bath was properly nested between the ceiling joists. A new ceiling was installed flush to the original, thus recapturing lost room height. Also as part of the renovation a new wall was added on the north side of the bedroom to create space for a powder room. By extending the new powder room wall across the entire width of the bedroom a new bedroom entrance was created. It was an intentional design decision to place a new powder room with its door in a neutral space outside the bedroom, providing convenient access to either overnight guests or daytime visitors. The bedroom closet on the right in the above photo is now incorporated into the neutral space, which allows it to serve as a general purpose coat closet.

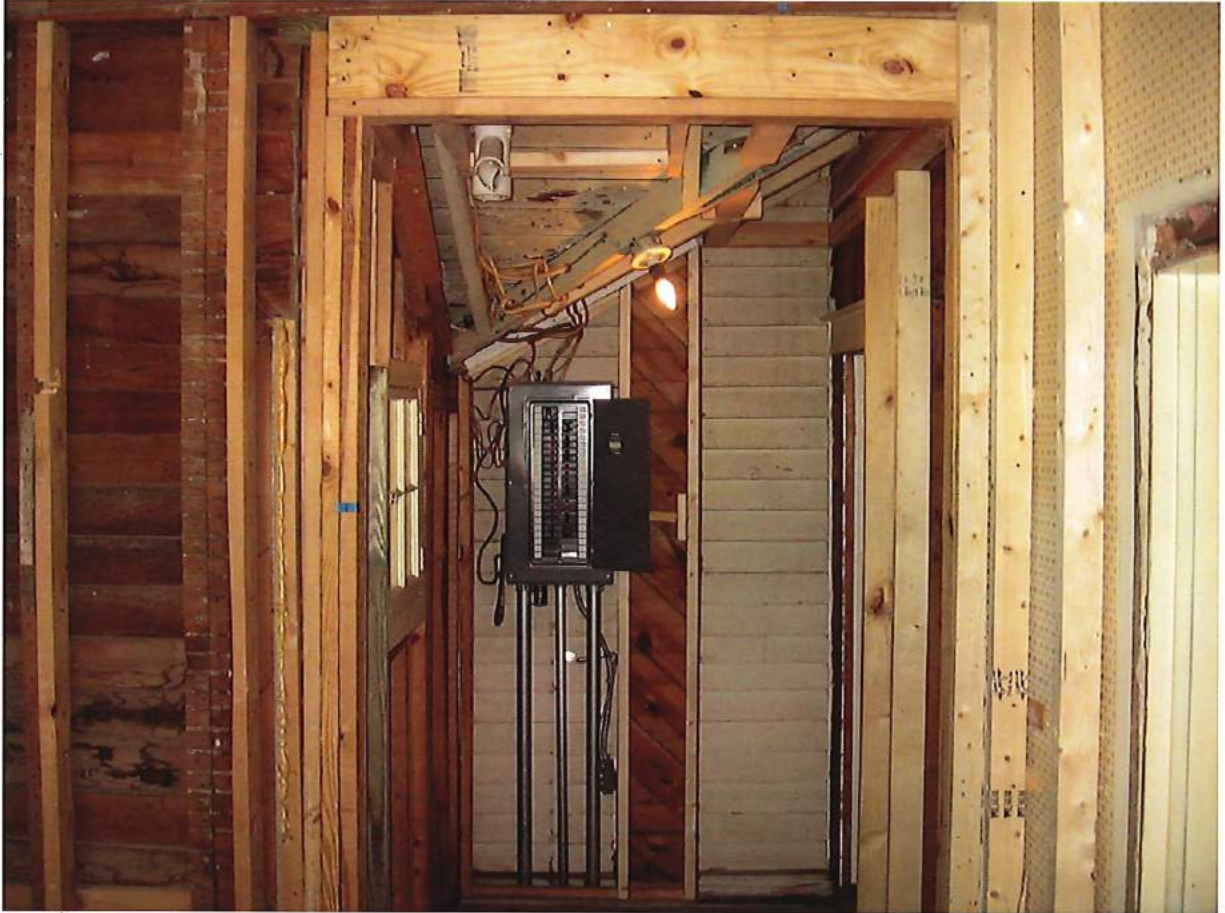
Short hall as viewed from the dining area during renovation. The exterior door framing had been covered up when this end of the porch had been enclosed to create a furnace room. Renovation as shown included removing the door frame and surrounding wall to create a short hall leading to the foyer, thus repurposing the furnace room space.

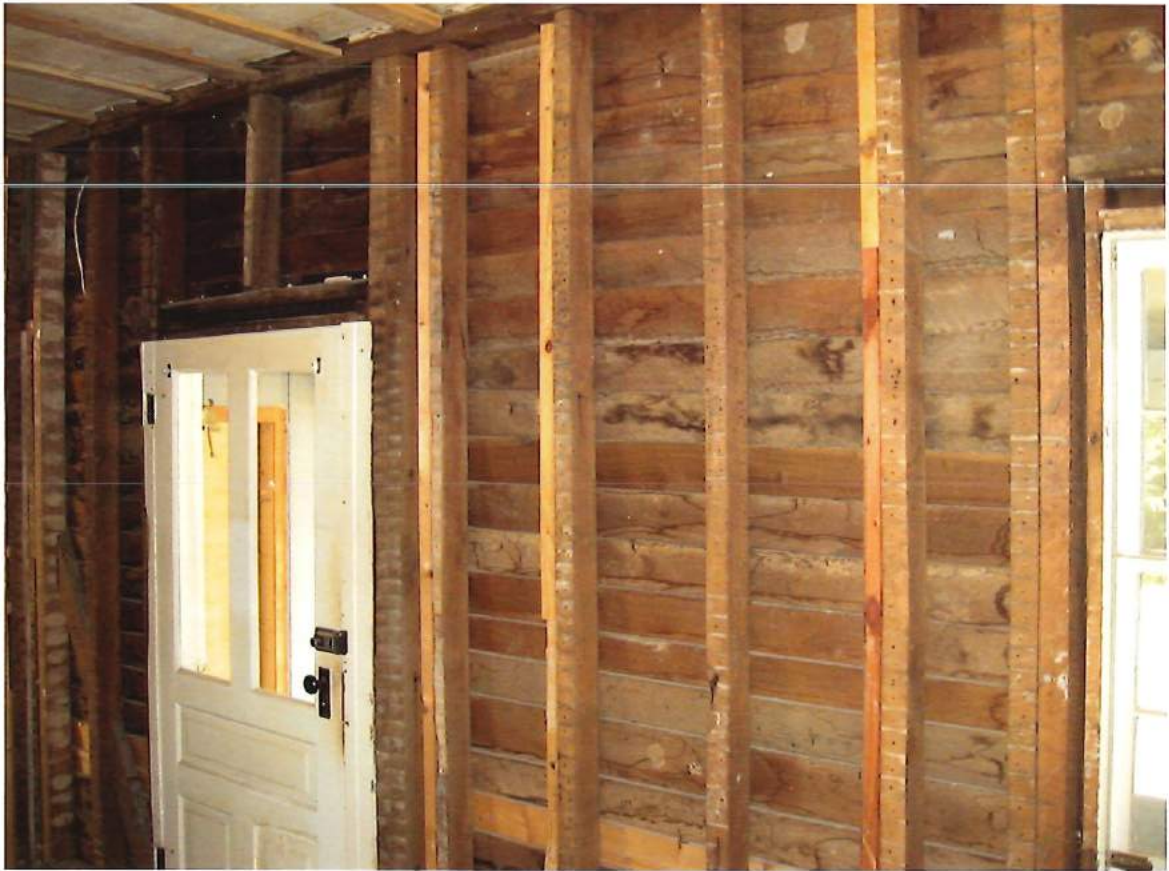
place as it was originally. This is an unusually short door. Several inches had been cut off the bottom of the door prior to installation. When the plaster was removed from the surrounding wall during renovation, it was clear that the rough-in framing was done specifically to fit this shortened door.

With the lath and plaster removed the framing for the short door to the back porch is seen as completely original. Also seen here are new studs sistered to the originals for a plumb drywall installation as well as furring strips for a new ceiling installation to cover up the damaged original.

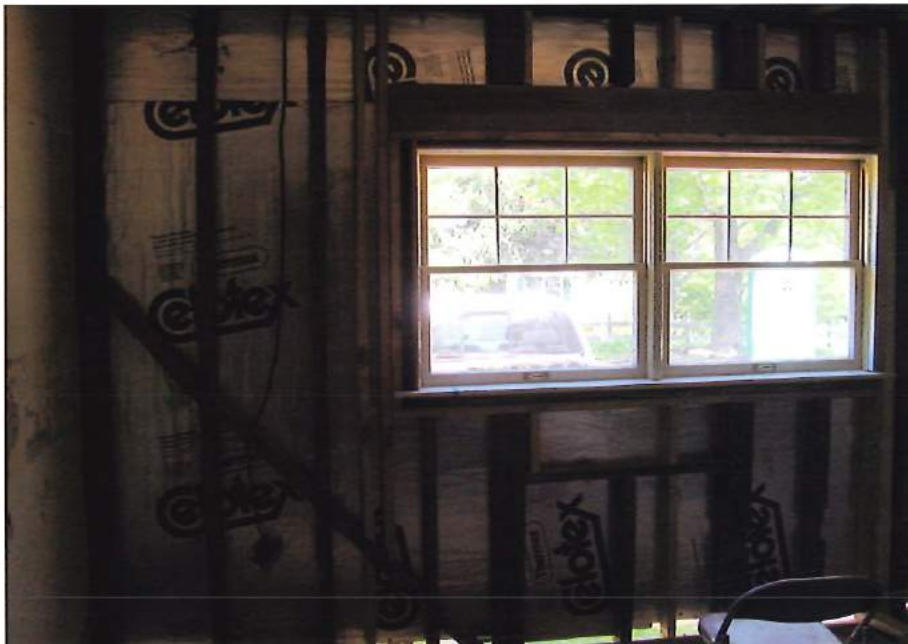
Short double window shown during demolition. Remnants of the lower part of the original single window's framing can be seen just beneath it.

View facing north. The short double window was replaced with an original sized single 6 over 6 window. The refrigerator was located on the wall to the left (not shown).

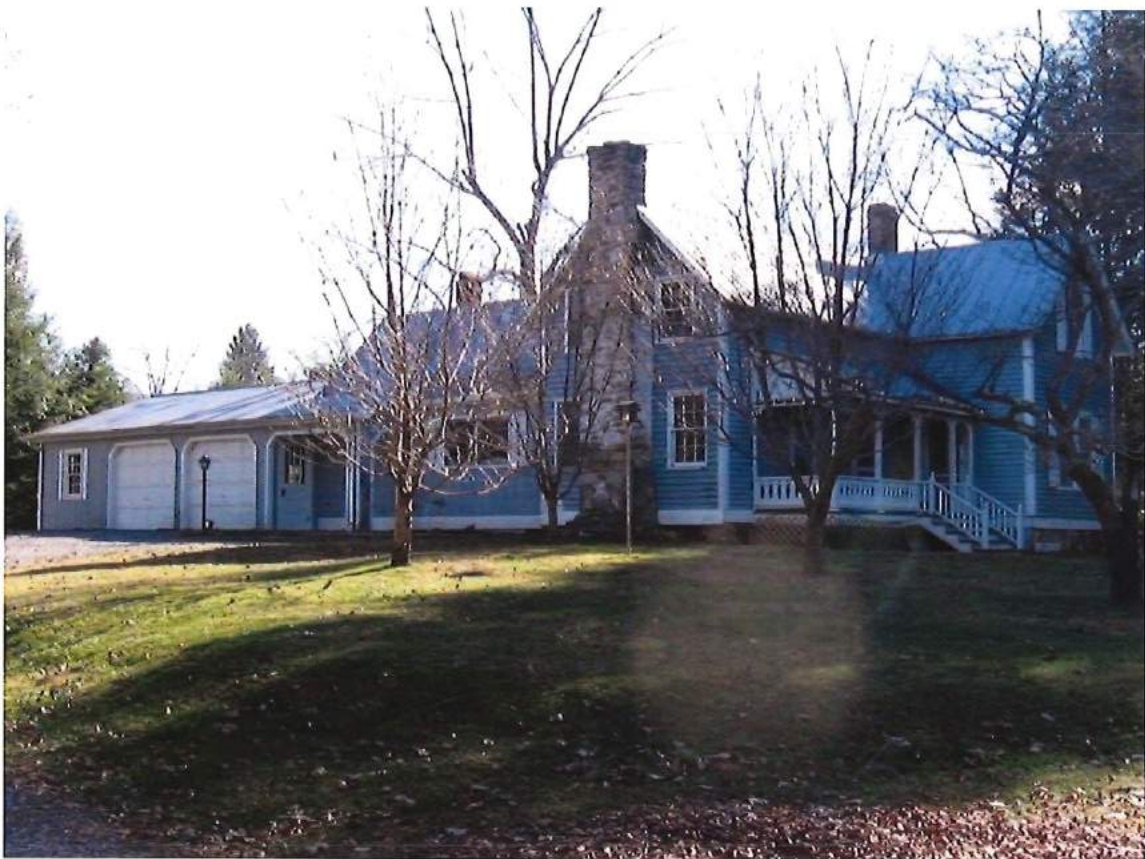
An exterior view as purchased. The north side required extensive renovation. The west (front) side required only faux shutter removal and new porch floorboard replacement.

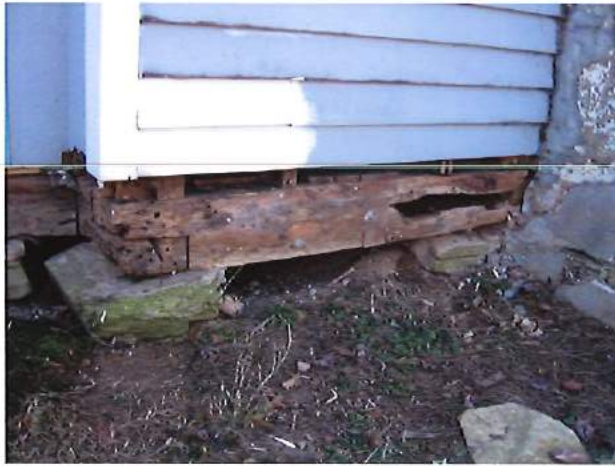
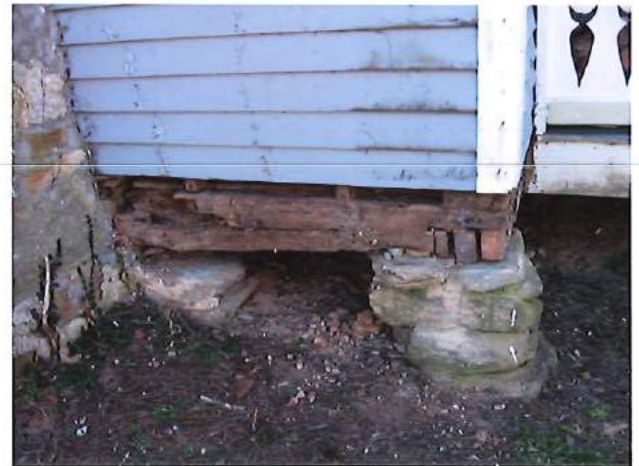
The house rests on sill beams supported by stone piers. A few beams, especially on the north side of the house, had to be replaced due to rot and/or insect damage over the years.

Rotted beams at the stone chimney base before replacement

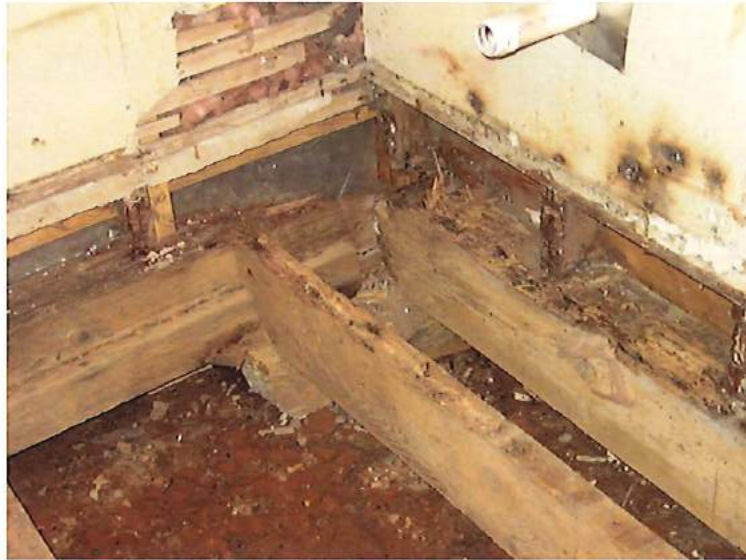
Rot on sill beams and floor joists in the northeast corner at doorway to the back hall.

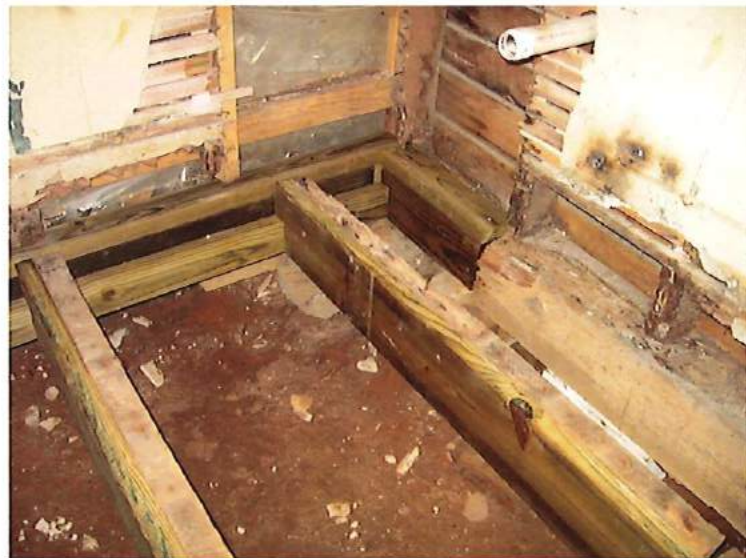
Framing repairs as completed before insulation and subfloor installation. This photo predates the cutting of the doorway to the back hall. The old PVC drain line had once been added for a sink in the old ½ bath.

Not shown here are similar repairs made to the floor in the short hall. Also the floor joists supporting the upstairs bathtub were beefed up by sistering new joists in place when ceiling work was being done in the downstairs bedroom.
