Inspection Report

3 Crestview Ct.
Arden NC 28704

Peter Young Home Inspections

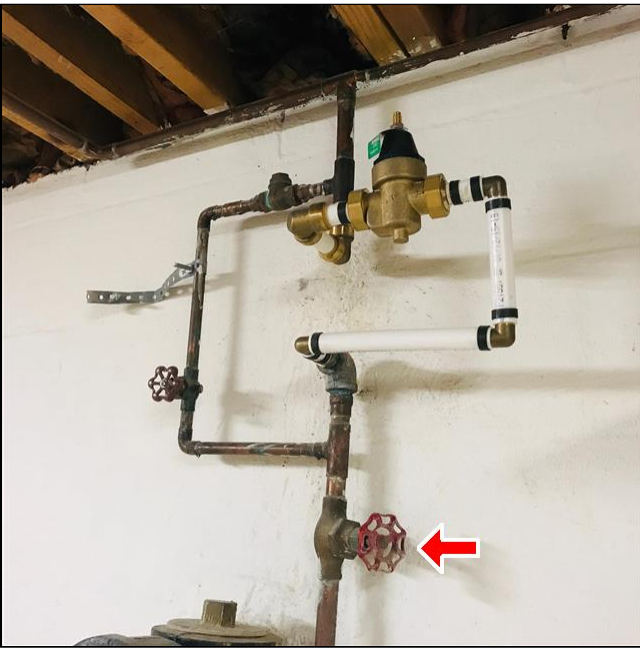
5.0 Item 1

5.0 The main water shut off is at the front wall of the unfinished part of the basement.

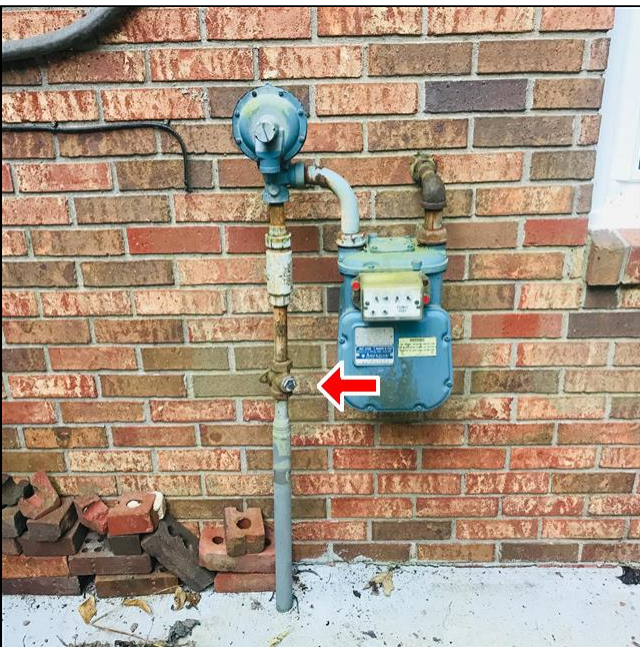
5.1 Item 1

5.1 The main fuel shut off is at the left side of the house at the gas meter.

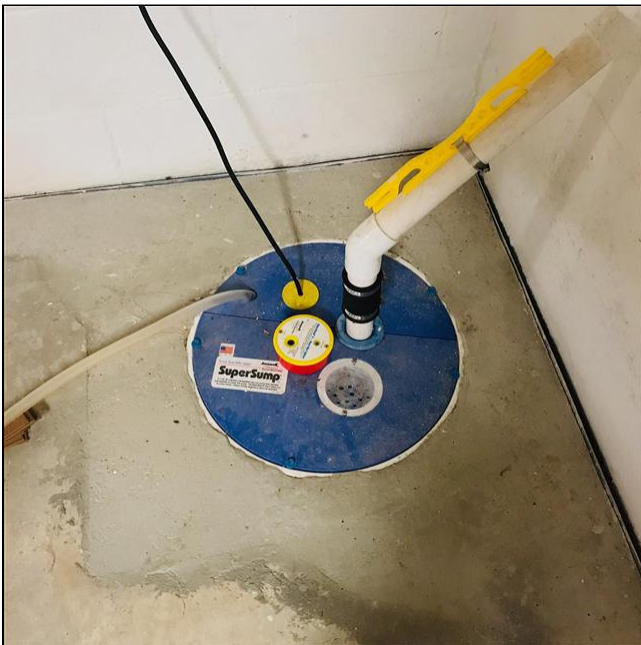
5.11 Item 1

5.11 The home had a sump pump installed in a pit in the basement/crawlspace floor or underfloor space with a sealed cover. I test pumps that are accessible without disassembly. This pump was not tested. I recommend that the sump pump be serviced annually to ensure that it is operable when needed.

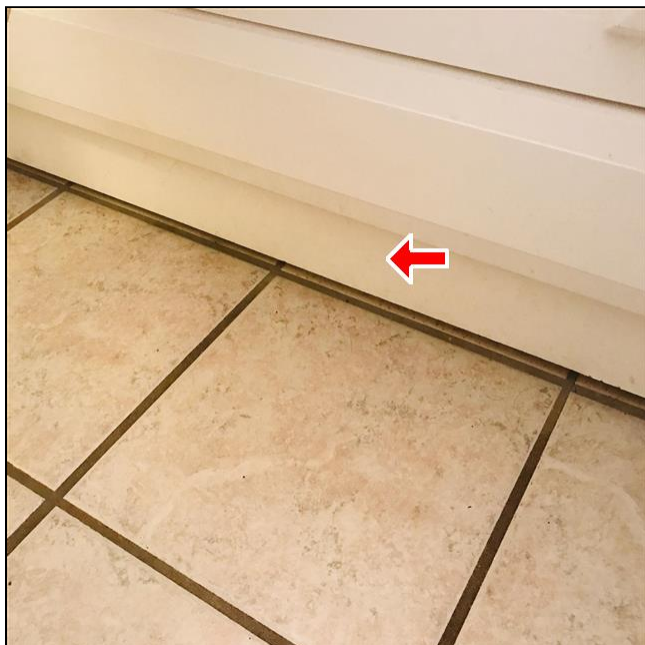
7.4 Item 1

7.4 The vents in the kitchen and hall bath were covered by the cabinet baseboards. These should be cut out and registers installed so that heat can flow into the rooms.

I recommend repairs by a competent handyperson.

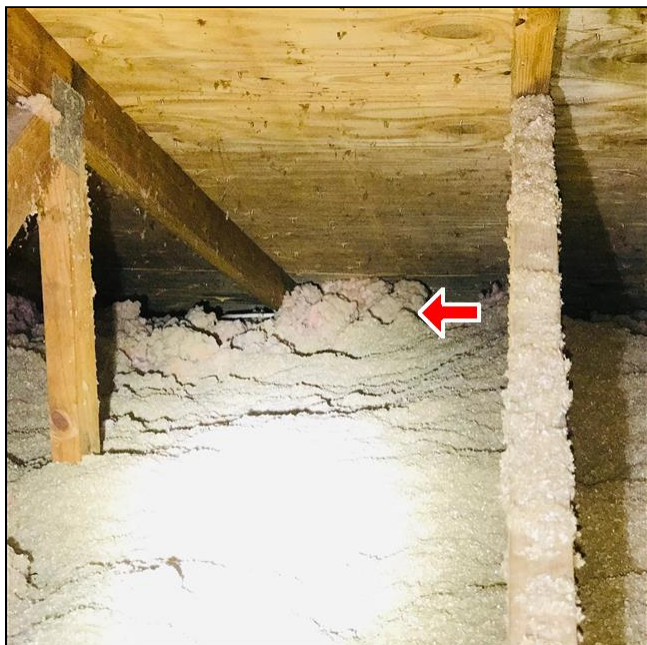
10.0 Item 1

10.0 In the attic, the ceiling installation extends to the roof edge and touches the bottom of the roof decking. This prevents the proper flow of ventilation air from the eave vents and could result in condensation on the under side of the roof decking.

I recommend repairs by an insulation contractor.

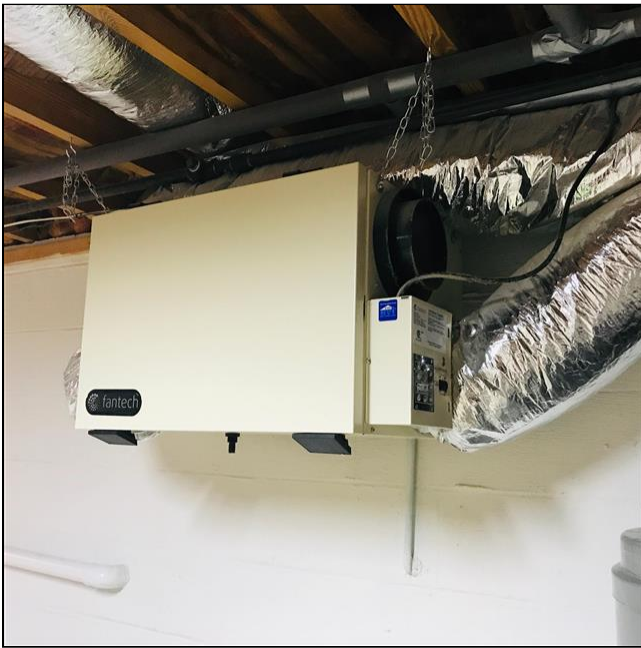
10.4 Item 1

10.4 There is a heat recovery ventilation system installed in the basement. I do not inspect these systems.

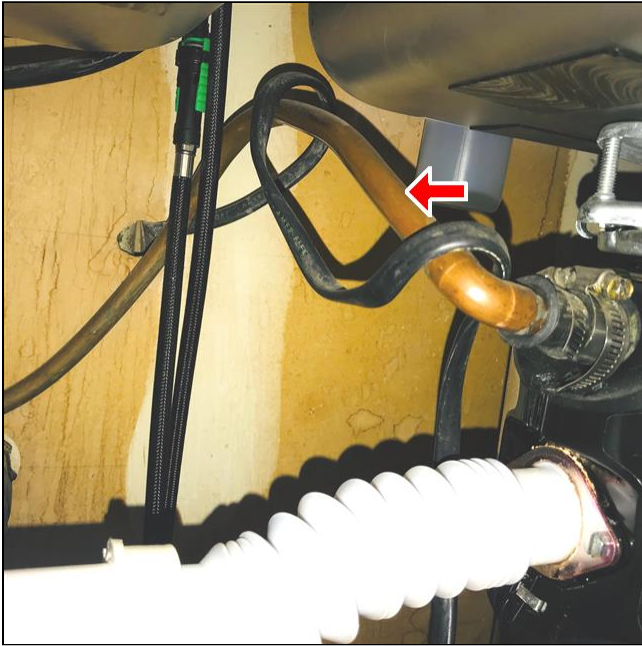
11.2 Item 1

The dishwasher drain line should be attached at a high point near the top of the cabinet to prevent water from the sink drain from entering the dishwasher drain. This dishwasher drain line could siphon water from the sink drain into the dishwasher, which could contaminate clean dishes in the dishwasher. Some modern dishwashers have valves to prevent backflow of water through the drain, but I could not determine if this machine has that feature.

I recommend evaluation and repairs as needed by an appliance technician.
