The William H. Grogan House
Brevard, North Carolina

The house is now listed on the National Register of Historic Places as the William H. Grogan house (named for the original owner).

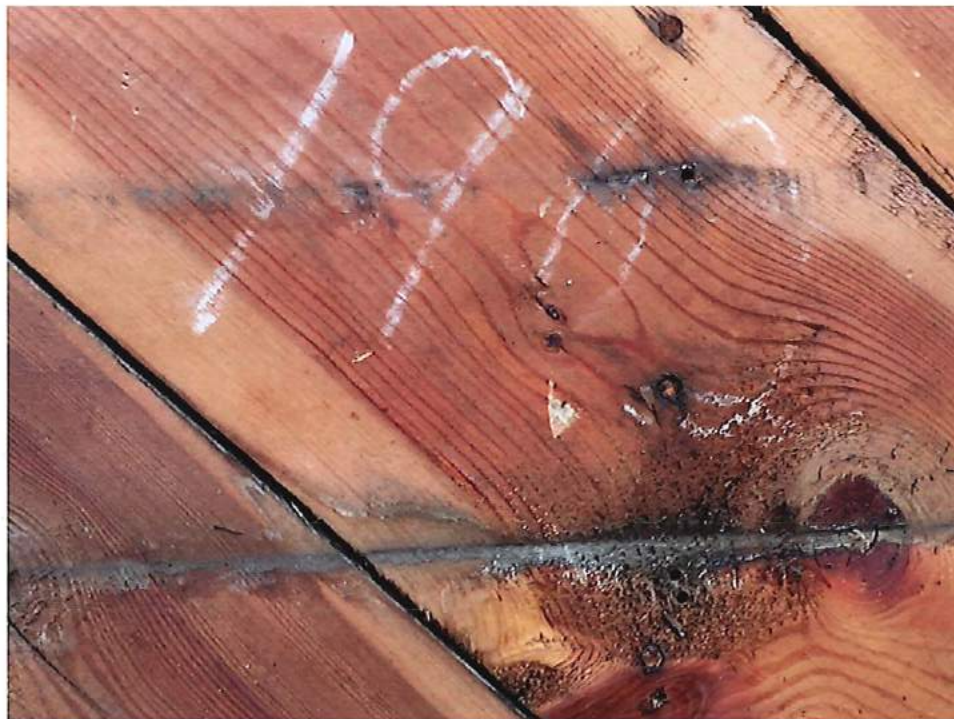
This photo of "1902" in chalk was taken before the replacement of damaged weatherboards.

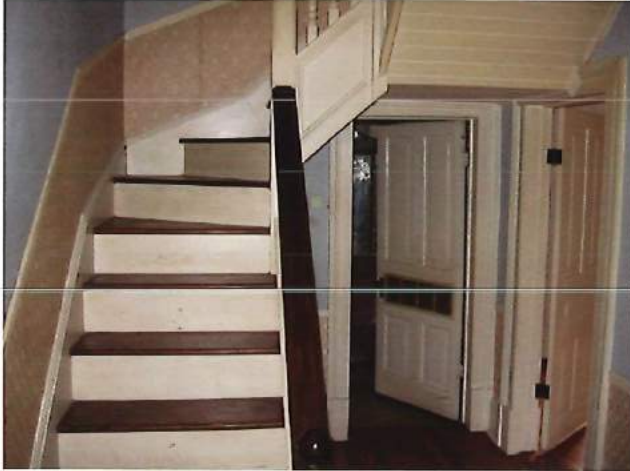
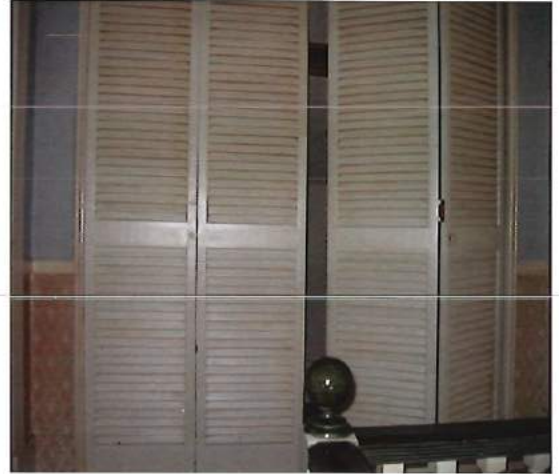
Foyer staircase and closet at the top of the stairs.

Foyer renovations were comparatively minimal. The floors, front door, beadboard ceiling, ceiling light fixture, and door casings remain unchanged. The storage closet under the stairs is now restored to its original purpose by removing a large cold air return duct which ran from the den to the furnace room via this closet. Flooring was cut from the closet to permit foundation repairs, and then replaced. The wooden sewing thread spool which serves as the closet door knob was left in place. Perhaps it was installed in the bygone era of Coates, Inc., a thread manufacturing plant once active in Brevard. Regardless, it serves as a quaint reminder of earlier times. Also unchanged is the staircase, handrail and the small window on the stair landing. Of note is the very low handrail at the top of the stairs. It was likely quite adequate back when people were generally of shorter stature. The foyer walls are all original lath and plaster, but did require repairs to cracks which resulted from the house settling over many decades.

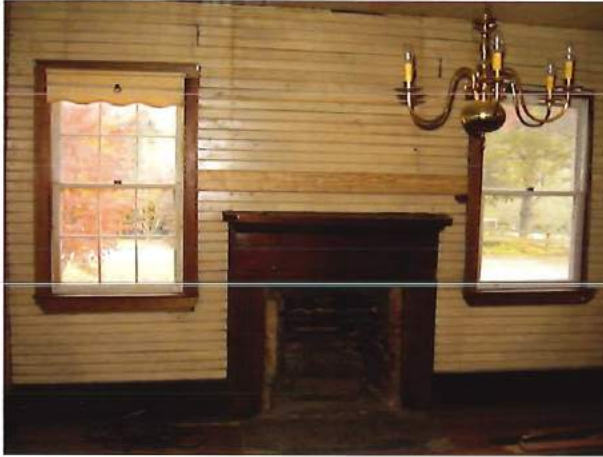
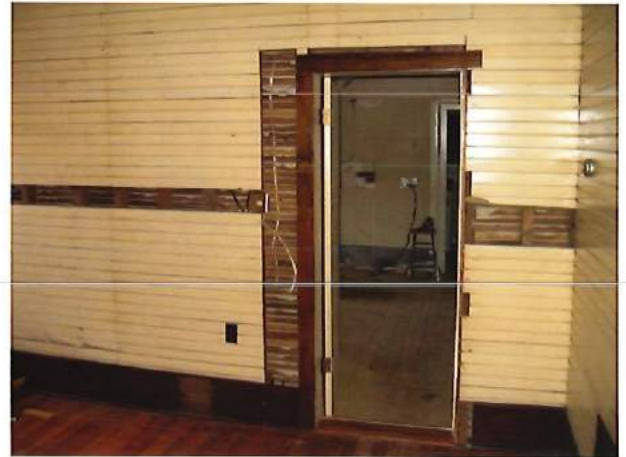
Den facing north and east with sheets of paneling removed.

All beadboard was removed from the walls and ceiling for structural repair, new wiring and insulation. The ceiling was badly sagging due to the use of undersized joists in the floor above, so it was removed and new lumber was sistered to the original bowed joists to achieve a flat (albeit slightly lower) ceiling. Then the salvaged beadboard from the ceiling was used to replace

damaged lengths on the walls during the reinstallation. A new sheet rock ceiling was installed.

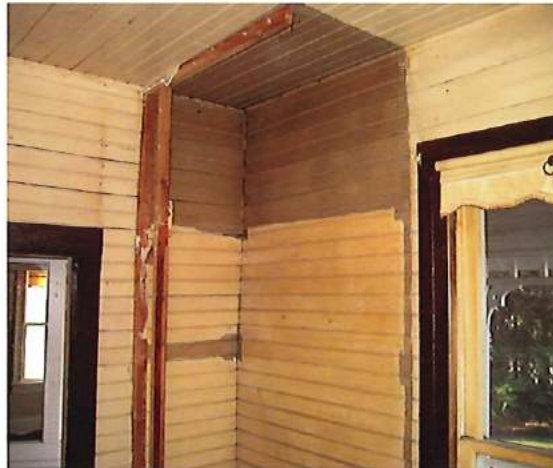
Remains of the den closet, exposing original olive paint. This photo also shows the bead board which was originally on the ceiling.

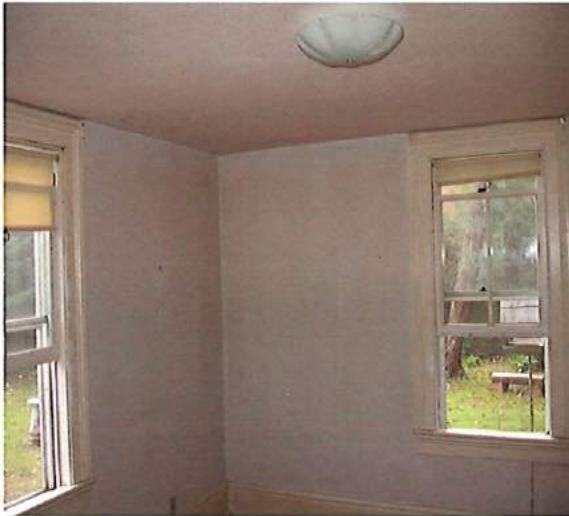
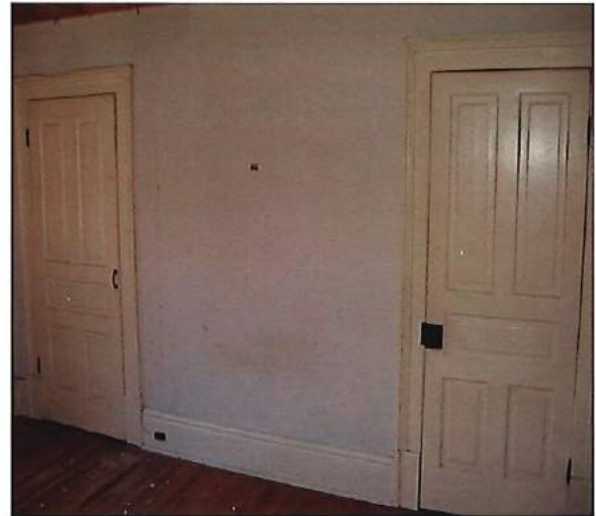
Downstairs bedroom views: Southeast corner (left) and west wall (right). (Photo on the left was taken before drop ceiling removal.)

The original downstairs bedroom measured roughly 13 feet square, with 2 windows and 2 closets as seen in the above photos. Notice in the above left photo that the ceiling rests immediately on top of the window casings. This was a clear indication that the ceiling had been dropped to accommodate plumbing when an upstairs bathroom had been installed sometime in the past.

This overhead ceiling framework was removed and new plumbing for the upstairs bath was properly nested between the ceiling joists. A new ceiling was installed flush to the original, thus recapturing lost room height. Also as part of the renovation a new wall was added on the north side of the bedroom to create space for a powder room. By extending the new powder room wall across the entire width of the bedroom a new bedroom entrance was created. It was an intentional design decision to place a new powder room with its door in a neutral space outside the bedroom, providing convenient access to either overnight guests or daytime visitors. The bedroom closet on the right in the above photo is now incorporated into the neutral space, which allows it to serve as a general purpose coat closet.

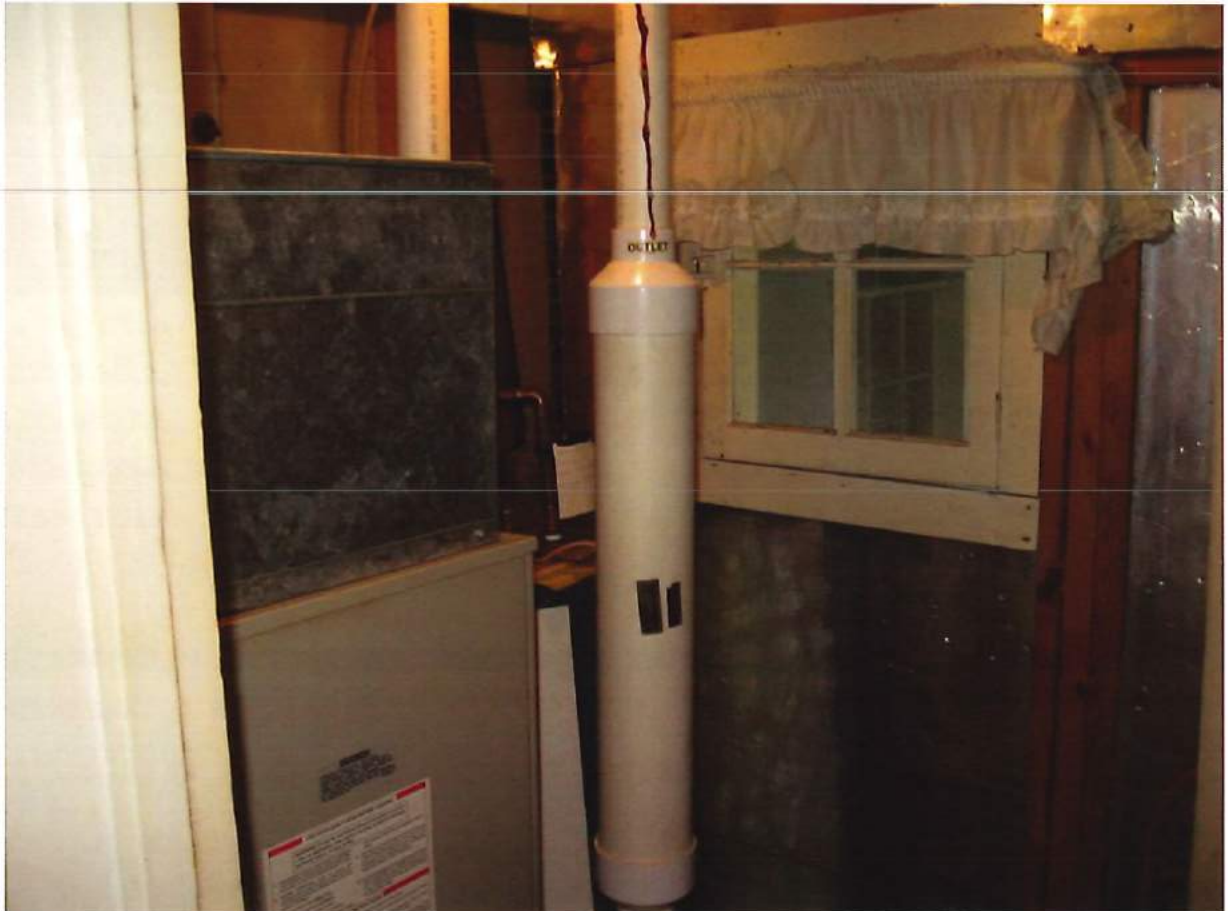
*Removal of the furnace allowed for the creation of the short hall.
Note the window which remains today.*

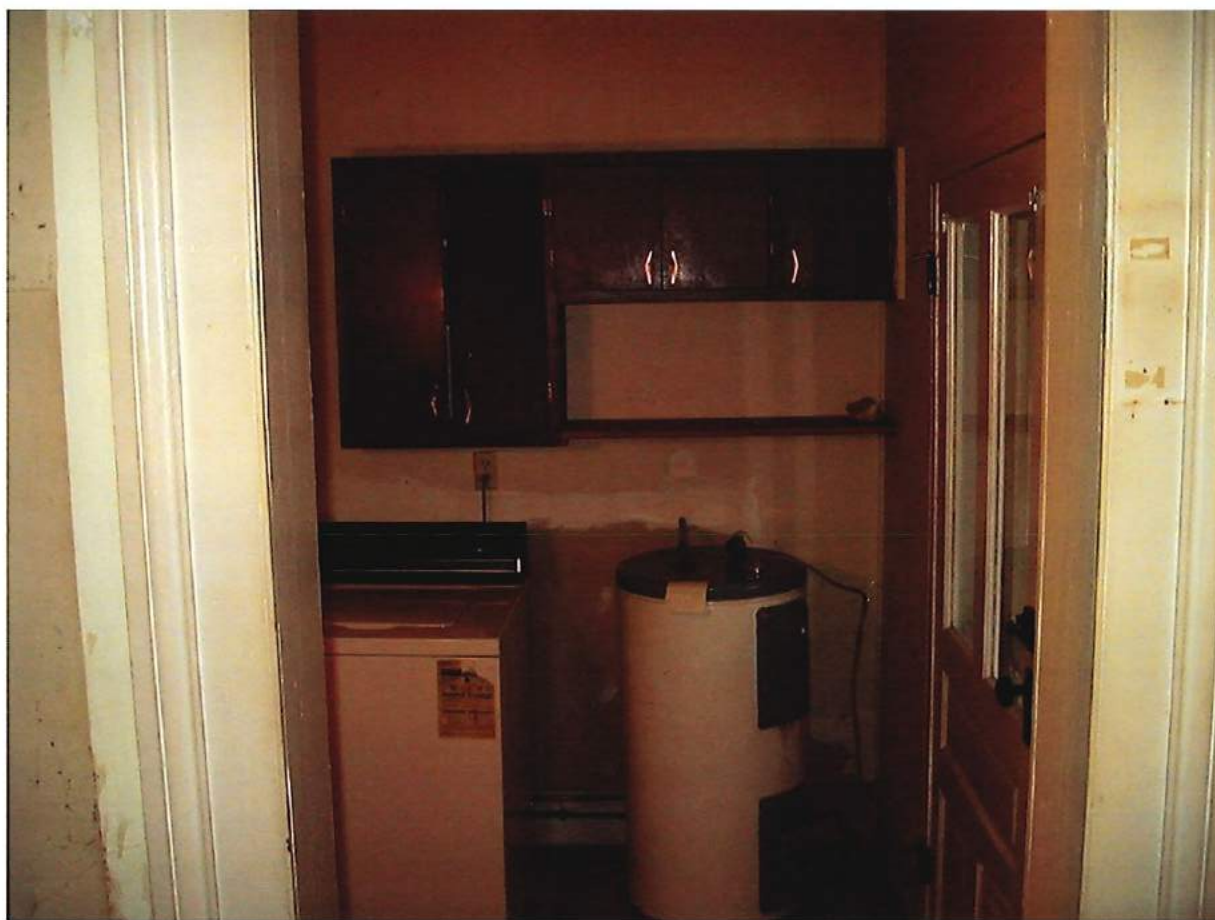
View into the old laundry room. The ½ bath is out of view to the left.

During renovation a doorway was cut behind the hot water tank to create access to the garage, which ultimately was included as living space for the pantry, new laundry area, and master bedroom en suite. Although these two small rooms and their interior walls were demolished, the exterior door shown to the right opening onto the back porch is still in

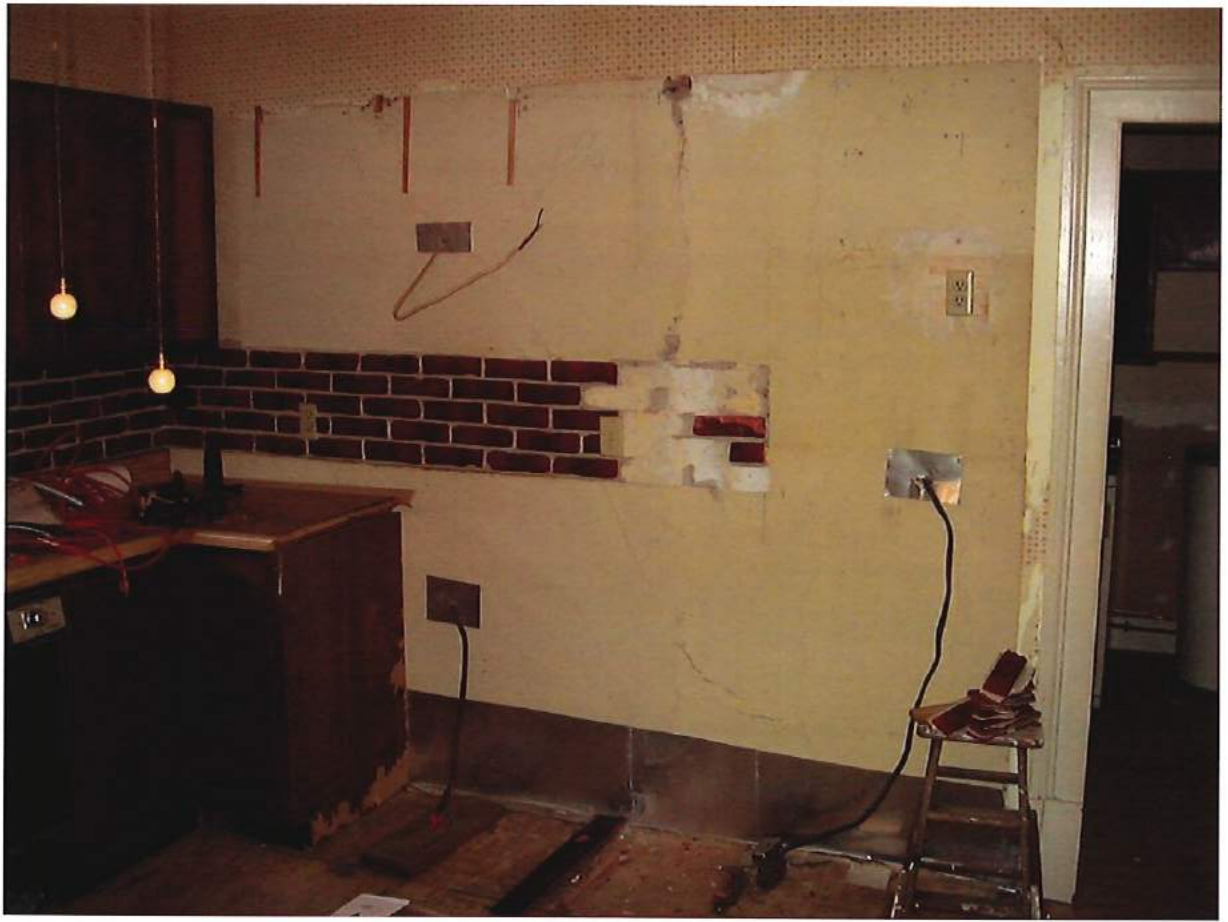
This interior wall was removed. The chimney is embedded in the wall. The laundry and ½ bath are through the doorway. The kitchen oven and cooktop (removed before this photo) were built-ins just left of the doorway. That's a chrome dishwasher knob at the far left beneath the countertop. The backsplash was a glued-on faux brick veneer.

Outside access to the kitchen was via the back porch door into the laundry, then through the doorway into the kitchen. This wall was removed to achieve balanced space utilization for the renovated kitchen and dining areas.

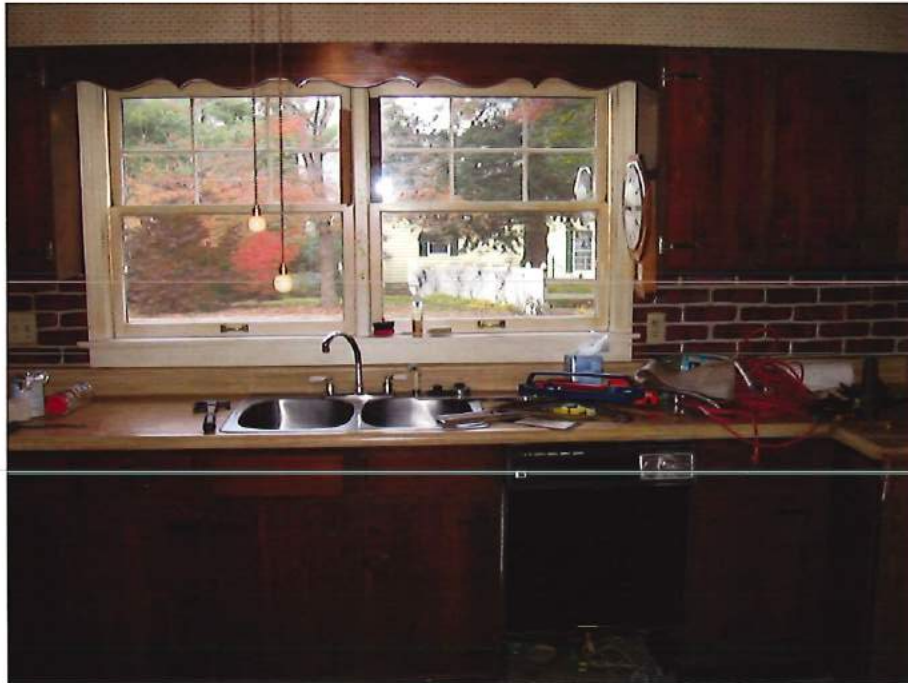
View facing north. The short double window was replaced with an original sized single 6 over 6 window. The refrigerator was located on the wall to the left (not shown).

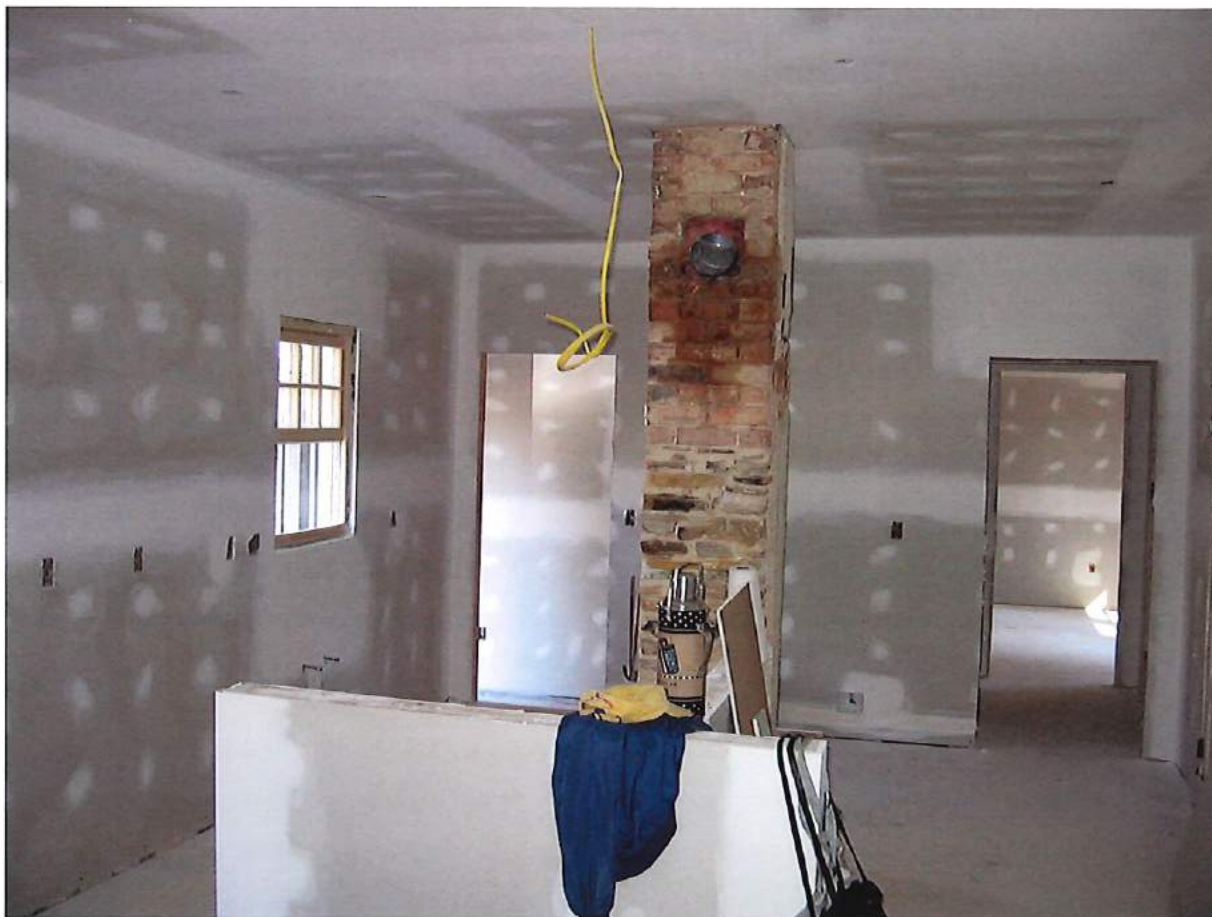
The new kitchen/dining interior rough-in has been completed and awaits cabinets and finish work. Two new doorways were cut into what was originally the exterior east side of the house. The doorway on the left leads to the back hall. The ½ bath used to be just in front of this doorway. In front of the doorway to the right was the old clothes washer and hot water tank. It leads past the new laundry area and pantry then into the master bedroom en suite.

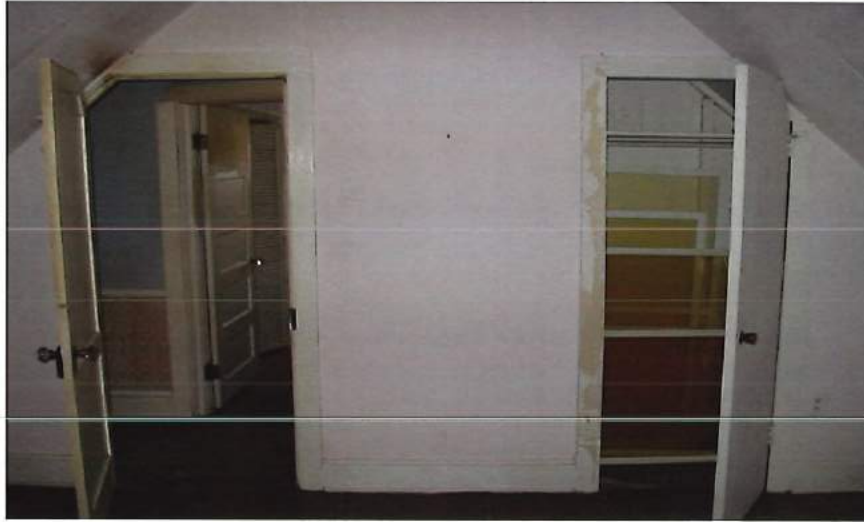
Entry door (left) before reversing. Closet (right) before demolition.

An odd shaped bedroom door was originally fitted to the narrow space between the slanted ceiling and the chimney. It was kept as found, but modified from right swing to left swing. This change kept the top of the door from striking the ceiling and causing damage. It now functions as it should, however the light switch is now located behind the door. (Relocating the switch during the renovation was not practical due to wall and ceiling framing constraints.) Installation of a ceiling fan light fixture with on/off pull cords eases the inconvenience.

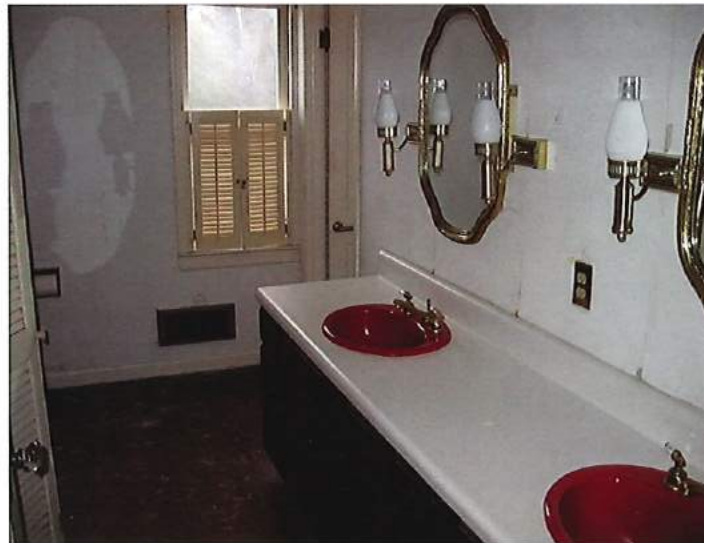
View just inside the bath door. The double vanity and its wall were removed. The toilet, not visible here, is in a nook at the far left rear. On the immediate left was a makeshift closet with double bifold louvered doors much like the ones removed from the upper foyer.

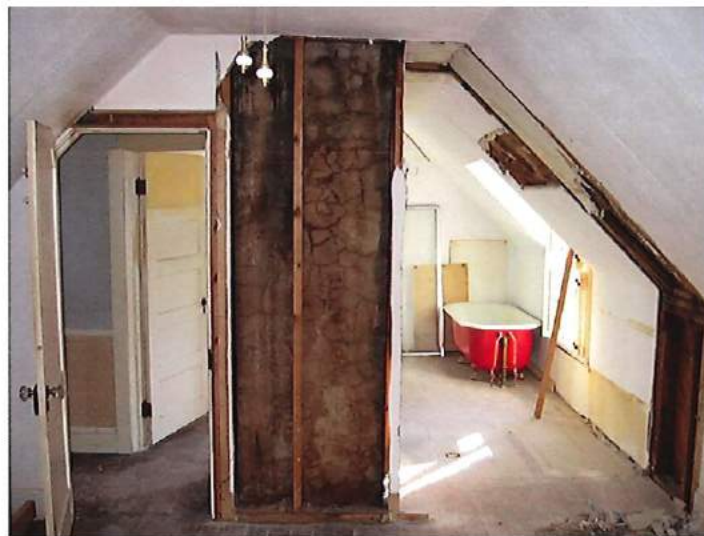
Partial view of the bathroom when the bedroom closet was removed to create a space for the mechanical room. The brick chimney for the Parlor fireplace, parged with mortar, is exposed.

The bathtub is seen in the back corner of the bathroom, and a fiberglass shower stall was located in front of the tub. The shower, as well as the bedroom closet, had been torn out prior to the taking of this photo.

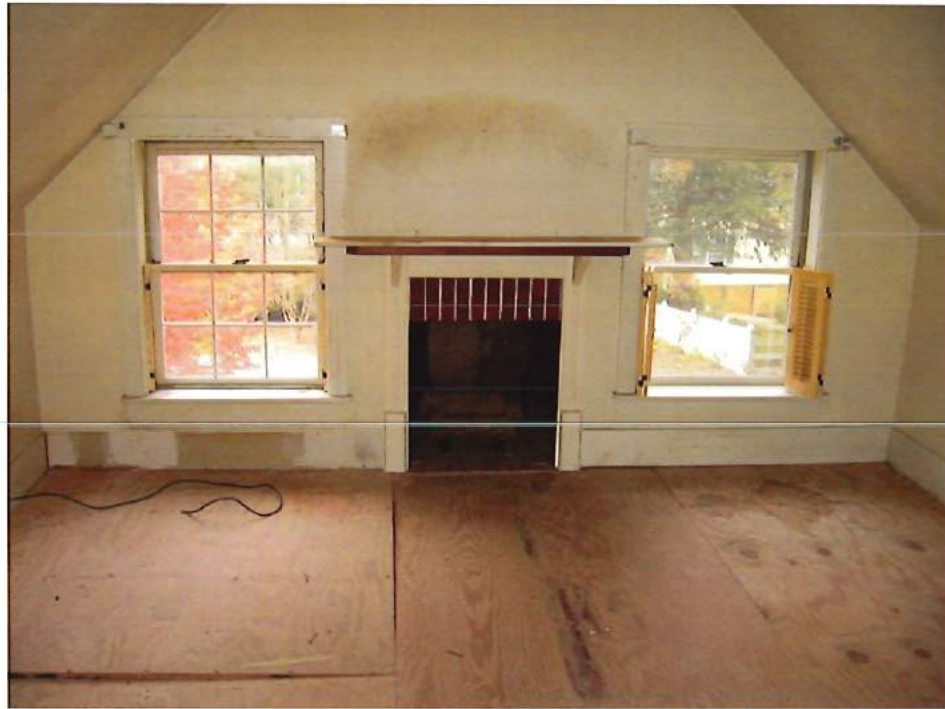
The upstairs den as purchased.

The two windows straddle a space where an upstairs fireplace originally stood. This fireplace, however, must have fallen into extreme disrepair and had been torn out. To fill the void, a former owner had constructed a faux fireplace from plywood. A featureless mantle built from plain lumber was nailed to the wall. Nothing remained of the original hearth and the hole in the floor had been covered in plywood. It would have been prohibitively expensive to recreate an authentic stone fireplace, so the exposed stone and flue were filled with insulation, the entire wall sheetrocked, and the floor hole repaired. Before closing it all up, this upstairs fireplace's flue was observed to have been constructed running in parallel to the flue from the fireplace directly under it. It is remarkable how such a complex double flue was formed inside the chimney using rough fieldstone. It is a credit to the stonemasons who built it long ago.

Also missing from this room was the original floor. It was likely removed because undersized joists were originally used and the floor had developed a severe sag over time. To remove the floor sag, the former owner sistered new 2 X 4s to the sagging joists. They replaced the floor boards with plywood.

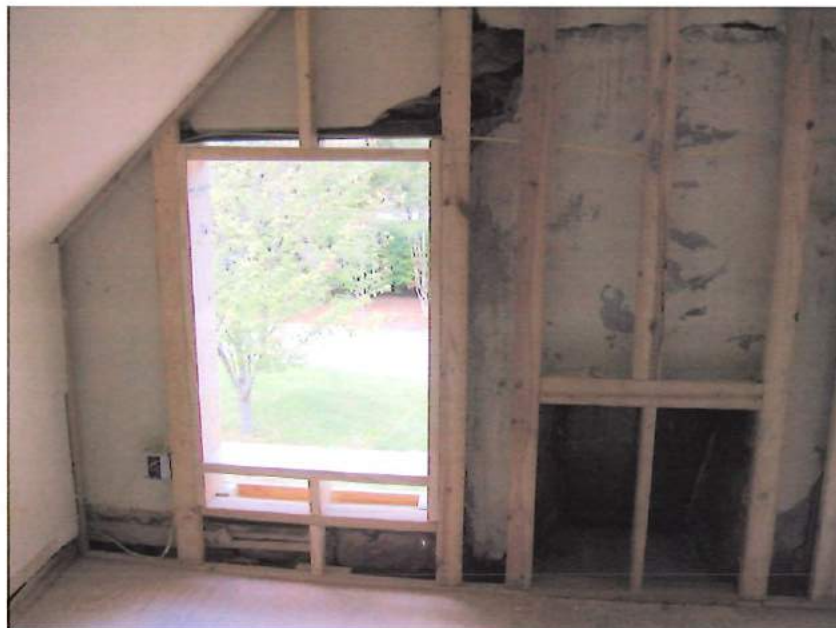
Mantle removed. Wiring and wall reframing for new windows completed.

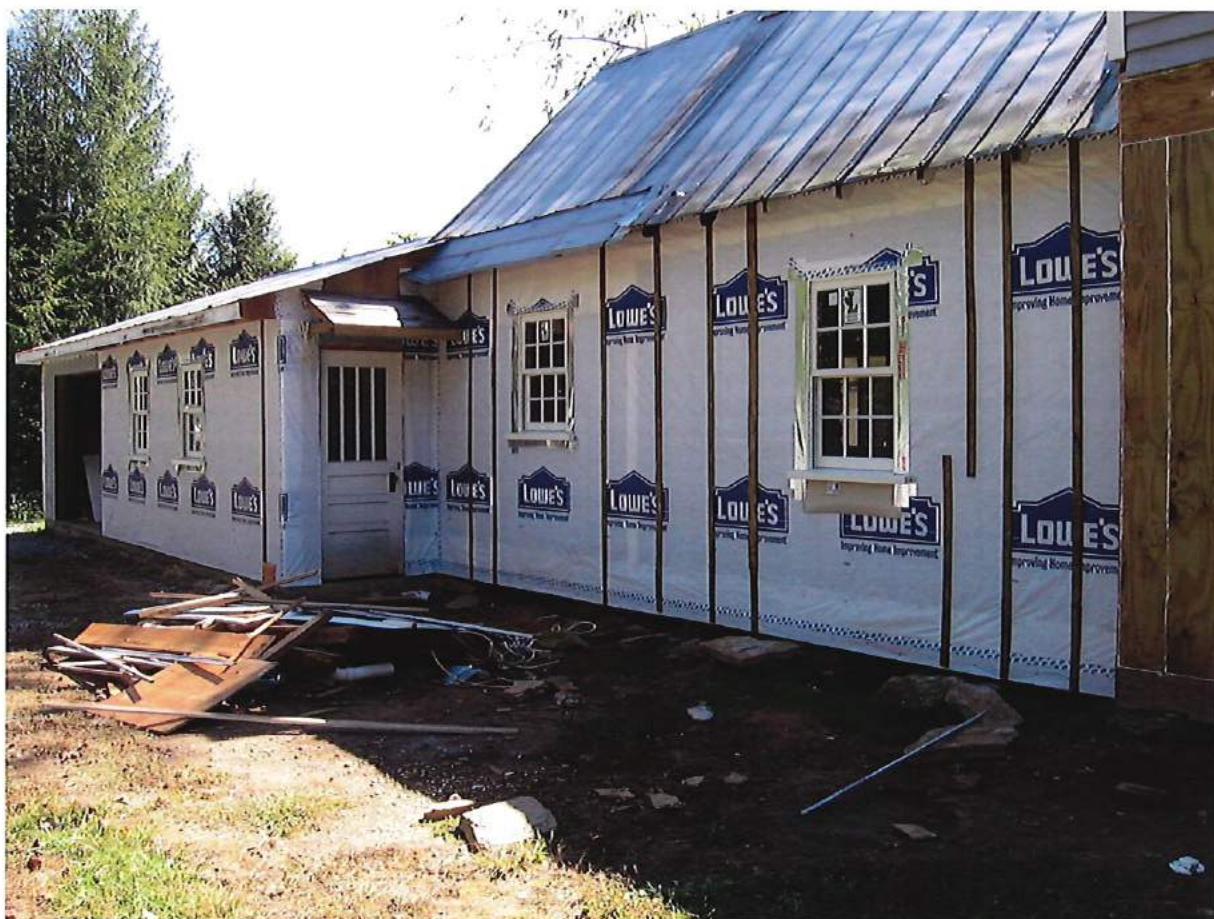
A shed roof above the side door was installed after demolition of the earlier side porch addition. The T-111 siding was house-wrapped and furring strips are partially in place awaiting new clapboards. Note the placement of all new windows and the garage door.

The garage entry door under the porch was kept as an entry into the back hall of the house. The two overhead doors were removed, with all garage space behind them repurposed for expanding first floor home living space. The far left window was replaced with one overhead garage door to allow for a single car garage.

of the 5-V crimp metal roofing had to be replaced where the covered entrance was removed. A small shed roof was built over the door as a more probable feature that would have been found on the house originally. It was built to mimic the style of the front porch roof. This is the only feature added to the exterior of the house and was recommended by the NCHP office. It is worth noting here that when damaged metal roof panels were being replaced the exposed topside of the roof rafters revealed countless nail holes, and that small pieces of wood roof shakes were found in the attic near the chimney. One must conclude that the original roof of the house was wood shakes. In all probability the tin roof was installed many decades ago, although it is not possible to say when this was done.

New clapboard, window casings, drip edge and skirt boards were installed as needed to match the original external design features of the house.

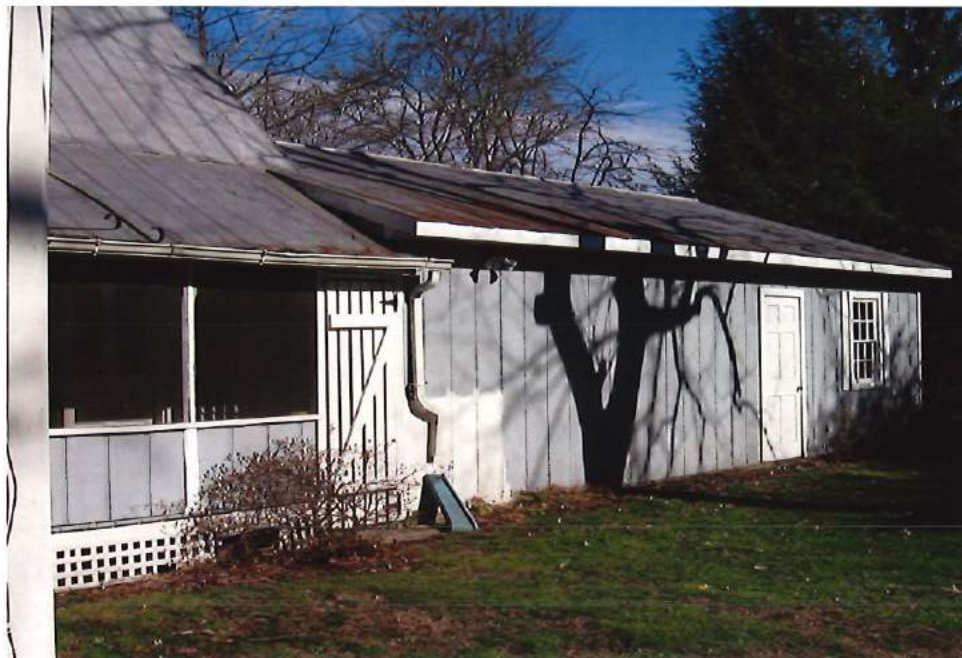
South exterior view as purchased.

The south facing (back) porch had been partially enclosed at some point. This was removed in keeping with the original appearance.
